# SERVICE BULLETIN

<b>Classification:</b> EL10-008d	<b>Reference:</b> NTB10-033d	<b>Date:</b> August 6, 2015
-------------------------------------	---------------------------------	--------------------------------

## AV CONTROL UNIT REPLACEMENT REQUIRES CONSULT-III PLUS CONFIGURATION

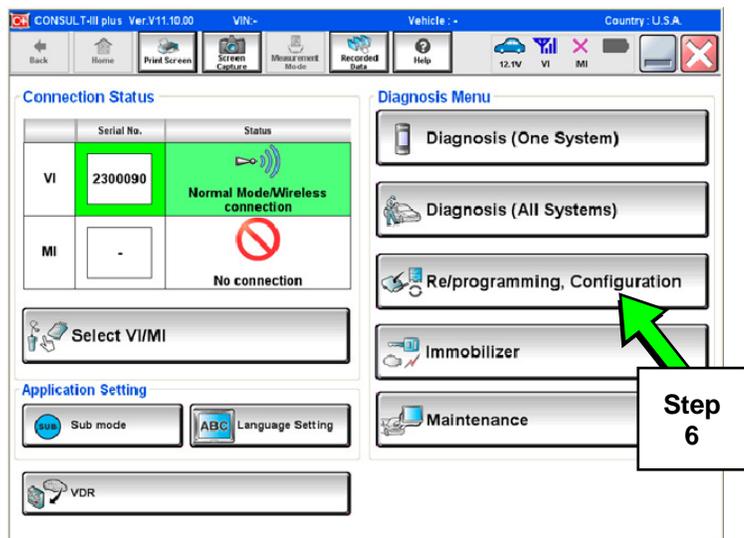
Figure 1

6. Select **Re/programming Configuration**.

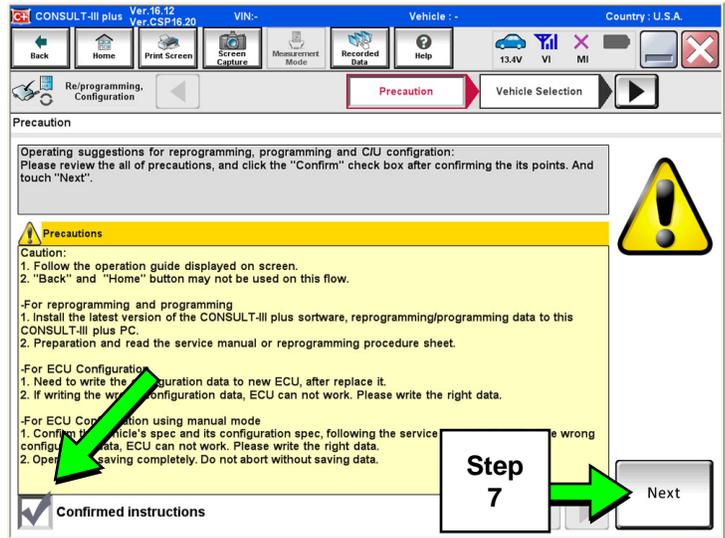
Figure 2

7. Read the General Precaution.

When finished, touch the “Confirmed instructions” box to insert a check mark, then select **Next**.

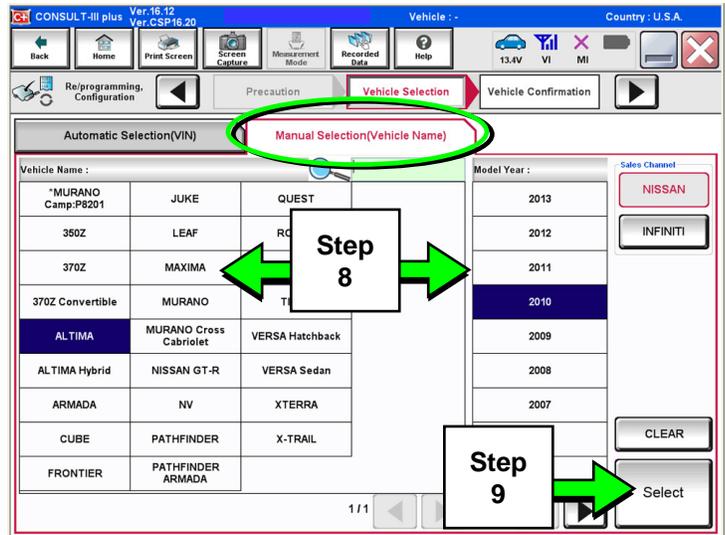
Figure 3

8. Select the **Manual Selection (Vehicle Name)** tab, then select the applicable **Model** and **Year**.

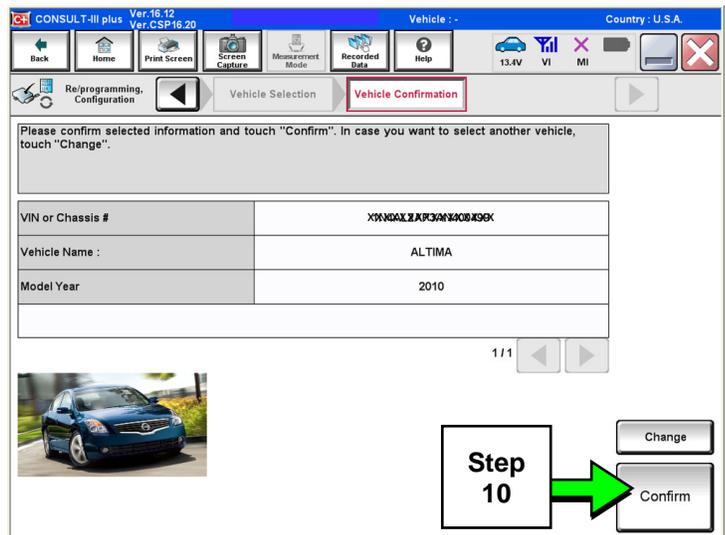
Figure 4

10. Confirm the correct **Model Name** and **Model Year** are displayed.

When finished, select **Confirm**.

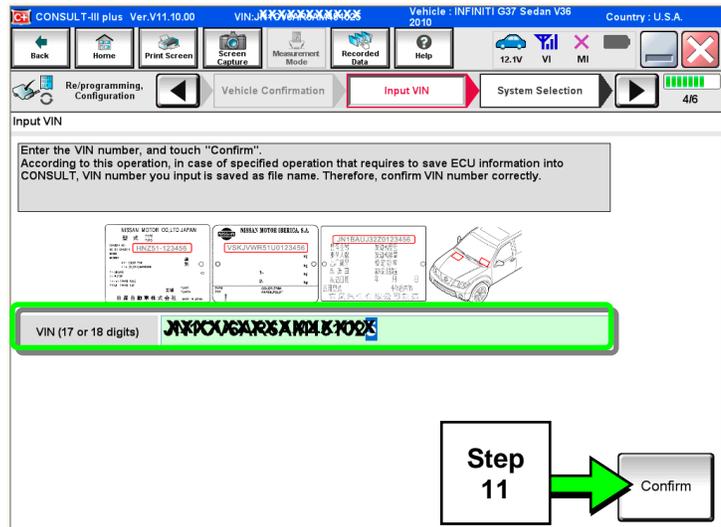
Figure 5

11. After system call completes, confirm the correct VIN is displayed.

When finished, select **Confirm**.

**NOTE:** If the VIN displayed is incorrect, input the correct VIN. When finished, select **Confirm**.

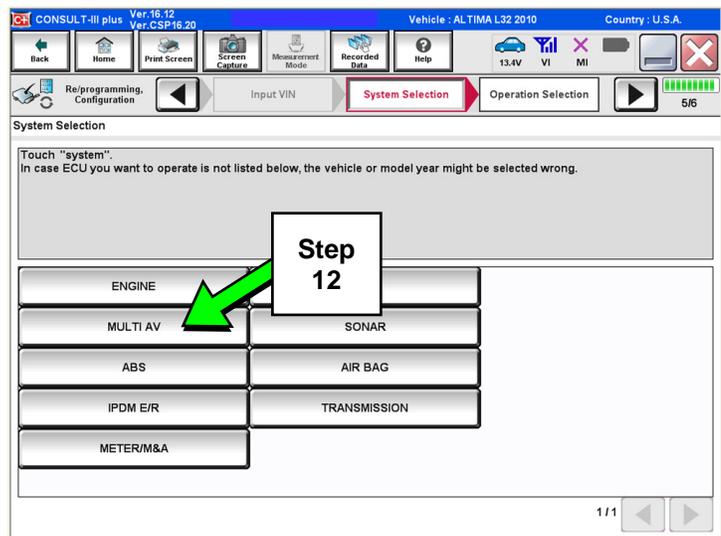
Figure 6

12. Select **MULTI AV**.

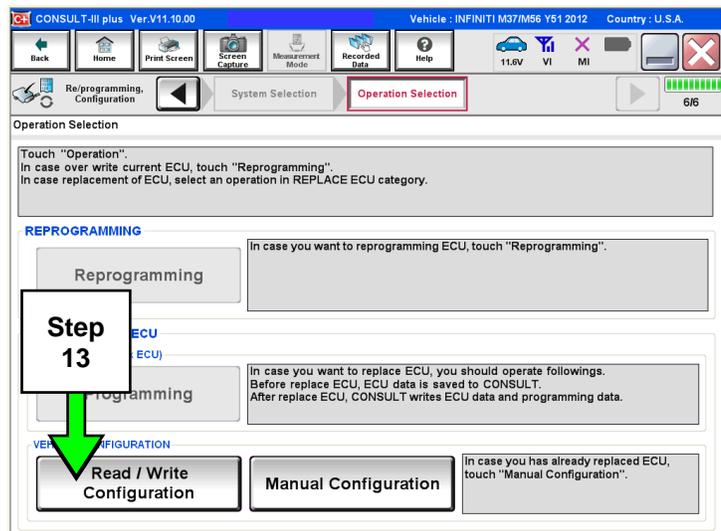
Figure 7

13. Select **Read/Write Configuration**.

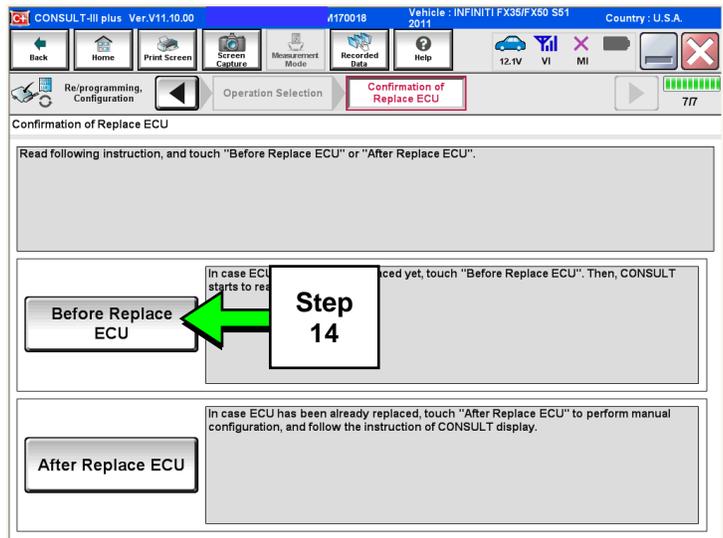
Figure 8

14. Select **Before Replace ECU**.

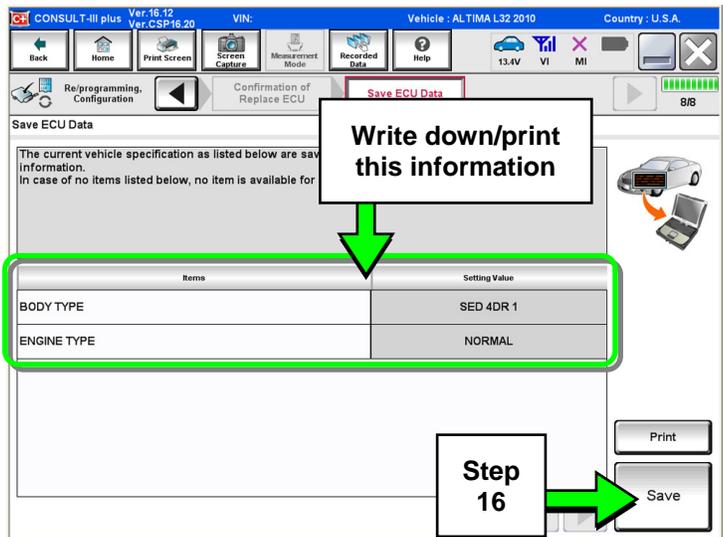
Figure 9

15. Confirm current configuration and write it down.

- Configuration can also be printed with the **Print Screen** button or **Screen Capture** button.

**NOTE:** Configurable options will differ between models. Your screen may look different.

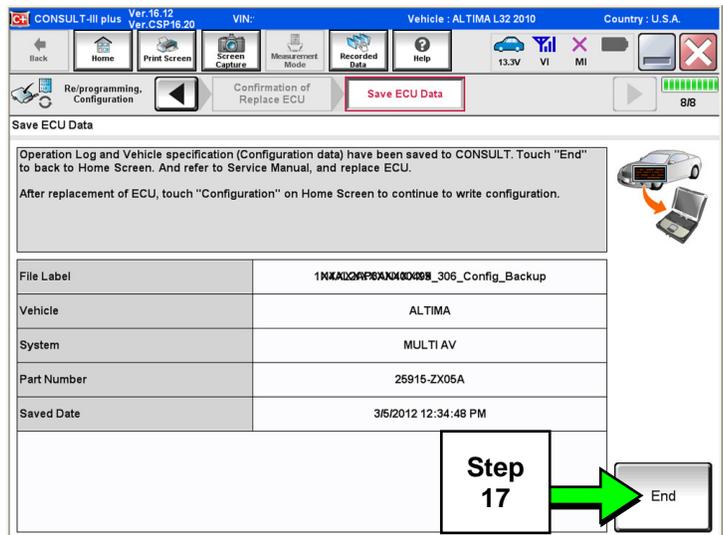
Figure 10

16. Select **Save**.

**NOTE:** If the configuration data cannot be saved, replace the AV Control Unit as instructed in the applicable Electronic Service Manual (ESM) and then proceed to **PART 3: Perform Multi AV Initialization** on page 7 of this bulletin.

17. Select **End**.

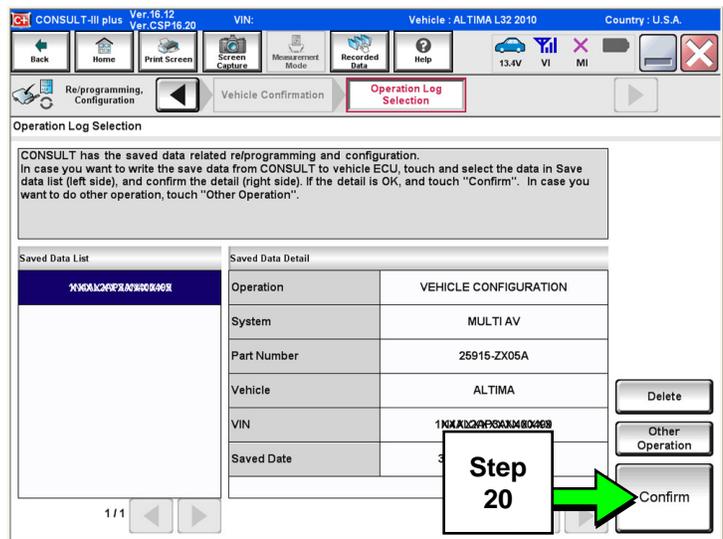
Figure 11

20. Select **Confirm**.

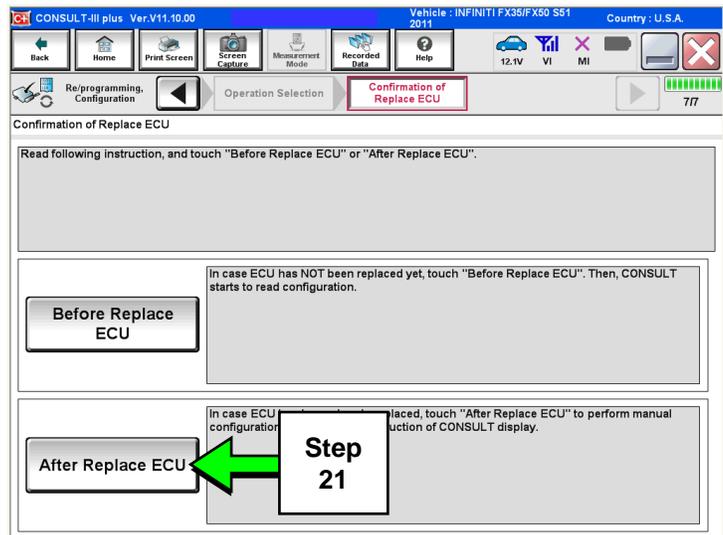
Figure 12

21. Select **After Replace ECU**.

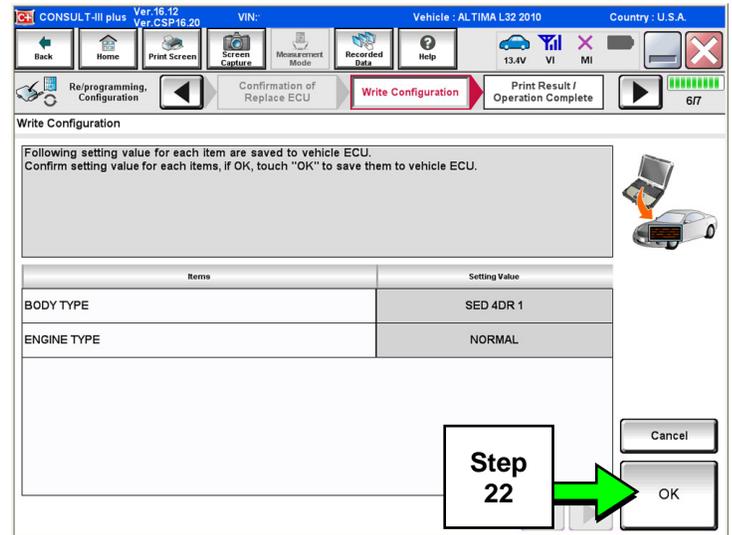
Figure 13

22. Select **OK**.

If an error message does not display:

If an error message does display:

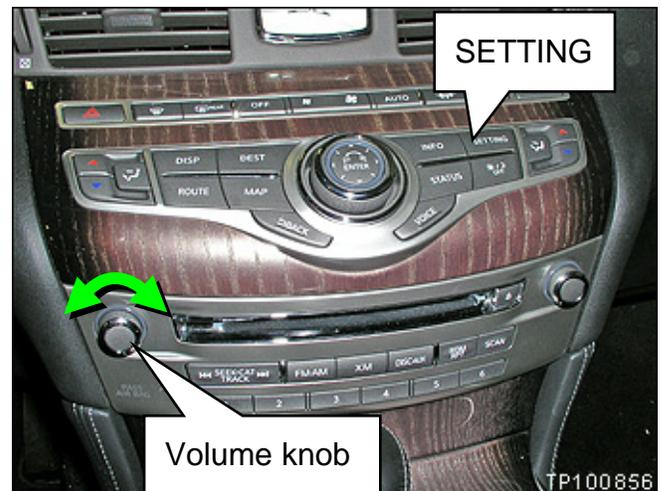
Figure 14

- Press and hold the **SETTING** button (see Figure 14).
- While holding the **SETTING** button, turn the volume control knob 40 clicks or more.
  - The volume control knob can be turned either direction.
  - When the system goes into the System Diagnostic Menu, the screen in Figure 15 will display.

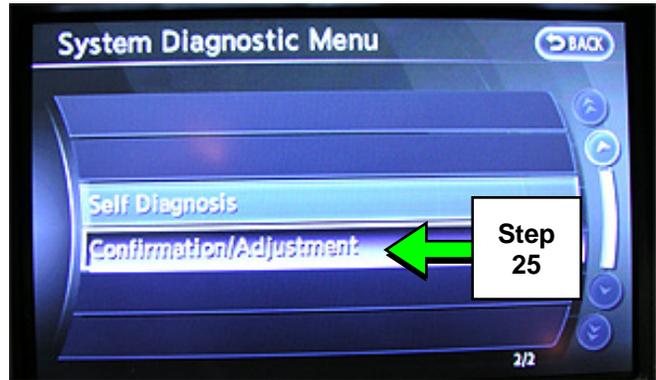
Figure 15

25. Select **Confirmation/Adjustment**.

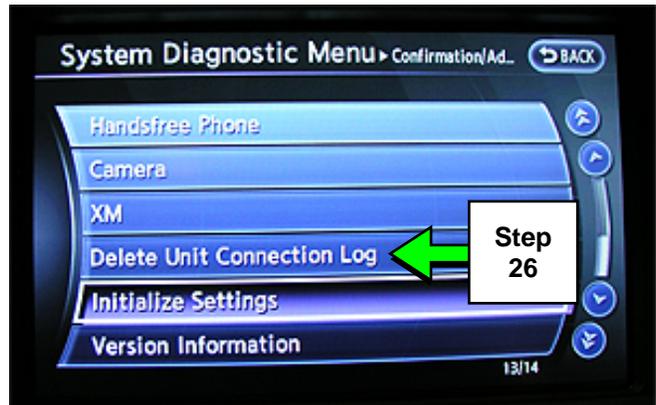
Figure 16

26. Select **Delete Unit Connection Log**.

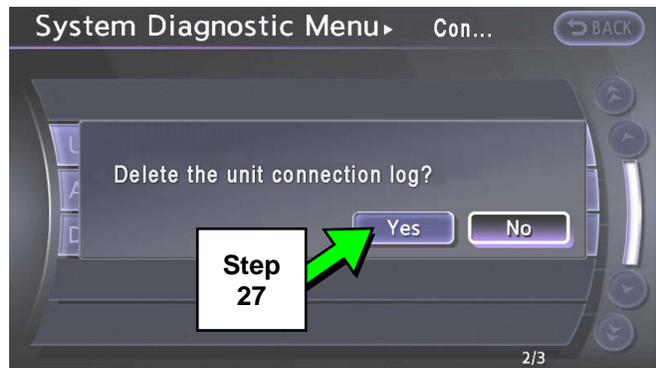
Figure 17

27. Select **Yes**.

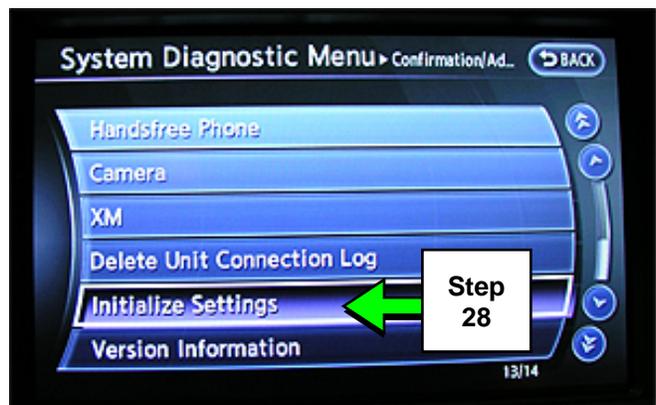
Figure 18

28. Select **Initialize Settings**.

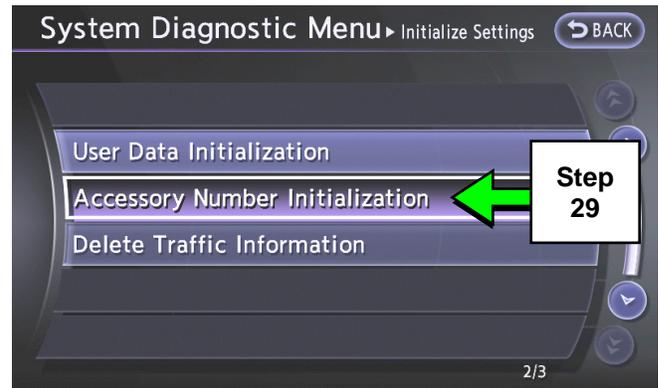
Figure 19

29. Select **Accessory Number Initialization**.

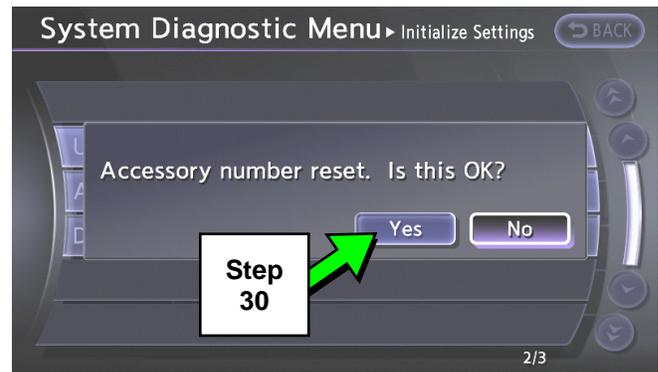
Figure 20

30. Select **Yes**.

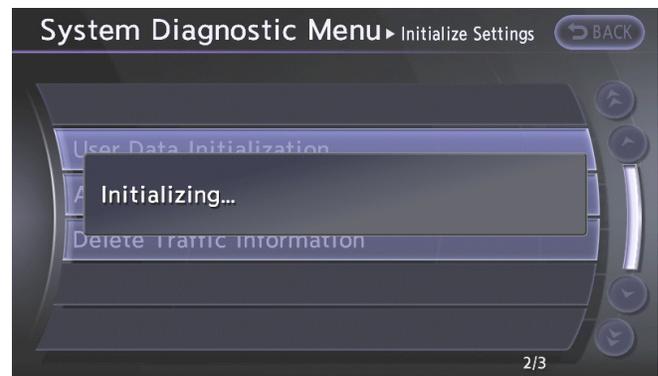
- The screen in Figure 21 will display while initializing.

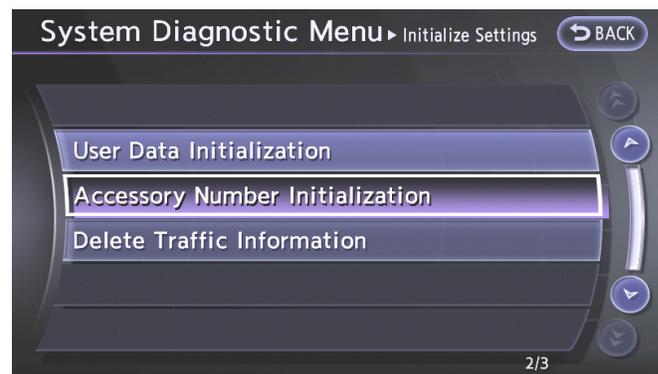
- The screen in Figure 22 will display when initialization is complete.

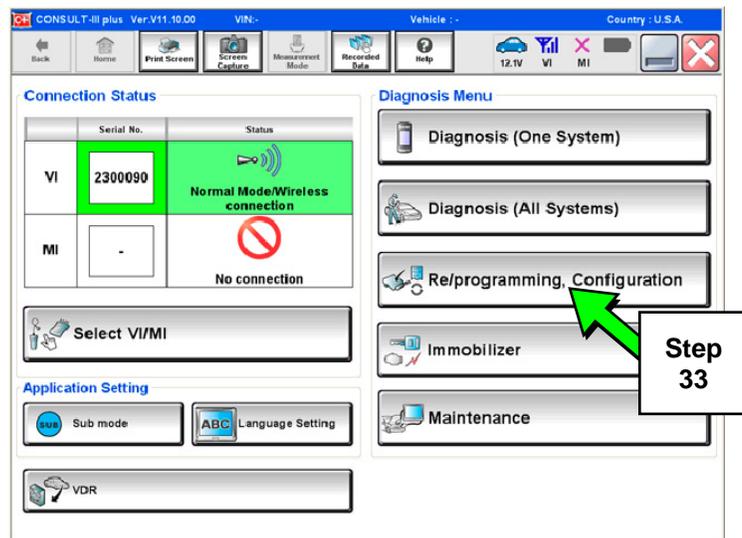
**NOTE:** If the screen in Figure 23 is not displayed, click on the **Home** icon.

33. Select **Re/programming Configuration**.

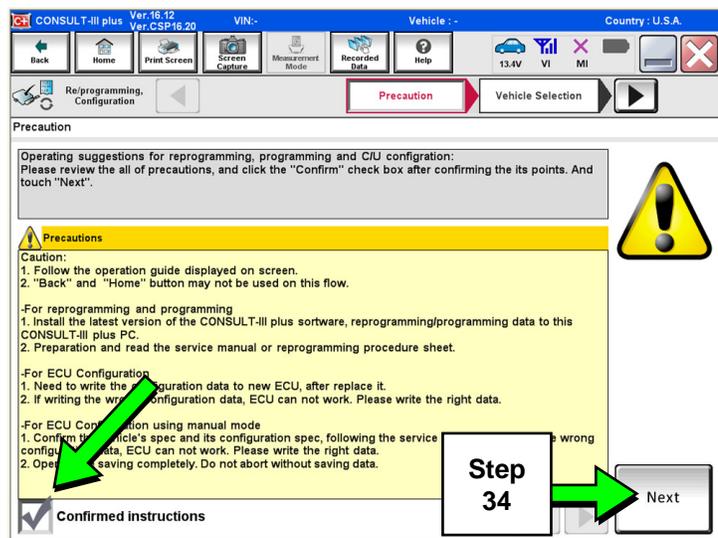
Figure 24

34. Read the General Precaution.

When finished, touch the "Confirmed instructions" box to insert a check mark, then select **Next**.

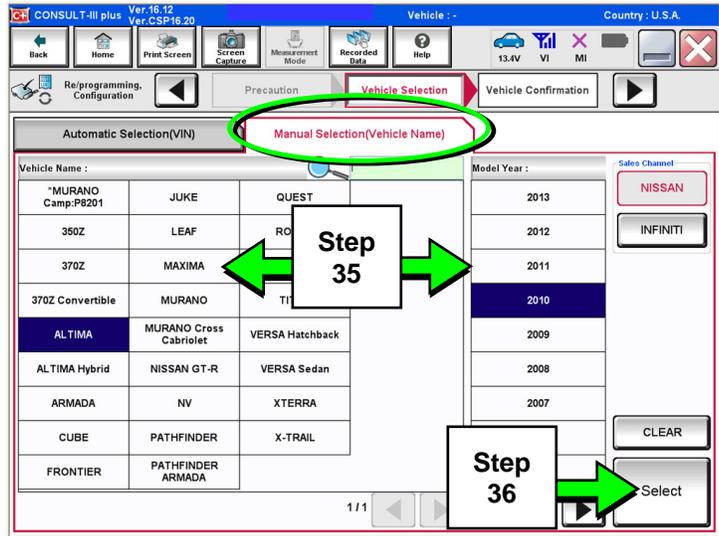
Figure 25

35. Select the **Manual Selection (Vehicle Name)** tab, then select the applicable **Model** and **Year**.

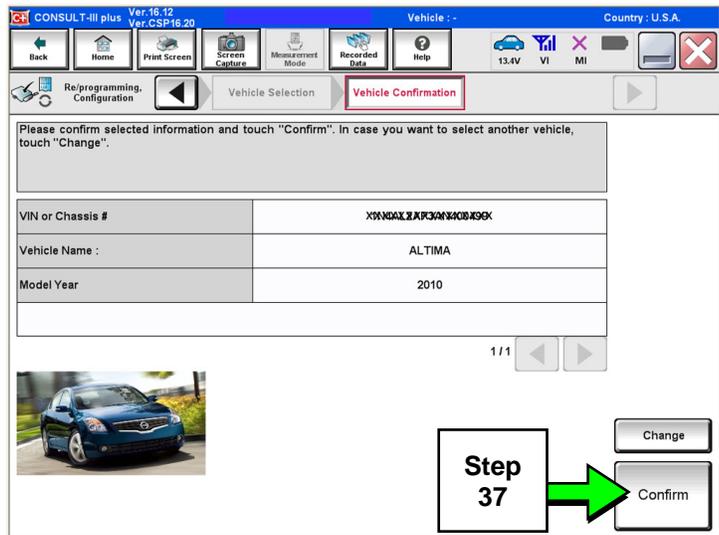
Figure 26

37. Confirm the correct **Model Name** and **Model Year** are displayed.

When finished, select **Confirm**.

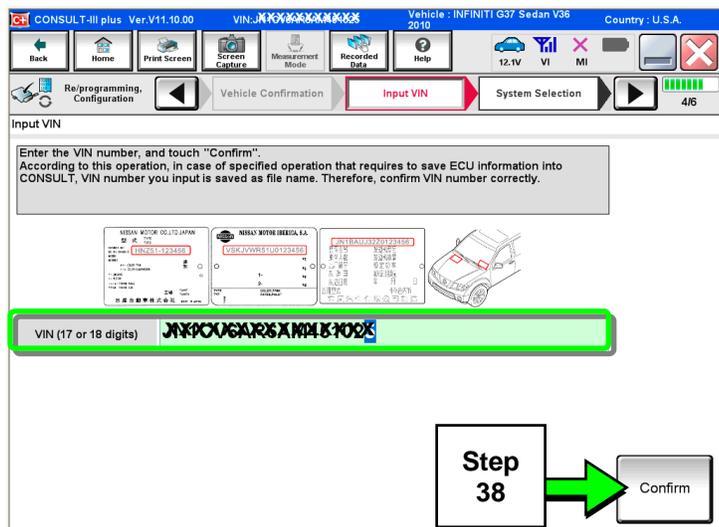
Figure 27

38. Confirm the correct VIN is displayed.

When finished, select **Confirm**.

**NOTE:** If the VIN displayed is incorrect, input the correct VIN. When finished, select **Confirm**.

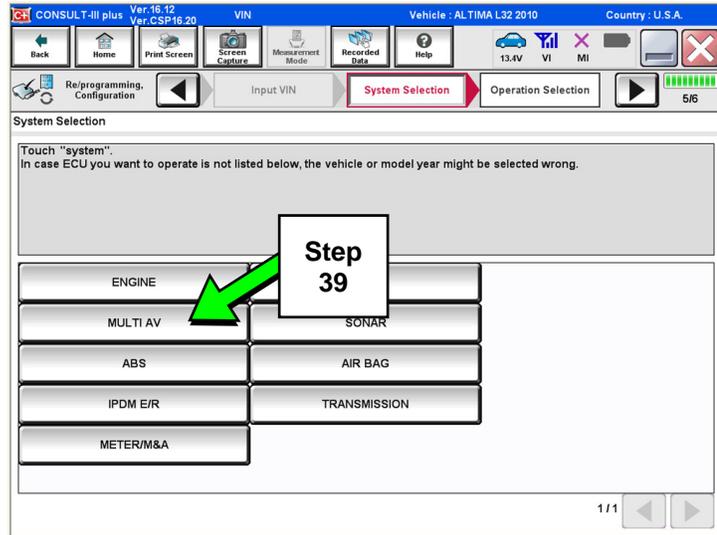
Figure 28

39. Select **MULTI AV**.

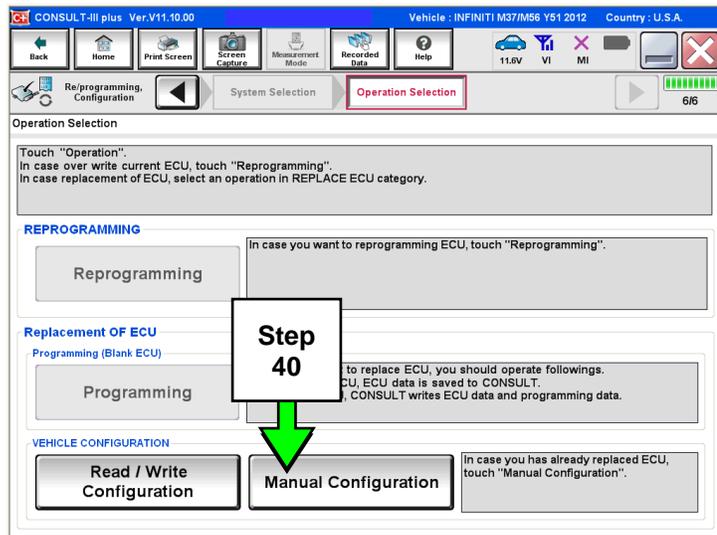
Figure 29

40. Select **Manual Configuration**.

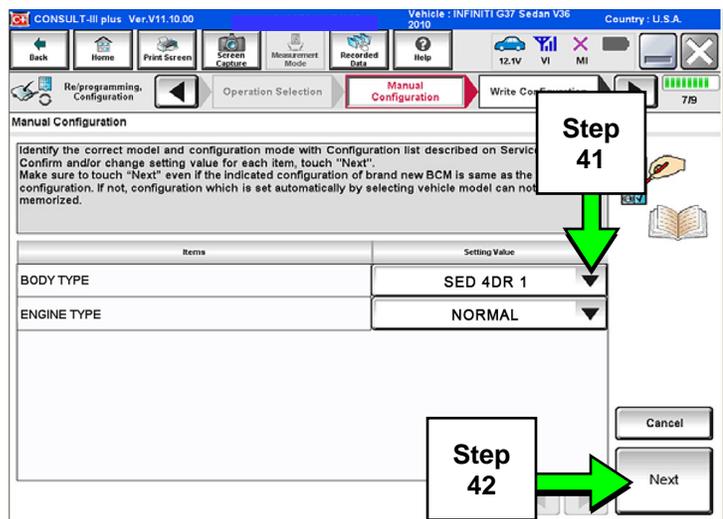
Figure 30

41. Use the drop down menus to select the **Configuration** options that were printed or written down in step 15.

- Configurable options will differ between models. Your screen may look different from Figures 30 and 31.

42. Select **Next**.

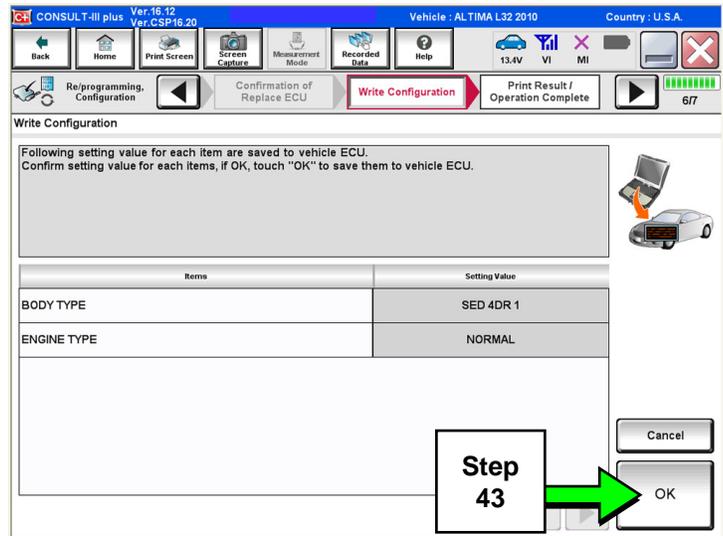
Figure 31

43. Confirm the configuration displayed is correct, then select **OK**.
