Service Bulletin

Bulletin No.: 15-NA-082

Subject: Clunking Noise from Front of Vehicle During Turns and/or Bumps

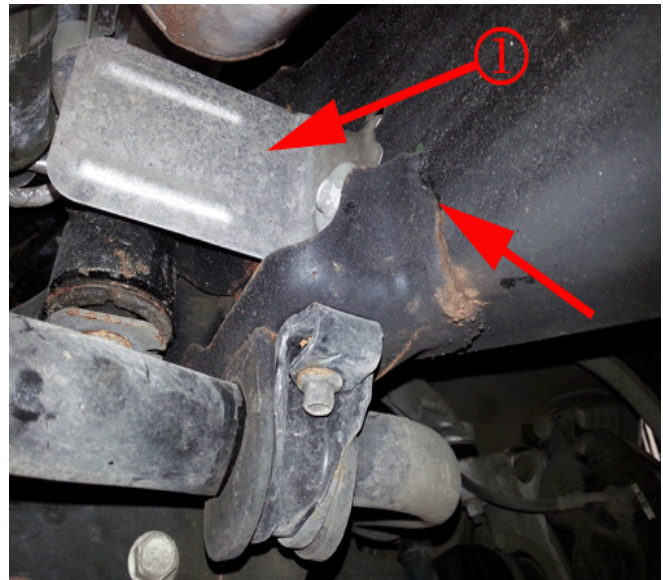
2. Raise the vehicle in the air and inspect the stabilizer shaft frame brackets (both left and right) for any abnormalities or cracks and inspect welds to ensure good alignment and integrity. Refer to Lifting and Jacking the Vehicle in SI.

Note: Be sure to inspect frame rails for any cracks or damage in relation to the stabilizer bracket. If the frame rail itself is cracked or damaged, repair should not be attempted.

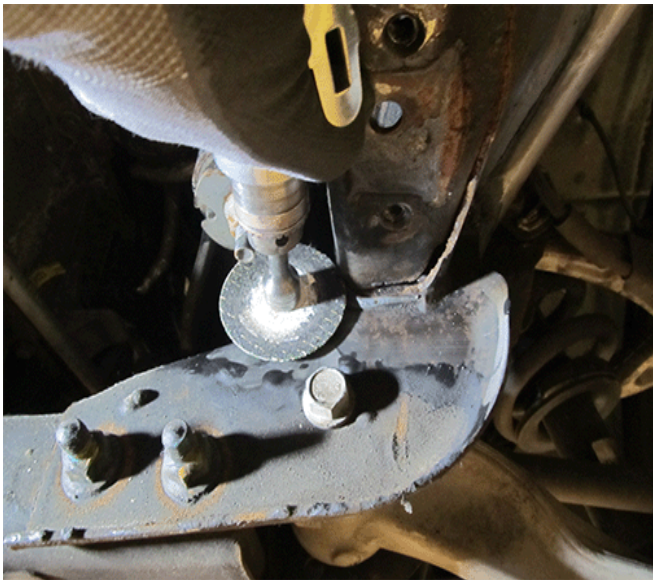
4223062

3. Once verified that the bracket is damaged or the welds are insufficient, remove the stabilizer shaft. Refer to Stabilizer Shaft Replacement in SI.
4. On 4WD models, once the stabilizer shaft is removed also remove the front frame/front axle mount exhaust heat shield (1) located above the stabilizer bracket.
5. With the stabilizer shaft and shield removed, using a rag and wax/grease removing solvent, remove the wax coating and any grease, oil, or undercoating from the truck frame in the affected repair area.

Important: Be sure to remove all wax coating around the areas of the bracket. If the wax coating is not fully removed, this could affect the weld quality when installing the new bracket.

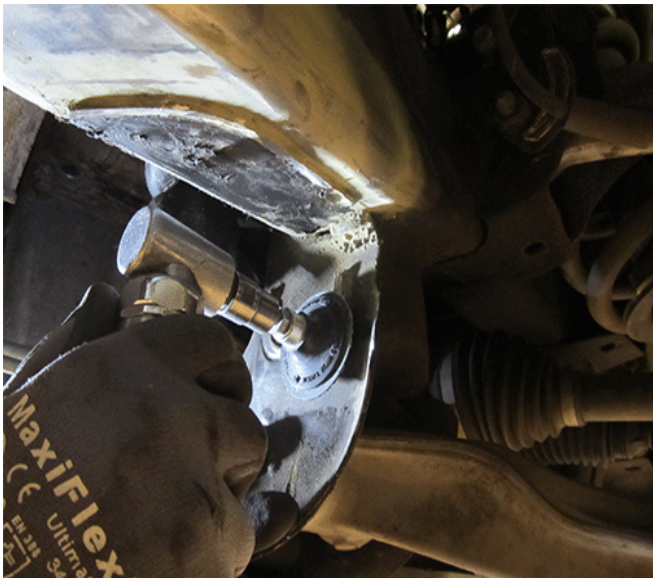
4223065

6. After all the wax coating is removed, using a cut off wheel, remove the old bracket from the frame.

Important: Be sure to not cut the frame in process of removing the bracket.

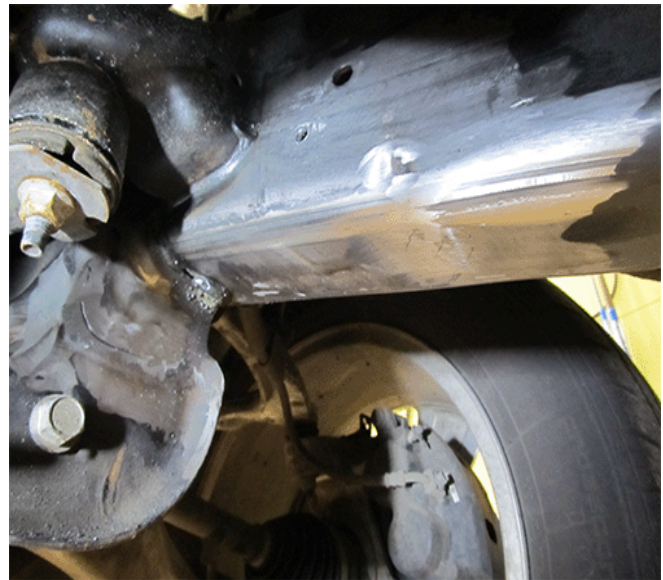
4223069

7. After the bracket has been removed, using an angle grinder with 24 grit sand paper or equivalent clean the areas of any excess bracket weld material from the frame so that the new bracket can sit flush in the location of the old one.

Important: Be sure to not grind away any frame material, only remove the weld material.

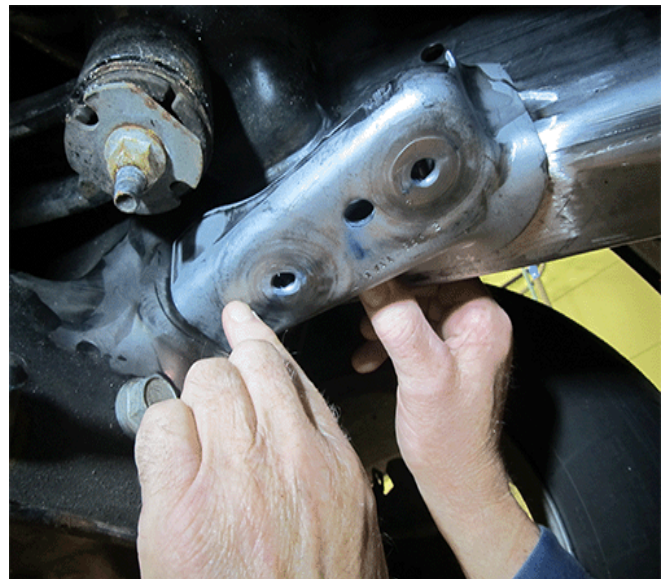
4223071

8. Clean the area of all debris in preparation of the new bracket to be welded to the frame.

Important: Be sure to inspect frame rails for any cracks or damage in relation to the stabilizer bracket. If the frame rail itself is cracked or damaged, repair should not be attempted.

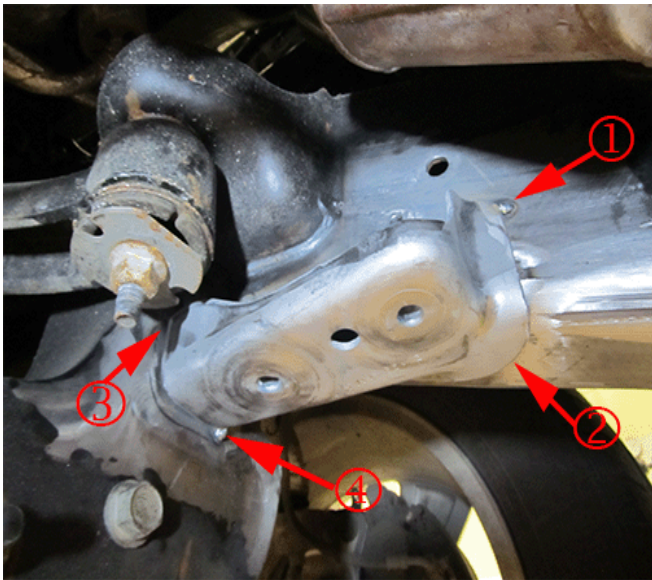
4223074

9. After the area is clean of all debris, place the new bracket in the location of the removed one. The bracket should seat against the frame crossmember bracket in the most forward position, along the lower surface of the frame rail, and along the inner surface of the frame rail in the rear.

Note: The new bracket will need the welding locations stripped of all coating. Be sure to grind all edges of the new bracket so that the quality of the weld will not be affected.

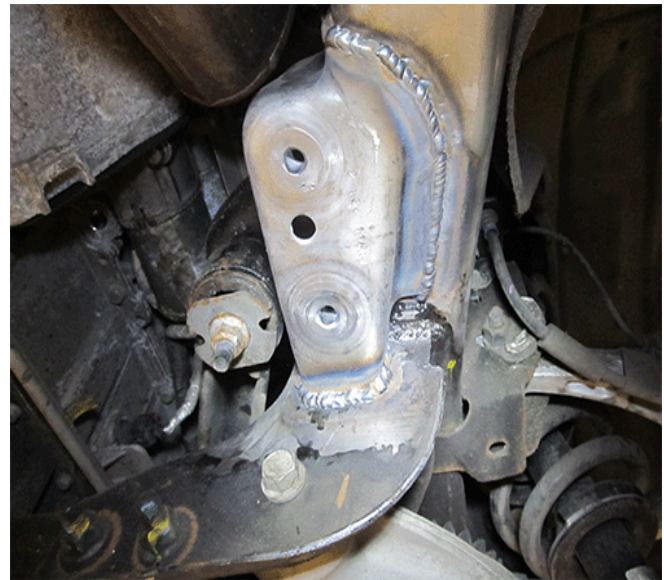
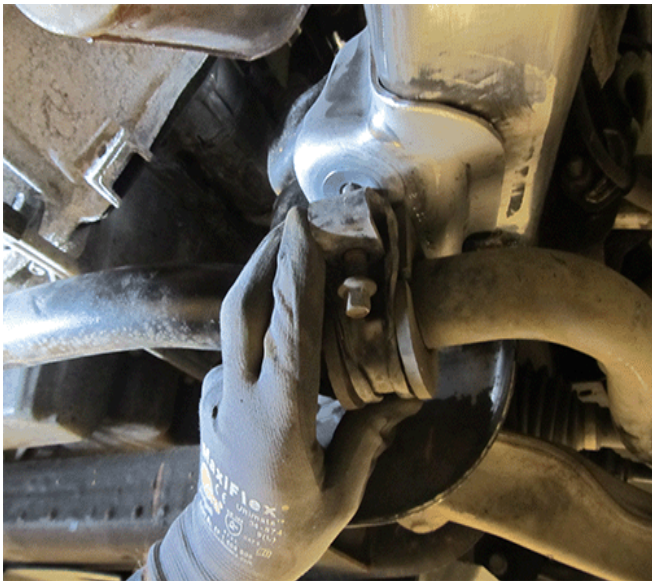
10. After the bracket is in location, tack weld the bracket to the frame in all 4 corners of the bracket. This will keep the bracket from moving while welding the bracket fully to the frame.

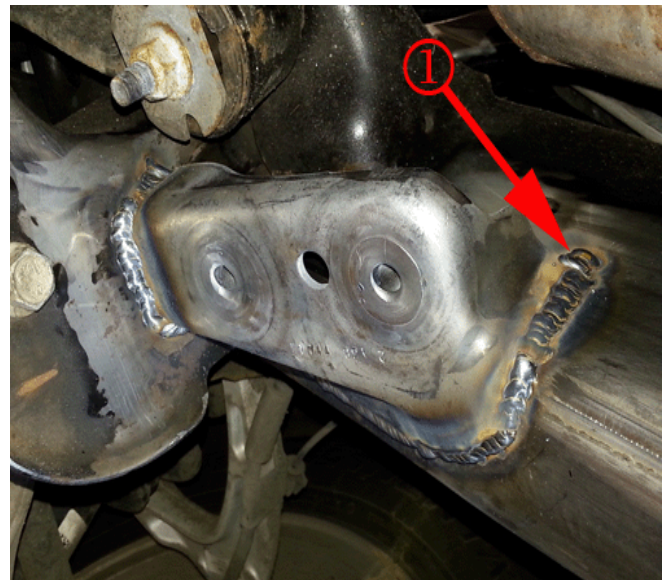
4279397

11. After the bracket is tack welded in the location, loosely position the stabilizer shaft to verify that the bracket is in the correct location. Refer to Stabilizer Shaft Replacement in SI.
12. After verifying that the bracket is in the correct location, remove the stabilizer shaft. Refer to Stabilizer Shaft Replacement in SI.

13. Continuous-weld the new bracket into position. Ensure the rear vertical weld (1) is extended approximately 15 mm above the edge of the bracket.

Note: When welding, be sure to start from the bottom of the bracket and work your way upward.

Note: Gas metal arc weld using ER70S-3 electrode and an Argon CO2 protective gas mixture. Alternatively, meeting AWS 7013.

Note: Provide a continuous weld around the bracket. If access does not permit a continuous weld, make a 6 mm minimum overlap of adjacent welds.

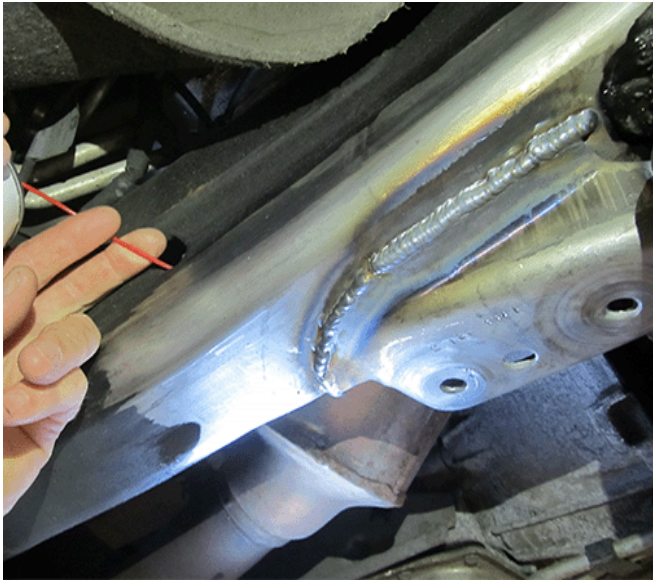
4223079

14. After the bracket has been fully welded to the frame, using Lloyd's Pure Prep™ Metal Surface Preparation P/N 25418 (10 fluid ounce bottle), or equivalent, saturate a towel or Scotch-Brite™ (3M) pad with the pre-diluted solution and scrub the area well, rendering a foaming of the Pure Prep.™ This will greatly improve adhesion and corrosion resistance in the repair areas.
15. Using a water dampened clean towel, remove any residue and dry the affected area. Dry the repair area completely using an air hose to blow dry the frame and bracket.
16. Check the repair area for phosphate treatment by wiping it to see if any corrosion residue can be picked up. Correctly treated areas will not have any residue on the surface.

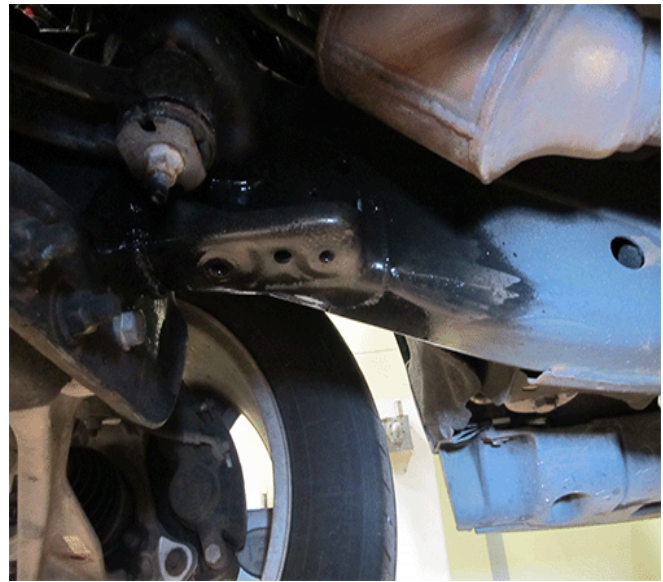
4223080

17. Apply a light flash-coat of Lloyds Kryptonite Metal Treatment P/N 36502 Life Long Rust Protection (14 ounce aerosol), or equivalent, to all bare areas of the frame where the wax coating was removed. This first coat should flash in approximately 3-5 minutes. Apply a light flash-coat to the inside of the frame rail using existing access holes, as shown. Insert the straw of the aerosol can as far as possible, and slowly work the straw back out while applying material.

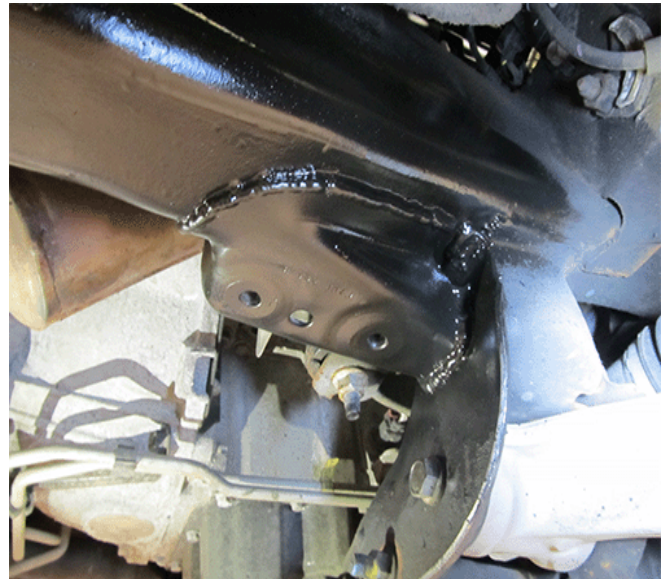
4223081

18. Apply a second coat of Lloyds Kryptonite. This can be a heavy coat; double and triple passes with this product, over a light first coat, are not a problem.
