# Program Bulletin

## CUSTOMER SATISFACTION PROGRAM

**SUBJECT:** Liftgate Strut Rod Detaches

**MODELS:** 2010-2015 Cadillac SRX  
2011-2015 Chevrolet Volt

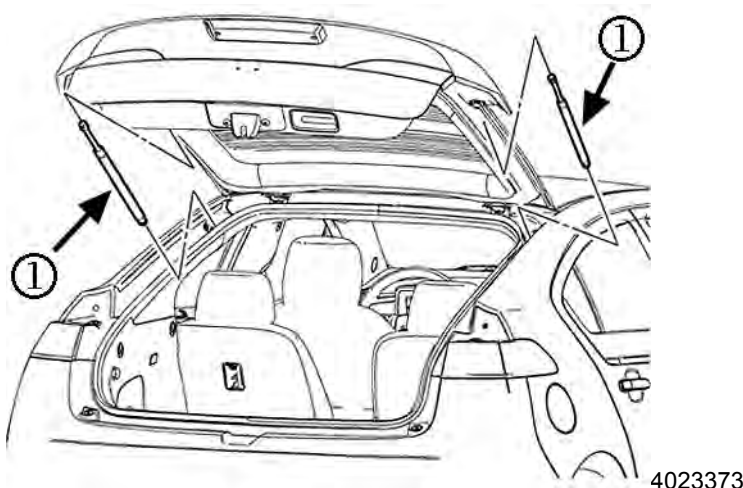
1. Remove the affected liftgate strut assembly (1). Refer to *Liftgate Strut Replacement* in SI.
2. Install the new liftgate strut assembly. Refer to *Liftgate Strut Replacement* in SI.

Dealers are to replace the liftgate struts.
