SB-10057451-1695

Subject: FCCC MT45G/55G Fuel Pump and Starter Relays

Models Affected: Specific Freightliner Custom Chassis MT45G/55G chassis manufactured February 15, 2010, through March 31, 2014, with certain starter or fuel pump relays.

March 2015
SF502A

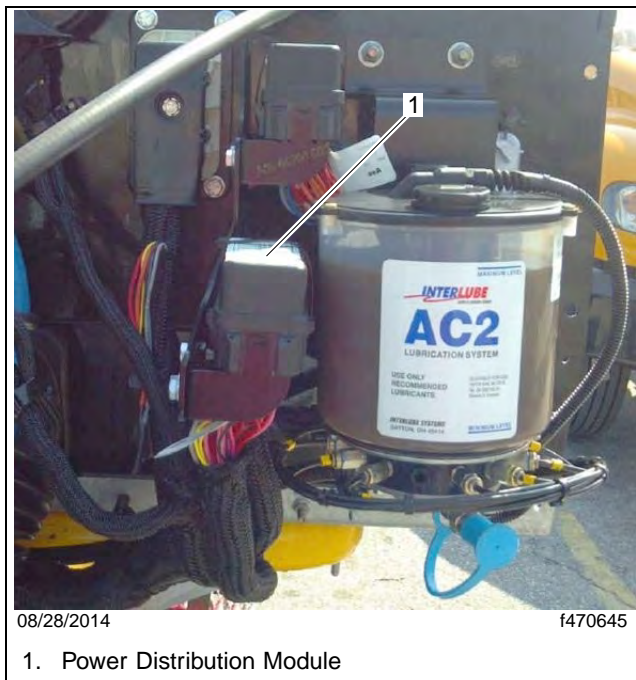
Fig. 1, Power Distribution Module Location

2. Park the vehicle on a level surface, shut down the engine, and set the parking brake. Chock the tires.
3. Locate the power distribution module (PDM) shown in **Fig. 1** and remove it from the mounting bracket. Remove the PDM cover. See **Fig. 2**.

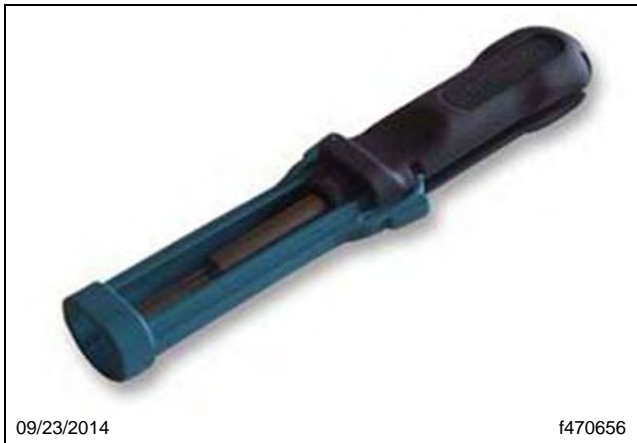
Fig. 3, Tyco Pin Removal Tool

IMPORTANT: The recommended pin removal tool is manufactured by Tyco and shown in **Fig. 3**. Alternative generic tools are shown in **Fig. 4** and **Fig. 5**.

IMPORTANT: The recommended pin removal tool is manufactured by Tyco and shown in **Fig. 3**. Alternative generic tools are shown in **Fig. 4** and **Fig. 5**. See page 5.

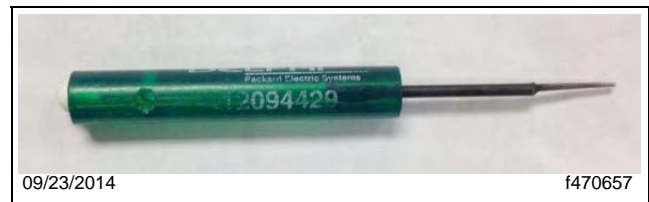
Fig. 4, Delphi Extraction Tool

If an alternative extraction tool is used, position one tool on each side of the terminal to disengage the terminal lock, then gently pull on the circuit to remove it from the cavity. See **Fig. 6**. If excessive force is required, the locks are not released. Reposition the tools and try again.
