Service Bulletin

14-084

Warranty Extension: Front Passenger and Left and Right Rear Passenger Door Lock Actuator

Year	Model	Trim	VIN Range	
2007–09	CR-V	ALL	Check the iN VIN status for eligibility

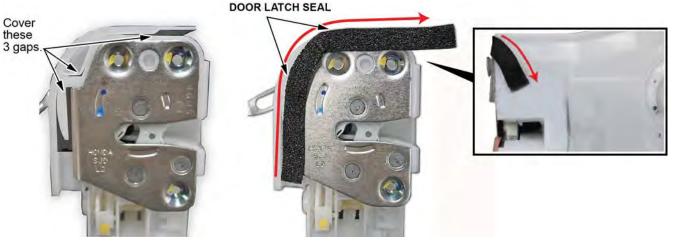
- 1. Remove the affected door latch; refer to the electronic service manual.
- 2. Attach a new door latch seal to the new door latch assembly.
 - Clean all the seal application areas with brake cleaner and a shop towel. Make sure you let it dry. If there is any grease or dirt on the housing, the weather seals may not stick properly.
 - Apply the door latch seal as shown; make sure the seal covers the three gaps between the latch and the actuator.

- Wrap the seal around the side of the assembly as shown.
- 3. Attach a new door lock seal.
 - Apply the door latch seal as shown; start just above the **HONDA** stamp.

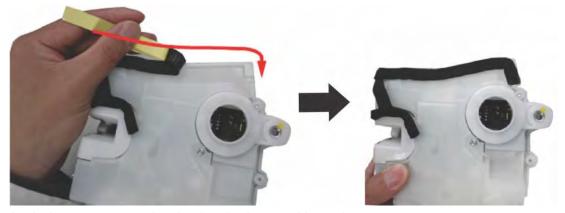
4. Using a new door latch seal, attach it along the upper gap between the latch and the protector cover as shown.
