SERVICE ADVISORY # 15-227

Summerland Mini Fuse

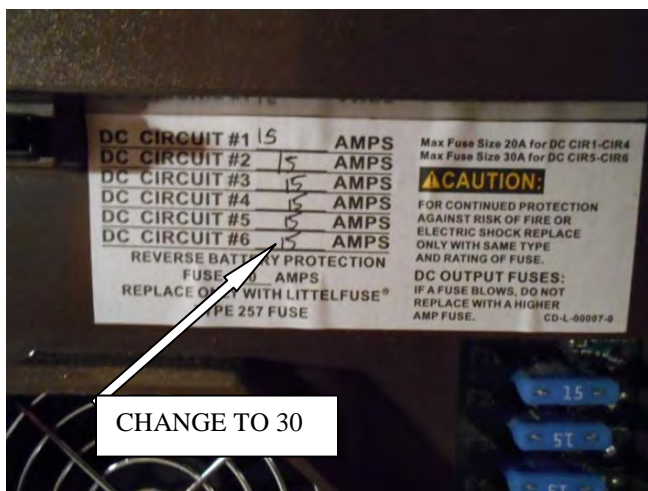
Fig. 1

It has been determined the below listed vehicles were manufactured with an undersized 15 amp fuse placed in the battery charging circuit which should have a 30 amp fuse. The circuit is wired and rated for 30 amp capacity. This advisory explains how to correct.

Step 2 Locate the fuse panel in the unit. Remove the 15 amp fuse from the number 6 location of the fuse panel. Replace the fuse with a 30 amp fuse. Change the noted fuse size of position 6 on the information label from 15 to 30.
