**NUMBER:** 08-022-15**GROUP:** Electrical**DATE:** March 11, 2015

Service Tire Pressure System Message

Jeep Wrangler

Dodge Caravan
Chrysler Town and Country

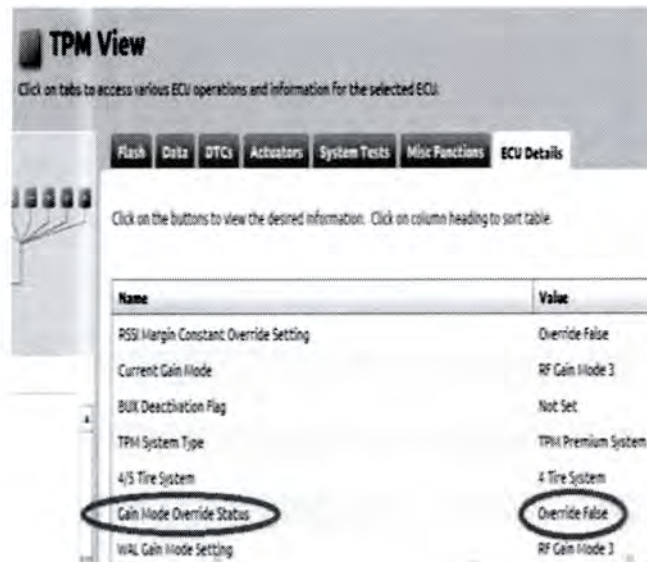
Fig. 1 Screen Shot of wiTECH.

1. Using wiTECH check if the Misc-Function routine has been performed.
2. Click on the TPM module, then ECU details and look at the "Gain Mode Override Status" value, as seen in (Fig. 1)

Override False

- 3. Does the value read "Override True"?
 - a. Yes >>> Proceed to Step #4.
 - b. No >>> This procedure has been performed, this bulletin has been complete. If DTC are present perform normal diagnostic.

- 4. Using wiTECH to turn off Gain mode Override, this is available under the 'Misc-Function' tab found in the TPM section of wiTECH.
- 5. Highlight turn off Gain Mode Override and follow wiTech pop-ups to complete this routine.
- 6. When the this routine was performed properly, the valve will read false.
- 7. Using the TPM-RKE Analyzer Tool, select TPM Functions, then enter the Model Year and the Body Style of the vehicle, and for the Trigger Selection select LEARN ID.
