Engine Harness Changes  
D11J, D13J  
VAH, VHD, VN

**FSB 284-056, Engine Harness Changes**

(April 2015)

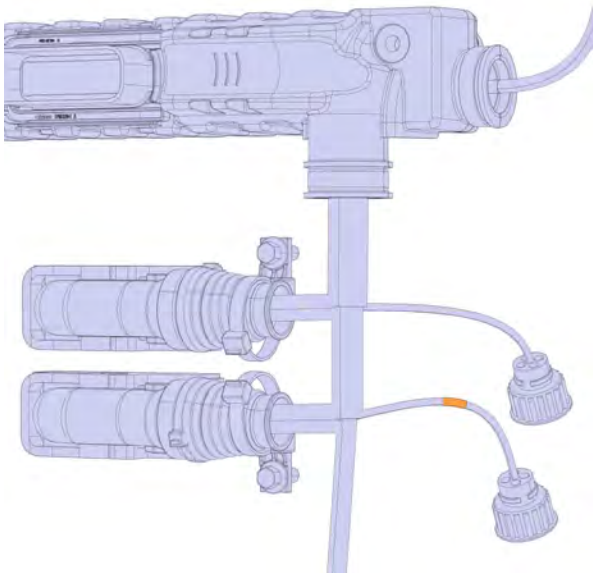
W2100467

- D13 Engine Only: Yellow marking tape added to crankcase pressure sensor wire. Blue marking tape removed from oil pressure sensor wire.

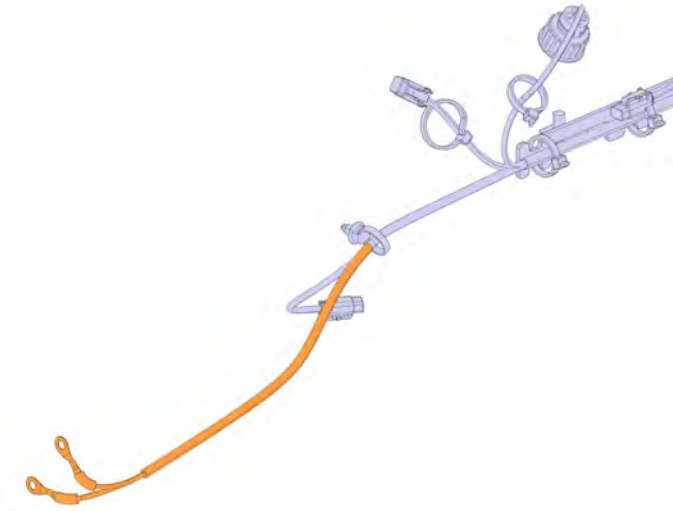
W2100052

- The starter solenoid wires now come from the front. Previous starter wire routed around the cold side of engine around the rear.

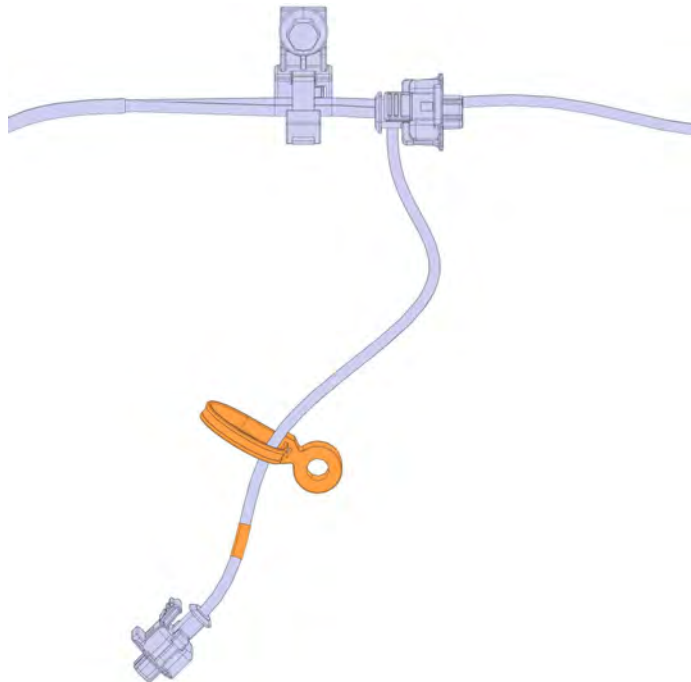
W2100055

- D13 Engine Only: Crankshaft speed sensor has yellow marking tape on it so it is not confused with EGR valve sensor. Stud-mounted cable tie added.
