GROUP CHA	MODEL 2015MY Sedona (YP)
	NUMBER 053 (REV 1, 04/07/2015)	DATE March 2015
TECHNICAL SERVICE BULLETIN		
SUBJECT: SERVICE ACTION: HYDRAULIC STEERING RACK INSPECTION AND/OR REPLACEMENT (SA182)

SUBJECT: SERVICE ACTION: HYDRAULIC STEERING RACK INSPECTION AND/OR REPLACEMENT (SA182)

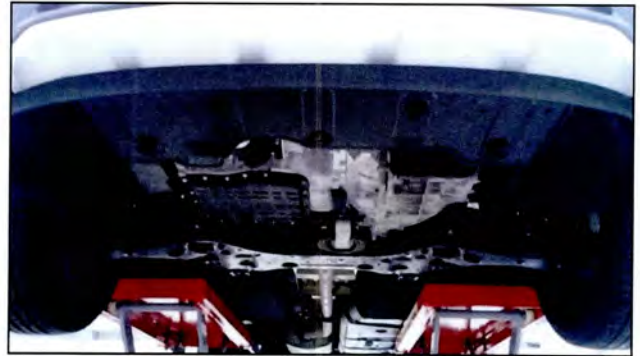
1. Place the vehicle on the lift.

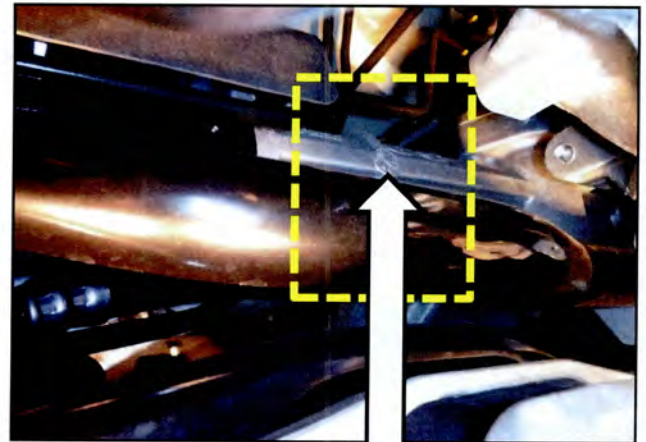
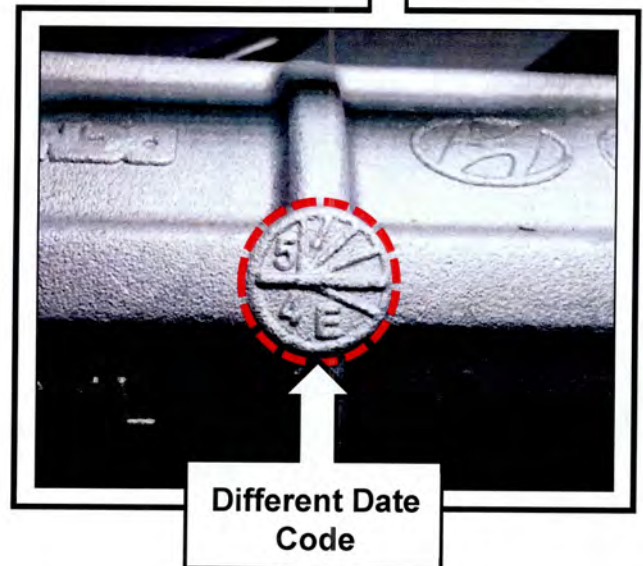
Reading the Date Code on the Steering Rack
4 J 1 7 (dots)

2. Locate the date code on the hydraulic steering rack. **NOTE: Refer to the table shown below to accurately read the date code information.**

A diagram showing a circular date code reader with seven numbered slots (1-7) and two letter slots (A, J). An arrow points from the diagram to a photograph of a steering rack with a date code stamped on it. The date code is 4 J 1 7 (dots).

3. If the rack date code matches 4 J 1 7 (dots), replace the rack with an improved part. Proceed to the Service Procedure on Page 3.
4. If the date code is different than 4 J 1 7 (dots), do **NOT** replace the rack. No further action is required.

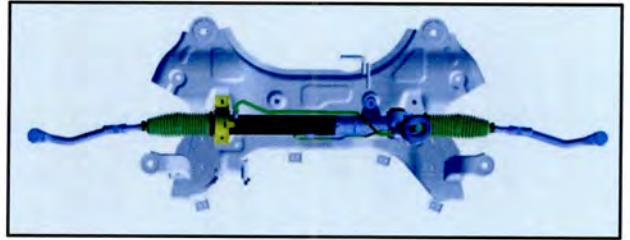
1. Replace the power steering gear box with an improved one by referring to "Steering System → Hydraulic Power Steering System → Power Steering Gear Box" chapter in the applicable Workshop Manual on KGIS.
2. Perform a front end wheel alignment by referring to "Steering System → Front Suspension System → Front Alignment → Repair procedures" chapter in the applicable Workshop Manual on KGIS.
