XENTRY

Driver door cannot be opened from outside

Topic number	LI80.20-P-061495
Version	1
Design group	80.20 Central locking system
Date	05-22-2015
Validity	C453 smart fortwo
Reason for change	
Reason for block

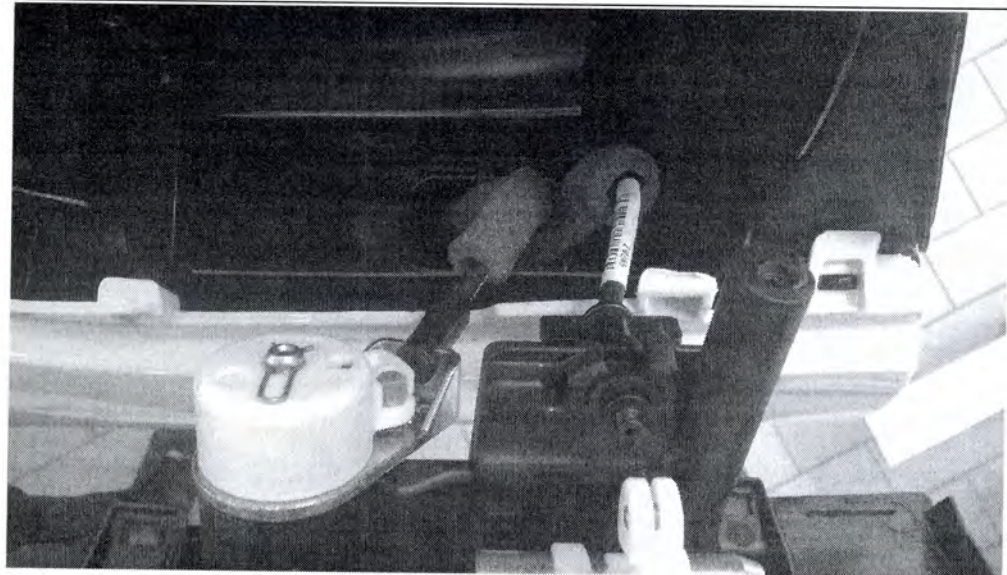
Bild 1.jpg:

Incorrect routing of the Bowden cables can result in one of the cables kinking and jamming. (See Figure 1).

Attachments	
File	Description
Bild 1.jpg	Incorrect cable routing

Replace the cables together with the lock and make sure that the cables are routed correctly. The cables must cross underneath the door handle, as shown in Figure 2.

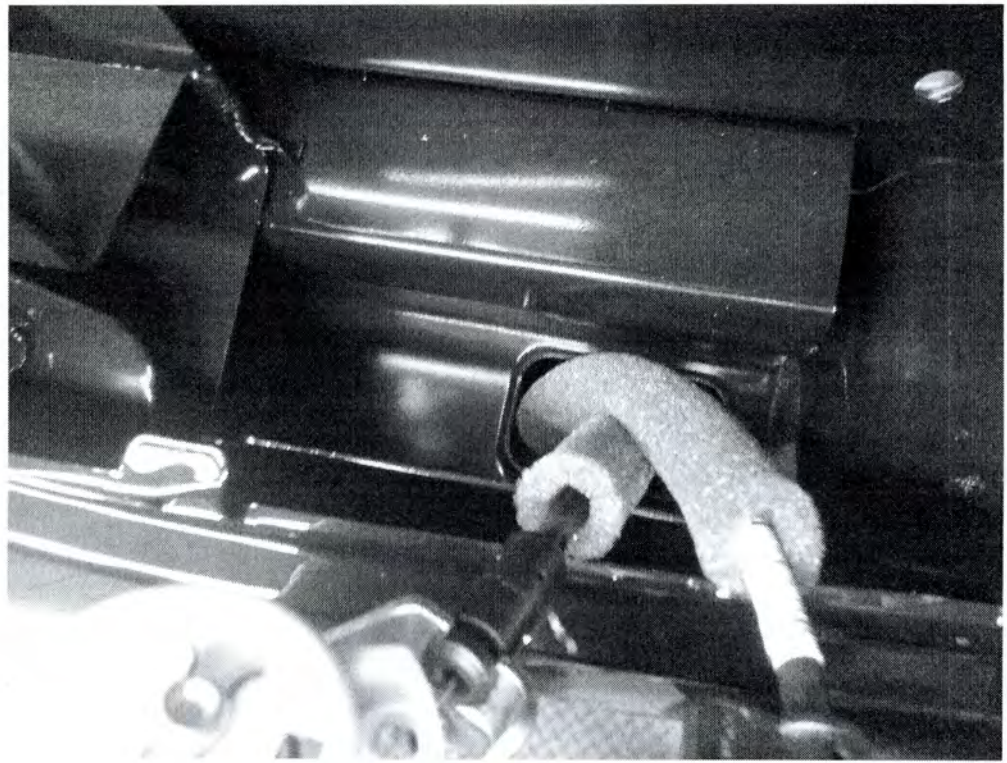
Bild 2.jpg:

Attachments	
File	Description
Bild 2.jpg	Correct cable routing
