# TECHNICAL SERVICE BULLETIN

TSB#: 15-006

## SB-10058396-6017

**ACTION REQUIRED:** Install protective trim to large oval hole in the macerator hose storage box.

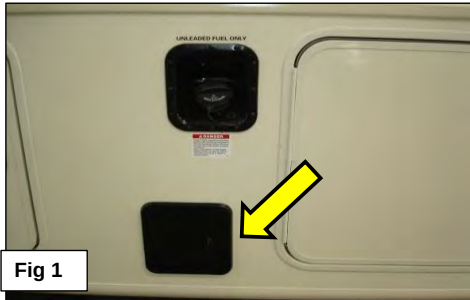
Fig 1

- 1 Fig 1: Open the macerator hose storage compartment door.
- Fig 2: Pull the hose out of the compartment to access the large oval hole in the back of the box.

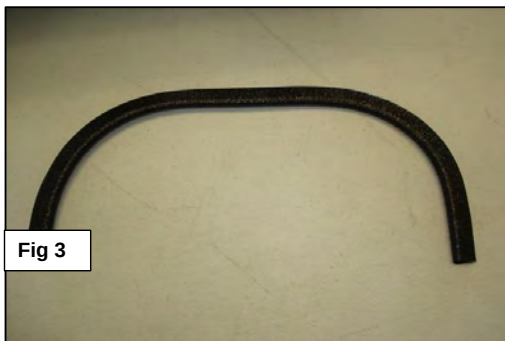
Fig 3

- 2 Fig 3: Place the 18 inch piece of trim lock around the hole and trim off excess.
- Fig 4: Shows the trim lock around the oval hole.  
Trim should fit around the entire perimeter of the hole.
- 3 Coil the macerator hose back in the box and close the door.
