SB-49

Automatic Generator Start (AGS) Wires
2016 Tiffin Coaches with Magnum Inverters and AGS

Service Bulletin 49

Automatic Generator Start(AGS) Wire Placement Instructions

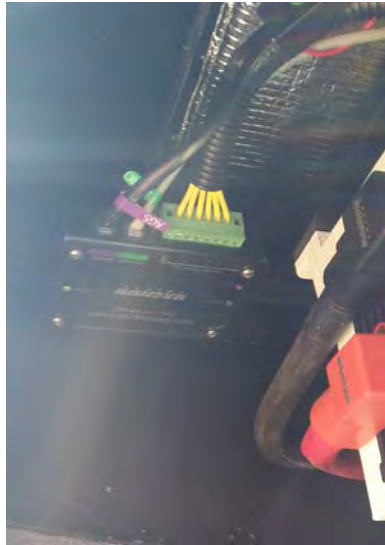
1) Inspect the AGS module while the roof A/C units are running. If the Ready light is not lit check for a blown fuse or tripped breaker then proceed to the next step once that problem is fixed and the light has turned on.

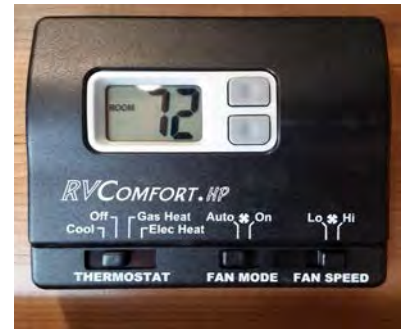
2) Turn all thermostats off and inspect the AGS again. If the ready light is no longer lit this means the AGS Power and A/C Trigger wires running into the AGS need to be switched.

The following steps are only necessary if the AGS only receives power when the thermostats are turned on.

If the AGS remains ready when the thermostats are set to off this means the wires are installed properly and no further action is necessary.

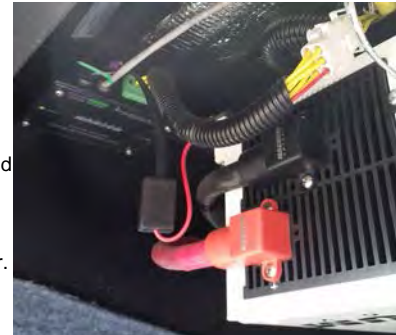
4) Trace the yellow wires from the AGS unit to the 6 pin Molex connector hidden around or above the inverter. Pull the bundle of wires out and disconnect the Molex. The wires that need to be switched are installed on the male side of the connector.

5) Refer to the drawing to identify the wires that need to be switched. Pay special attention to the position key to ensure the connector is oriented correctly. The wires will be labeled "(RED) AGS POWER" and "(GRN) A/C TRIGGER"
