23 MIL on, no start or rough running (DTCs P0087, P0088, P0191)

23 15 32 2040752/1 June 22, 2015.

Model(s)	Year	VIN Range	Vehicle-Specific Equipment
Q7	2009 - 2012	All	TDI clean diesel
A3	2010 - 2012	All	TDI clean diesel

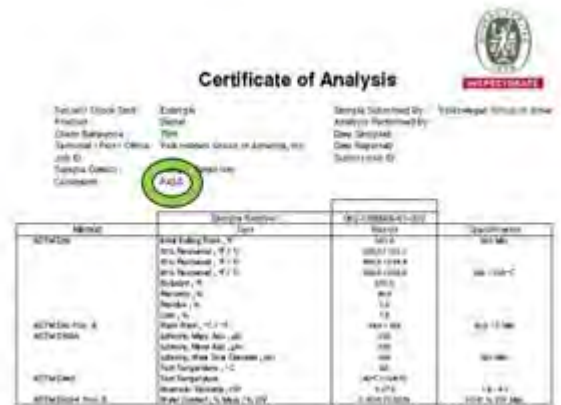
- Review the test results. The results will be marked “PASS” or “FAIL” in the comments section of the certificate of analysis (Figure 5 and Figure 6).

Figure 5. Example of a clean fuel sample analysis.

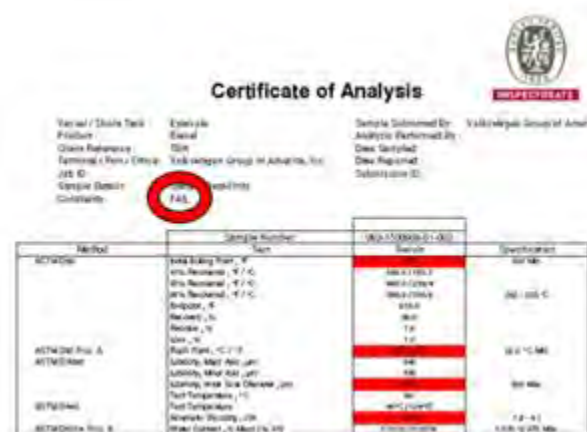
Figure 6. Example of a contaminated fuel sample analysis.
