## **SB-10058968- 3326**

### **SP 366-003, Front Radar, Failure**

(August 2015)

Certain VOLVO VN trucks built between 11/11/2013 and 01/14/2015, equipped with front radar may experience loss of front object detection or erratic operation of cruise control functions. The terminal seals of the harness is allowing moisture and corrosion to build up in the front radar harness and/or radar antenna module. To ensure proper operation of the front radar, the harness is inspected for the proper seal and/or corrosion, and the module is inspected for signs of corrosion. If the harness, seal or module fail inspection, replacement of the harness and/or radar antenna is required. Follow the inspection and repair procedures outlined in this Service Program (SP).

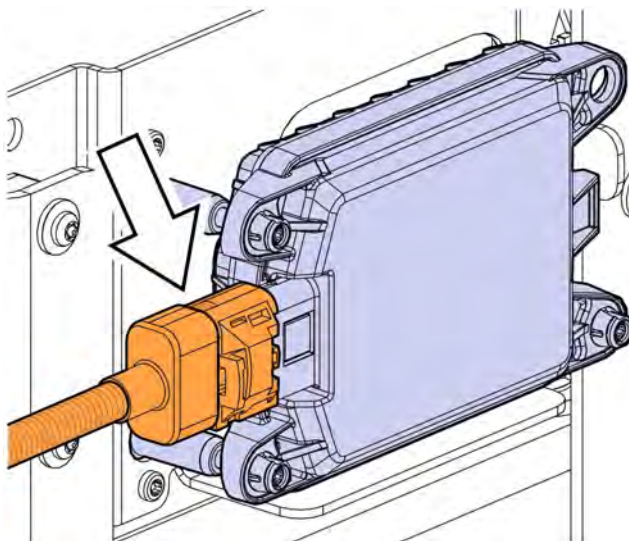
W3103447

1 Disconnect the radar connector.

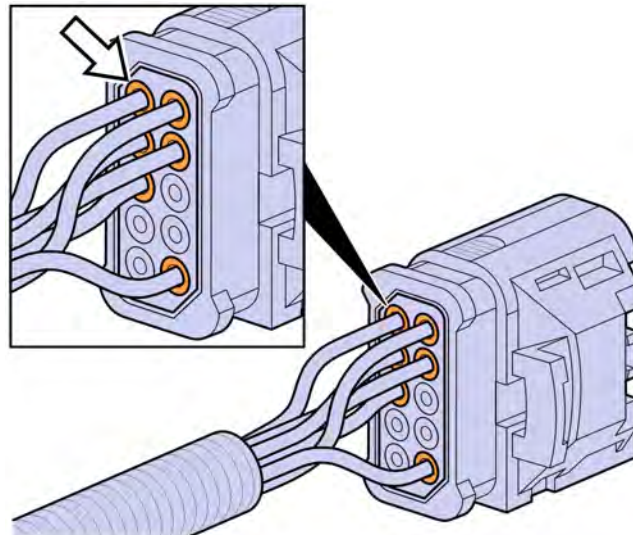
W3103448

- 2 Inspect the radar connector for water intrusion and corrosion on the terminal pins.

- 3 Inspect the connector to determine if the proper seal was installed in the connector housing.

**Note:** If the color of the terminal seals are(**BLACK**) and no corrosion is present, connect the radar connector, and no further action is required. Continue to page 24, (**Commission the truck for Operation**), and follow steps 1 – 2.

**Note:** If the color of the terminal seals are(**YELLOW**), and no corrosion is present, continue to page 5, (**Front Radar Harness Replacement**) and replace the harness only.

**Note:** If there are signs of water intrusion, corrosion of the harness and front radar module, continue to page 11 (**Front Radar and Harness Replacement**) section and follow the repair procedure.

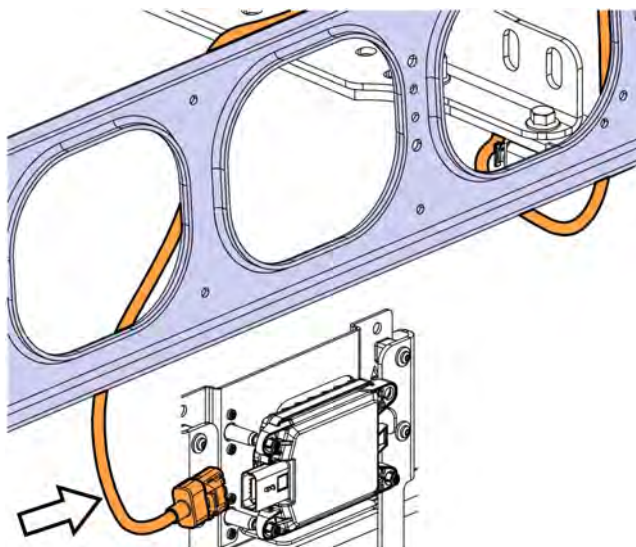
W3103451

- 6 Remove the existing front radar harness.

**Note:** Note the routing of the existing harness for installation of the replacement harness.

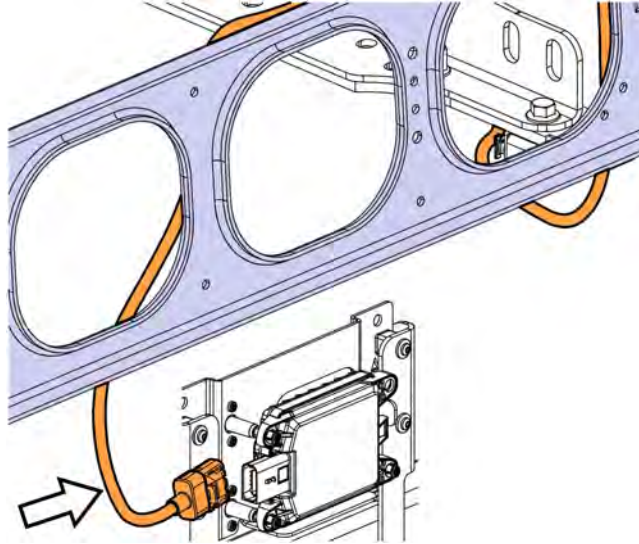
W3103451

- 7 Route the replacement front radar harness into position as shown.

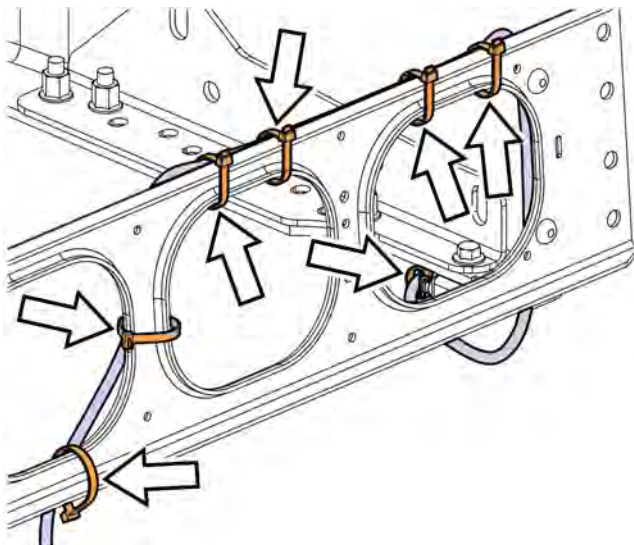
W3103449

10 Using cable ties, secure the front radar harness as shown.

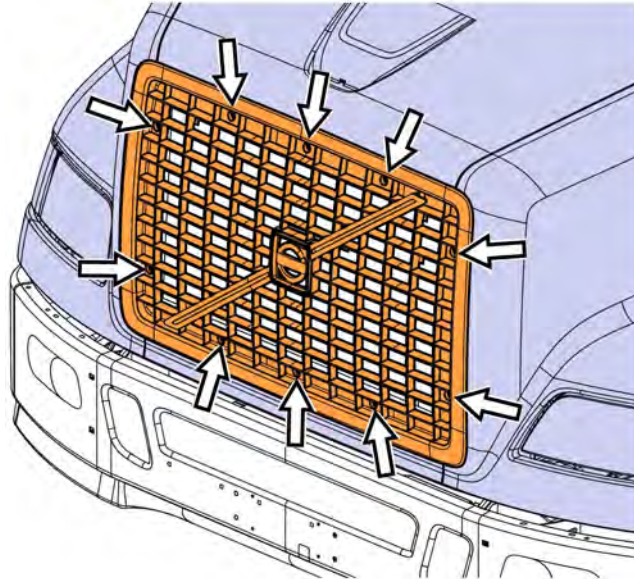
W2083544

13 Install the fasteners securing the grille.

14 Tighten the grille fasteners to  $2 \pm 0.3$  Nm ( $17 \pm 3$  in-lb).

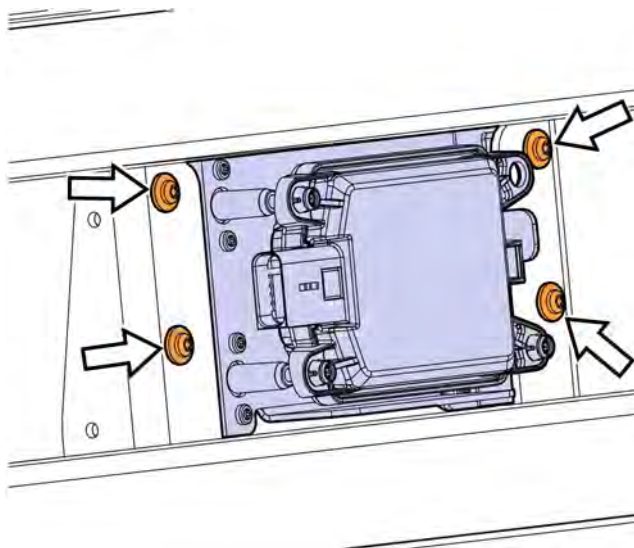
W3103452

1 Remove the fasteners securing the radar assembly.

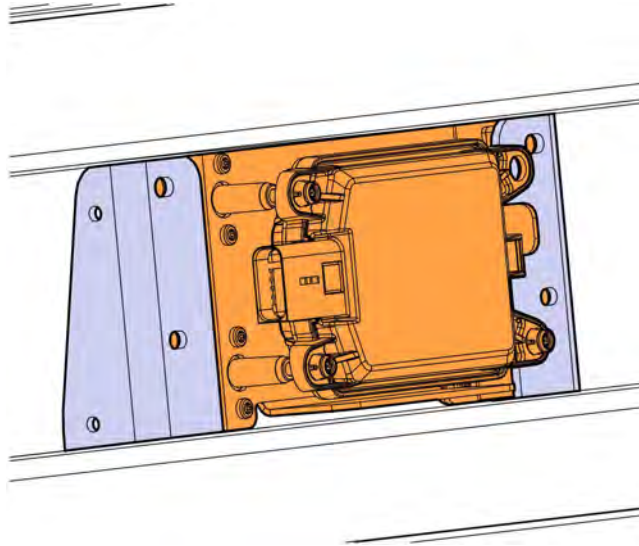
W3103453

2 Remove the radar assembly and discard.

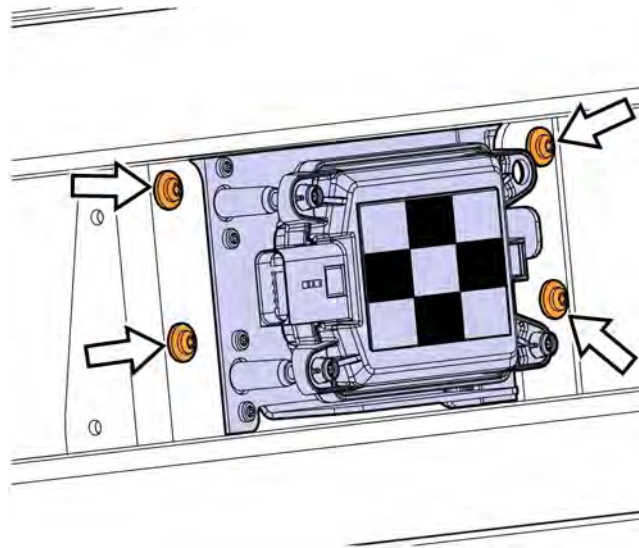
W3103455

- 4 Install the fasteners securing the front radar assembly.
- 5 Tighten the radar assembly fasteners to  $2 \pm 0.3$  Nm ( $17 \pm 3$  in-lb).

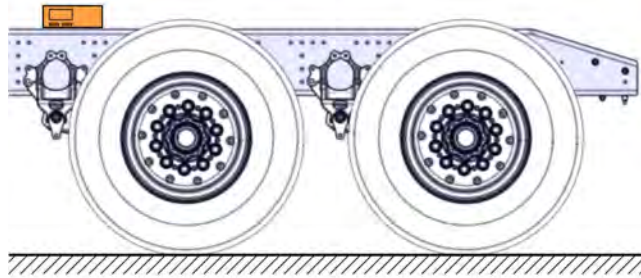
W8085795

- 20 Perform the Sensor, VOLVO Enhanced Cruise (VEC), Alignment Check and Adjustment procedure as shown in steps 21 – 31.
- 21 Place a digital angle gauge on top of the vehicle frame rail as shown. Reset the digital gauge to 0 degree.

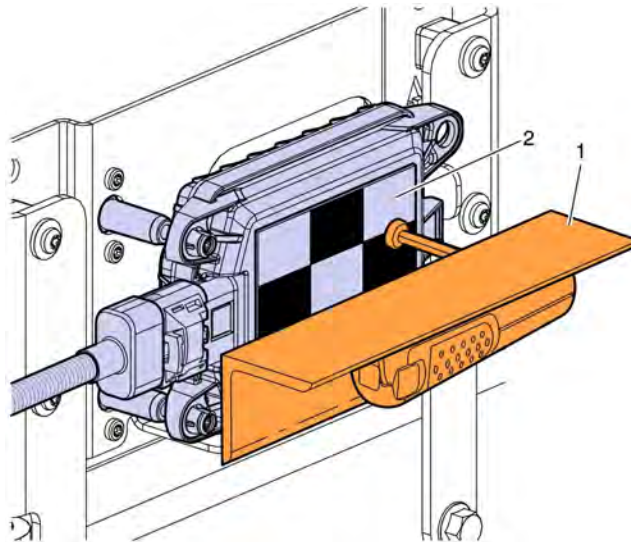
W3103456

- 22 Attach Bendix Alignment tool (part number K065284) to the front of the radar sensor cover.

**Note:** A cover (2) is included with the replacement radar sensor. If the cover is missing, use assistance to hold the alignment tool (1) on the radar sensor.

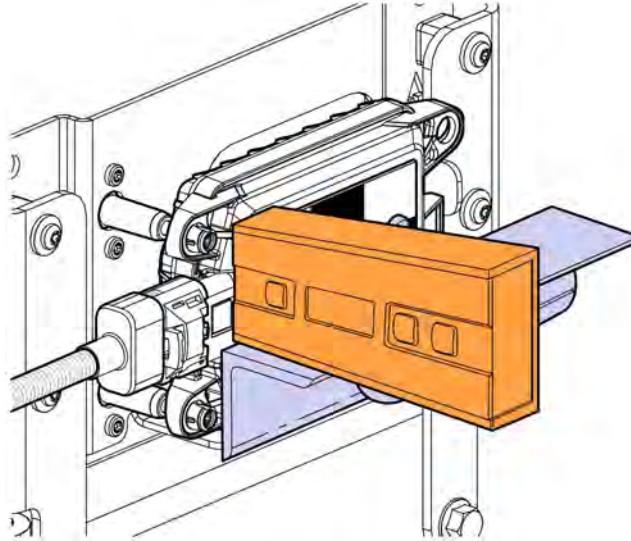
W3103457

23 Attach the digital angle gauge to the alignment tool.

24 Check the vertical alignment tool and ensure the digital angle gauge is reading 0 degrees.

**Note:** If the vertical alignment tool with the angle gauge is not reading 0 degrees, adjustment of the radar sensor's vertical angle is required.

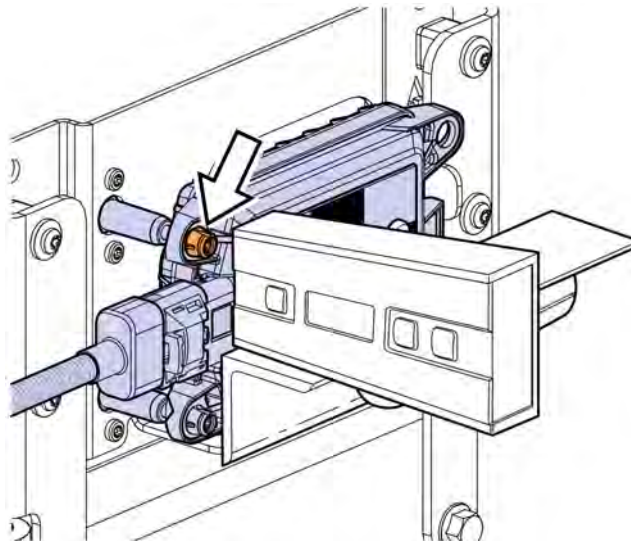
W3103458

25 If applicable, adjust the vertical alignment of the radar sensor to 0 degrees.

**Note:** Periodically recheck the alignment tool and angle gauge during the vertical alignment procedure.

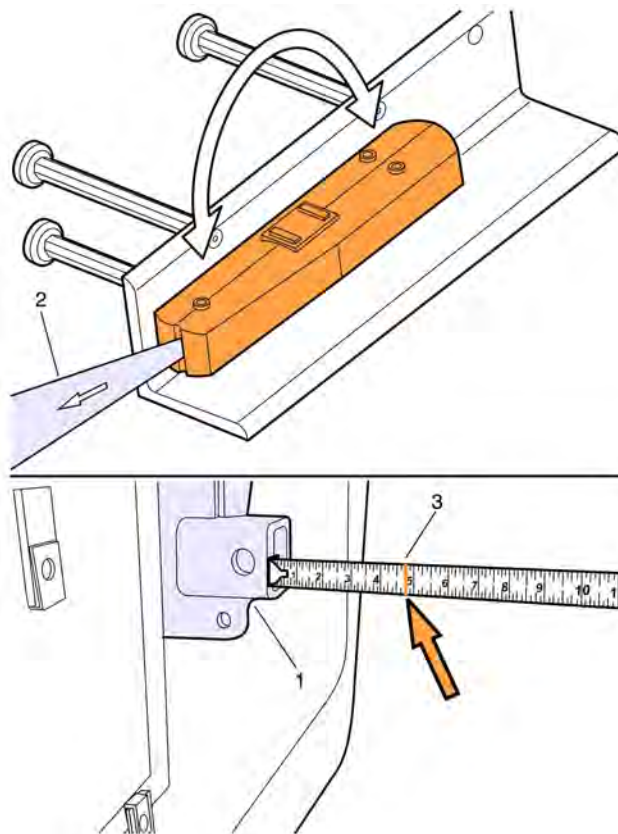
26 Using the alignment tool. turn the laser on and check the sensor's lateral alignment.

Do not stare into the laser beam (2).

**Note:** Use the tow hook receptacles (1) or frame rail ends as a measuring point if possible.

27 After the first lateral measurement (3), turn the laser off.

28 Flip the laser and orient it towards the opposite side of the truck.

29 Turn the laser on, and record the second lateral measurement (3) from the tow hook receptacle (1).

**Note:** If the lateral measurements vary by more than 3 mm (0.125 in) of each other, adjust the lateral alignment of the radar sensor.

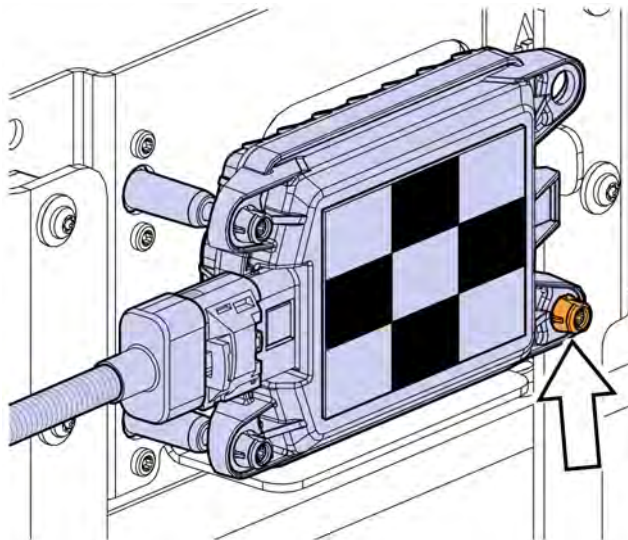
W3103460

30 If applicable, adjust the lateral alignment of the radar sensor until the two measurements are (Less than 3 mm (.125 in) of each other.

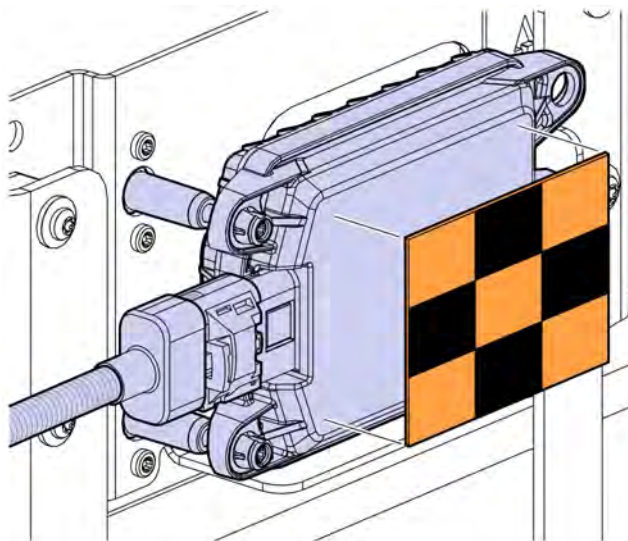
W3103461

31 If applicable, remove the cover from the front of the radar sensor.

**Note:** Failure to remove the cover will cause a Diagnostic Fault Code (DTC).
