Service Bulletin

Bulletin No.: PIP5288

Subject: Oil Leak From The Oil Filter

Models: 2015 Cadillac Escalade
2015 Chevrolet Silverado 1500 Suburban, Tahoe
2015 GMC Sierra 1500 Yukon Yukon XL
Built with RPO's 5.3L 6.2L L83 L86
With a engine build of K and between dates 15005 – 15117
St Catherine's engine plant= K
The numbers in the box are the date code

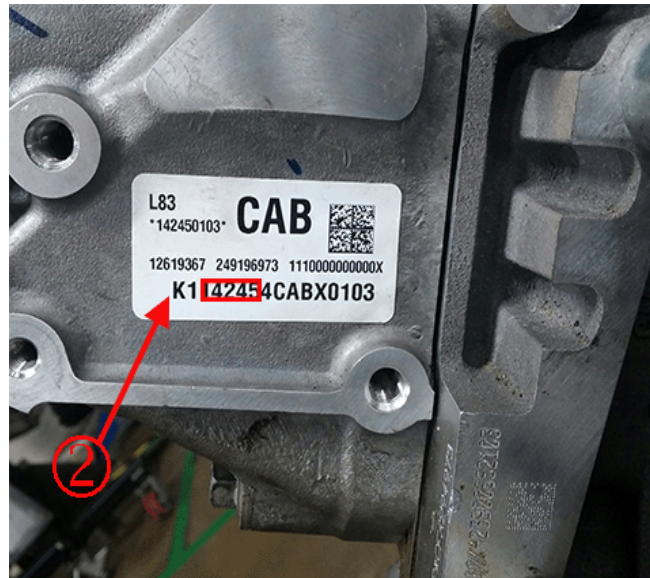
4179080

With a engine build of K and between dates 15005 – 15117

St Catherine's engine plant= K

The numbers in the box are the date code

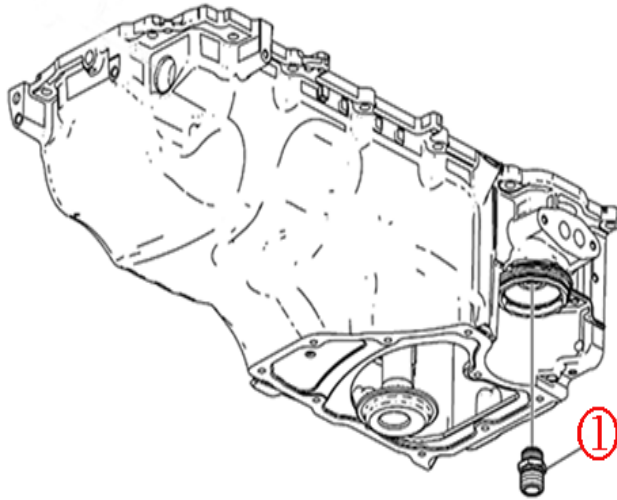
4179079

If a loose oil filter adapter is found to be the cause of the engine oil leak,

Tighten oil filter adapter to 55 Nm or (40 lb ft)

Clean oil pan of any residual oil
