Recall Bulletin

PRODUCT EMISSION RECALL

SUBJECT: Fuel Pump Module Mounting Ring

MODELS: 2015-2016 Chevrolet Trax

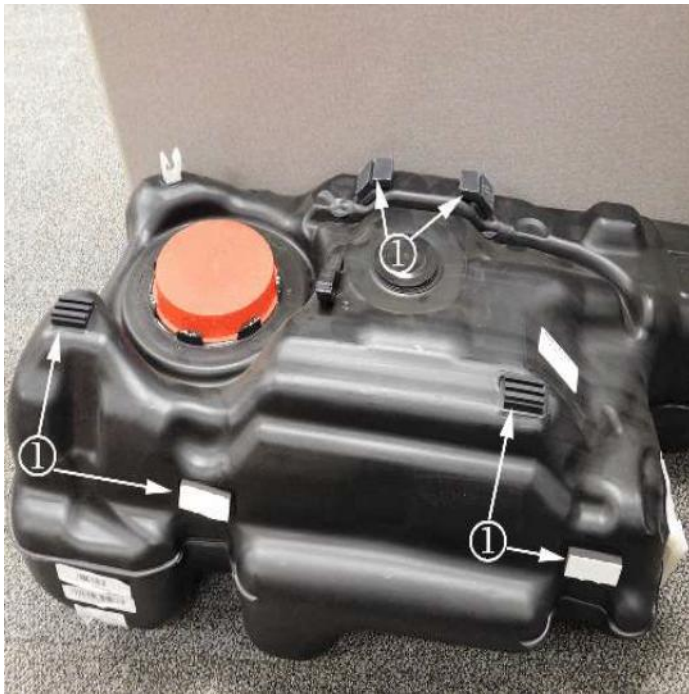
4260715

2. Install new fuel tank insulators onto the new fuel tank (1).
3. Remove the fuel tank shield from the original fuel tank and install on the new fuel tank.
4. Install the new fuel tank. Refer to *Fuel Tank Replacement* in SI.
5. **California, CONNECTICUT, DELAWARE, MARYLAND, MASSACHUSETTS, MAINE, OREGON, VERMONT, & WASHINGTON vehicles only:** Install a Recall Identification Label. Also, for California vehicles complete a "Proof of Correction" certificate upon recall completion.
