Subject: WHITE DOOR ARMREST(S) PINK DISCOLORATION	Bulletin No: 09-046/15
	Last Issued: 12/22/2015

2014-2016 Mazda6 vehicles with VINs lower than JM1 GJ ***** 458701 (produced before November 09, 2015)

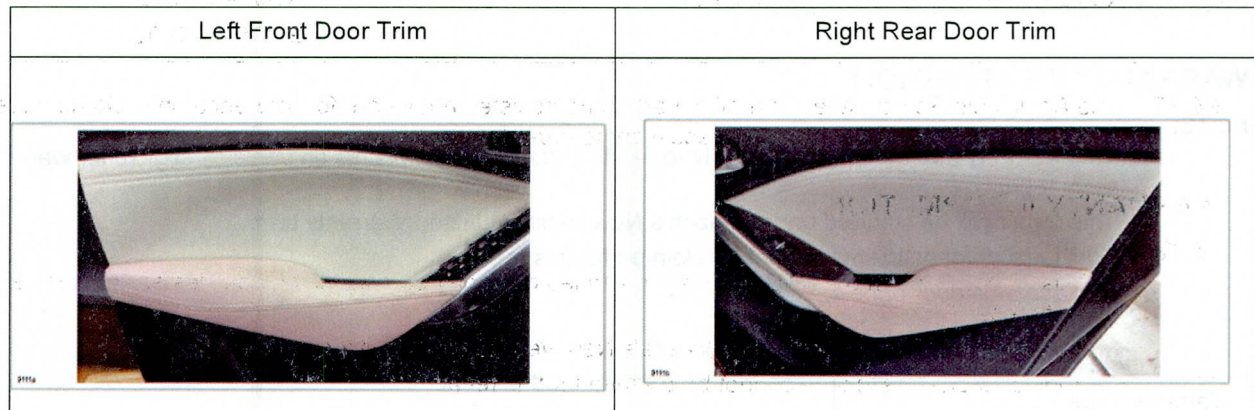
Some customers may complain about a white door armrest(s) pink discoloration. The discolored armrest does not match the other white parts of the door panel.

1. Verify customer concern.
2. Replace all 4 door panels. Refer to MS3 online or Workshop Manual section 09-17:
 - FRONT DOOR TRIM REMOVAL/INSTALLATION
 - REAR DOOR TRIM REMOVAL/INSTALLATION
3. Verify repair.
