MODEL
**2016MY
Sorento (UMa)**

NUMBER
PS412

SUBJECT: SUN VISOR LIGHTS ARE INOPERABLE OR STAY ON

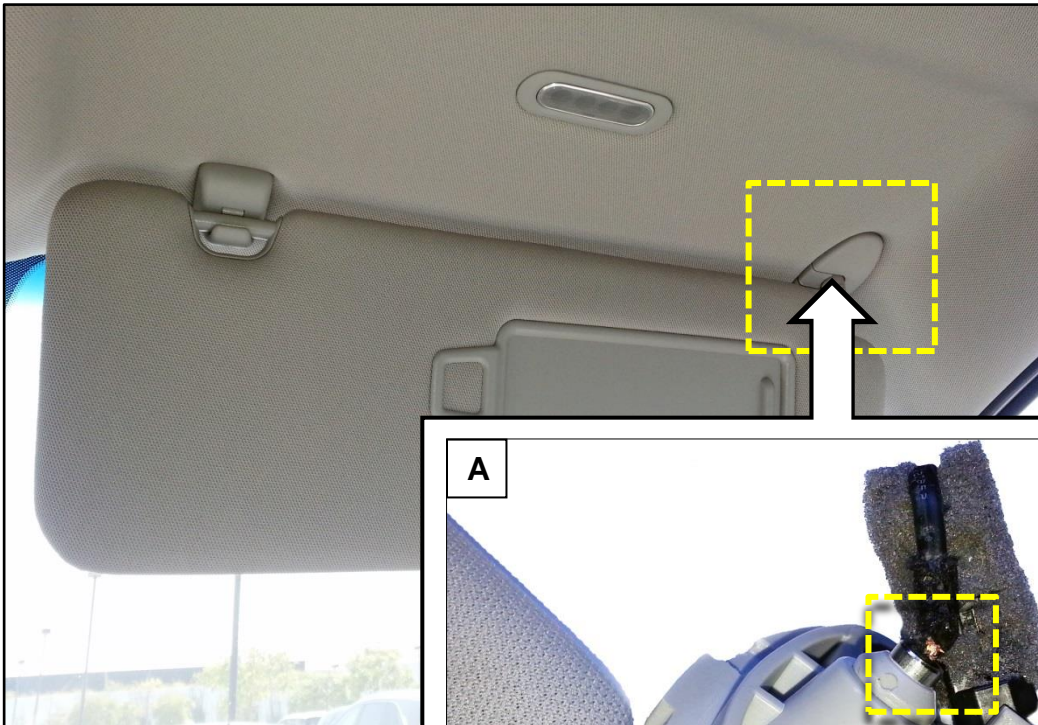
When diagnosing a concern related to inoperable, or constantly on, sun visor courtesy lights, check the condition of the Interior Lamp 10A fuse. If the fuse is blown, inspect the harness on both sun visors for the possibility of frayed wiring causing a short to ground (A) or a severed harness creating an open circuit. If either sun visor harness is visibly damaged, replace the affected sun visor to resolve the concern. Finally, replace the Interior Lamp fuse, if needed, and test for proper sun visor courtesy light operation.
