| Reference | SSM72190 |
| Models | XF / X250 |
| Title | X250 Saloon Headlining Rattle and Creaking Noises |

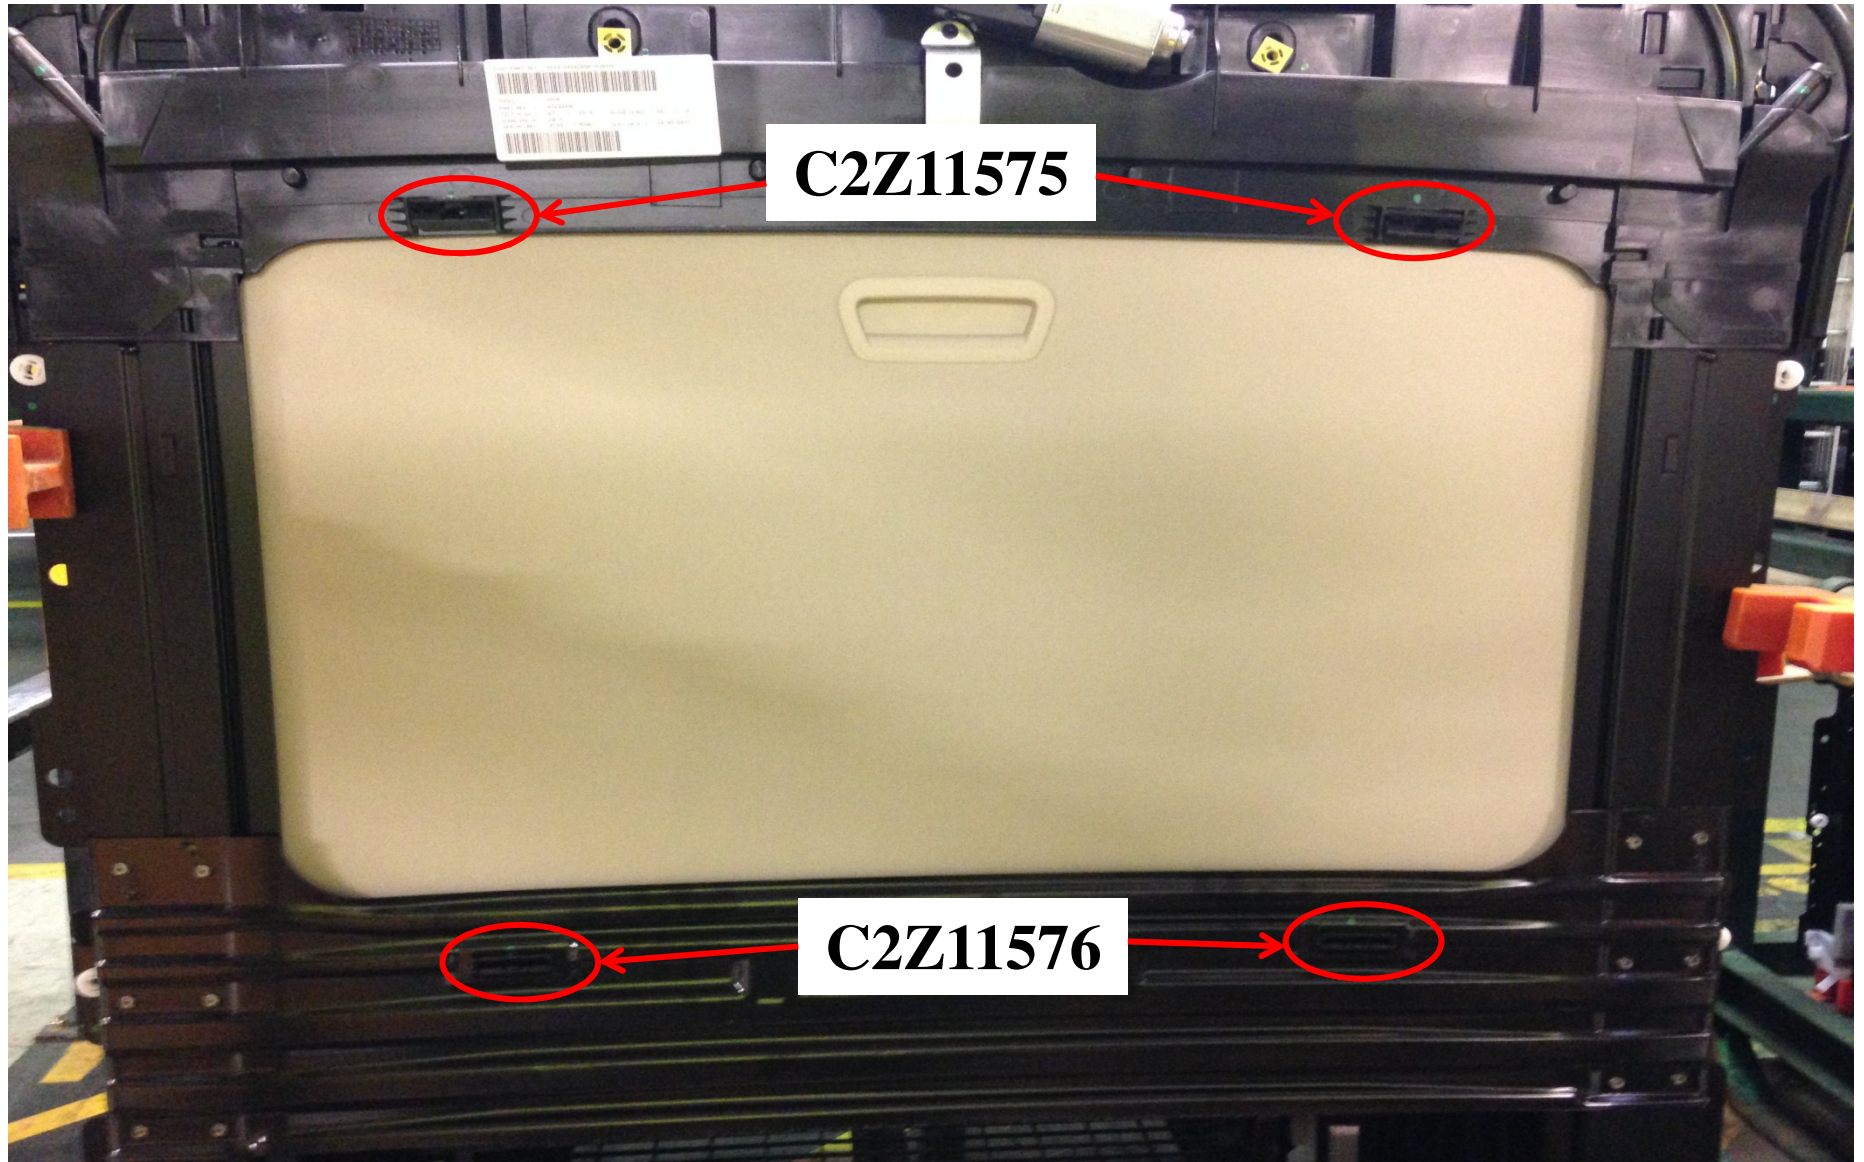
| Content | <p><u>Issue:</u> JLR have seen a number of warranty claims reporting various headlining creaks and rattles</p> <p><u>Cause:</u> The clips used to secure our headliners on X250 are one use only. (please view attachment). When removing the headliner the clip mechanism will become damaged and the headliner will not will not be secure.</p> <p><u>Action:</u> When headliner has been removed or partially removed please replace all clips.</p> |
