Reference	SSM72419
Models	F-TYPE / X152
Title	X152 F TYPE SEAT BELT TICK / CREAK
Category	Body
Last modified	10-Sep-2015 00:00:00
Symptom	101000 Seating
Attachments	X152 Seatbelt to Seat Noise SSM Images.pdf
Content	lssue:

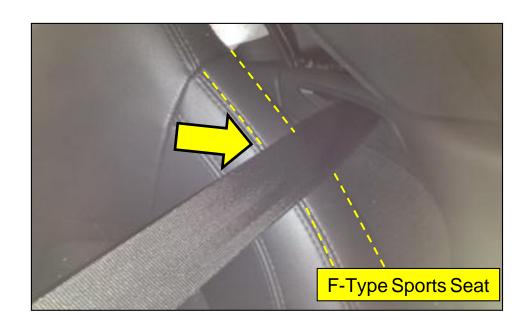
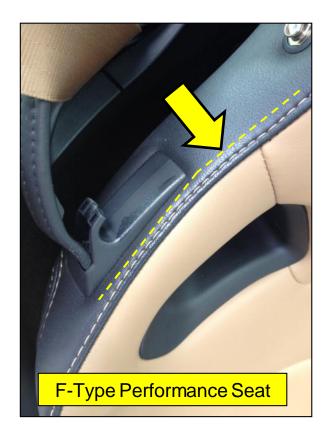
In the as-worn condition, the seatbelt webbing can come in contact with the seat material. This condition can be present or not depending on occupant size, shape and seat position. Under dynamic inputs, the webbing can rub across the seat material and creating a creaking/ticking noise in some cases.

Slide 1 shows the area on both variants of seat where the seatbelt can contact in the form of the dotted lines.

If the seatbelt contacts the seat in the as-worn condition, it will only contact the vinyl side panels of the seat, NOT the main leather squab panel.

Apply either one of the following anti-friction coatings supplied in the Squeaks and Rattles kit to the area of the side panel on the seat which the seatbelt contacts in the as-worn condition. Coat evenly to ensure a transparent finish:

- PEOX 612 Apply using a clean, dry cloth
- PEOX DF Apply using the applicator provided.

Allow 48 hours with no surface contact for the coating to fully cure.
