TECHNICAL BULLETIN

JTB00432NAS2

Vibrations and/or Rattles When Listening to the Entertainment System

F-TYPE (X152)

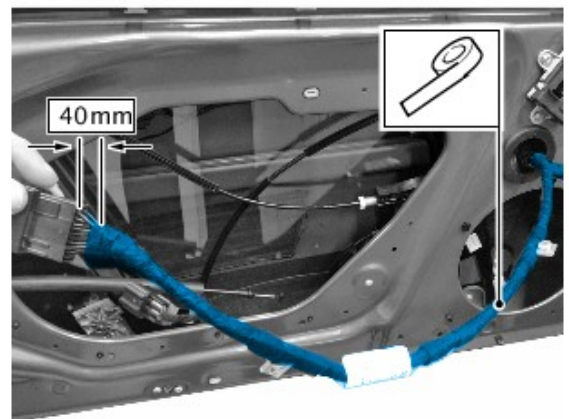
4 **CAUTION:** make sure when installing the felt insulation tape a gap of 40mm is left at the connector end to allow for electrical wiring harness movement.

Install the felt insulation tape along the length of the door electrical wiring harness.

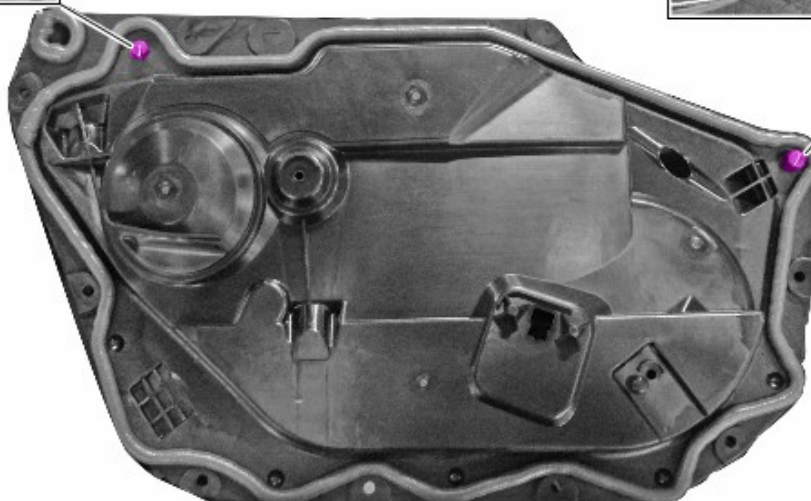
E179789

16When installing the door panel, make sure that the locating lugs are correctly located into the door.

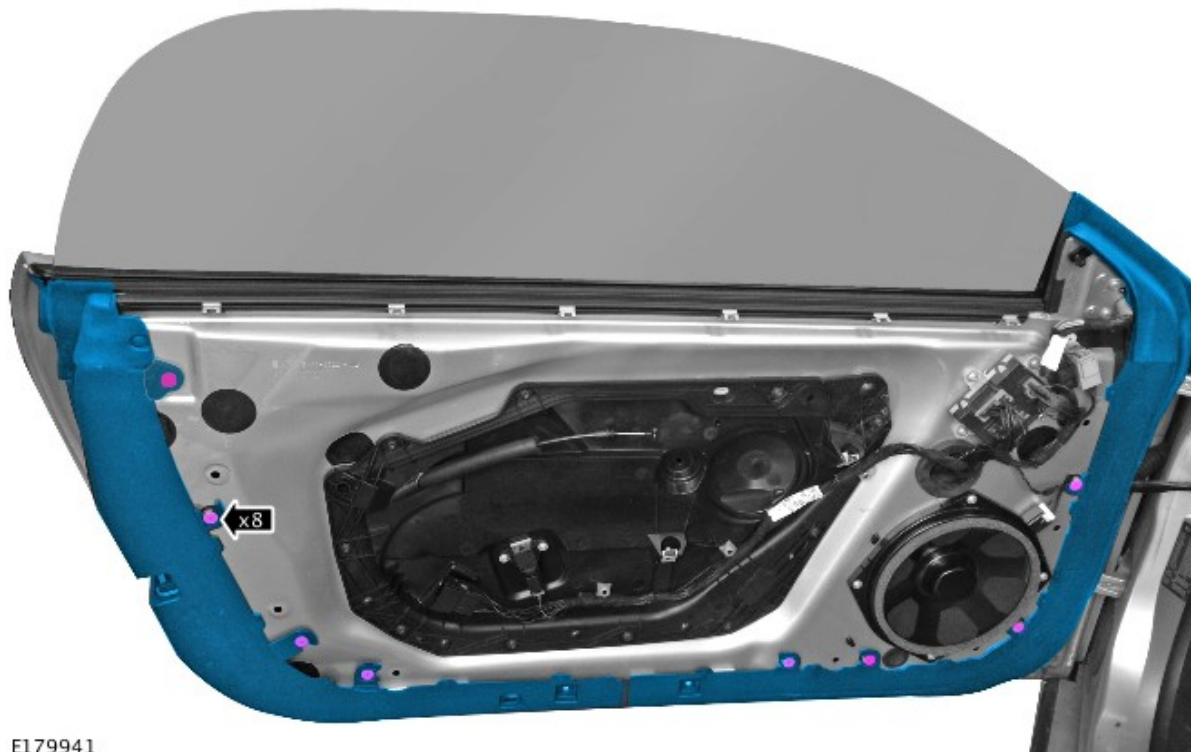
E179941

20 Remove the door trims.

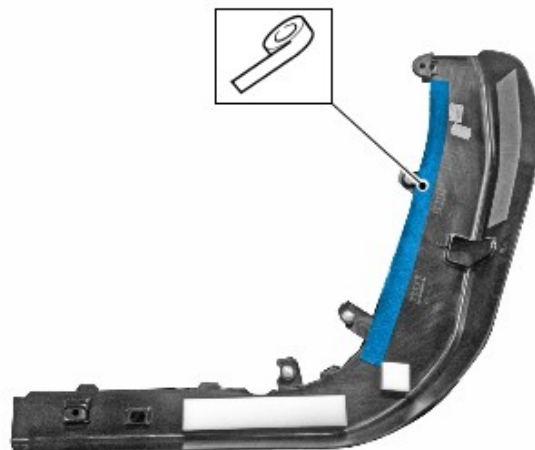
E179792

21 Install 0.5mm felt insulation tape to the door trim as shown.

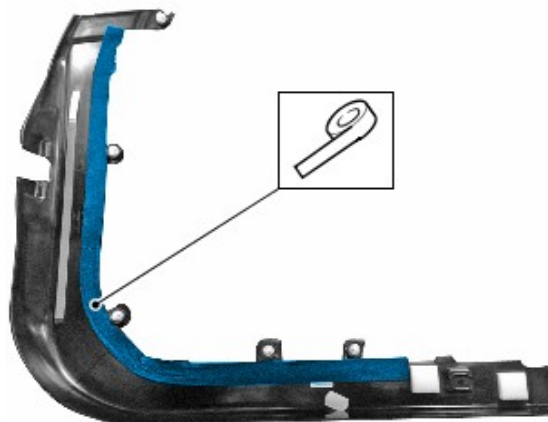
E179793

22 Install 0.5mm felt insulation tape to the door trim as shown.

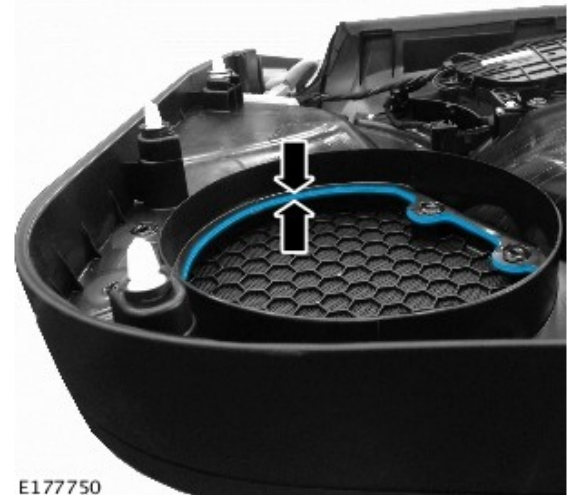
E177750

25 Inspect the speaker grille on the door trim panel.

- Using a suitable feeler gauge check the clearance between the speaker baffle and the door trim panel.
- If a clearance is found proceed to step 6. If no clearance is found proceed to Step 7

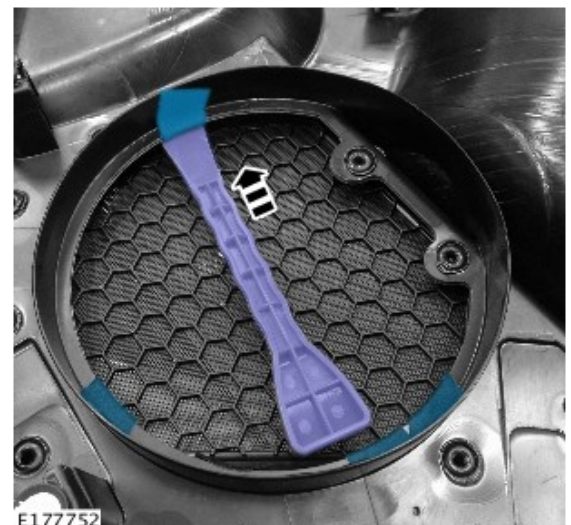
E177752

26 Using a suitable trim tool, install felt tape between the speaker baffle and the door panel trim.

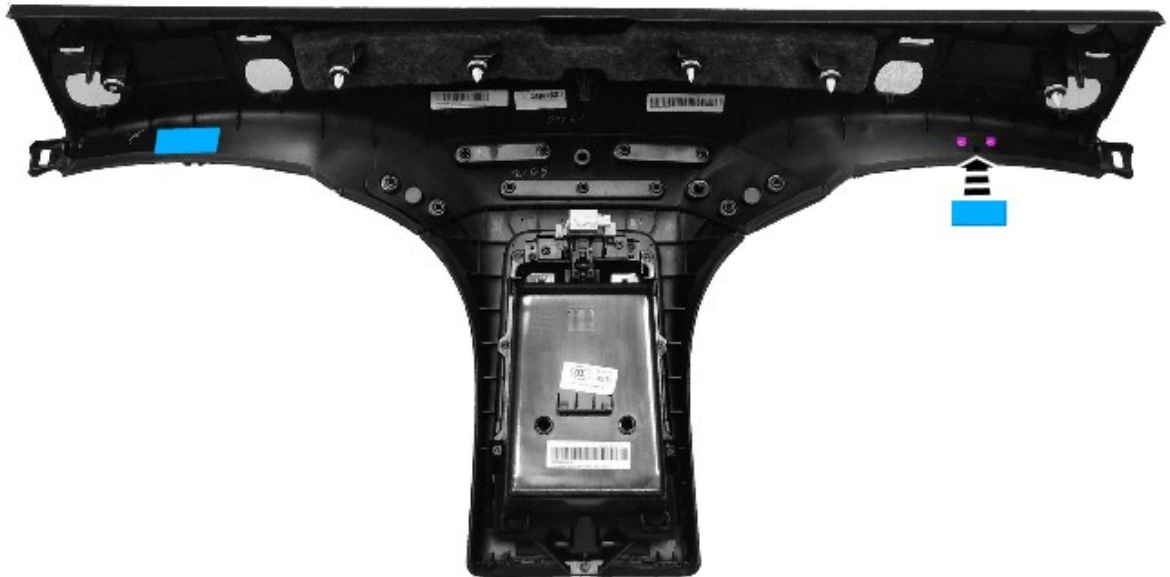
E177756

**NOTE:**
Convertible
shown;
Coupe
similar.

When the parcel shelf is removed, install foam pads to the contact areas shown.
