52148-02140 Version 4

**Warranty Extension: MIL Comes On With DTCs P0301 thru P0304**Supersedes 13-080, dated August 15, 2014, to revise the information highlighted in **yellow**.**AFFECTED VEHICLES**

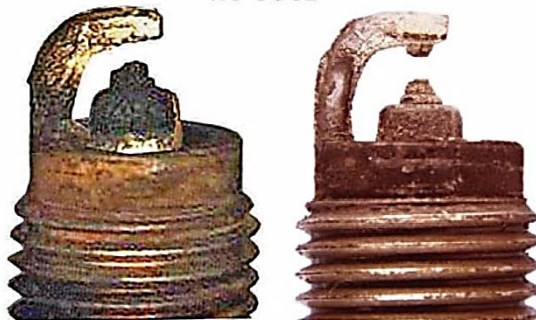
2. Remove and check the spark plug(s) on the affected cylinders (example: if P0301 is stored, check the spark plug on cylinder No. 1).

**GOOD**

**NO GOOD**

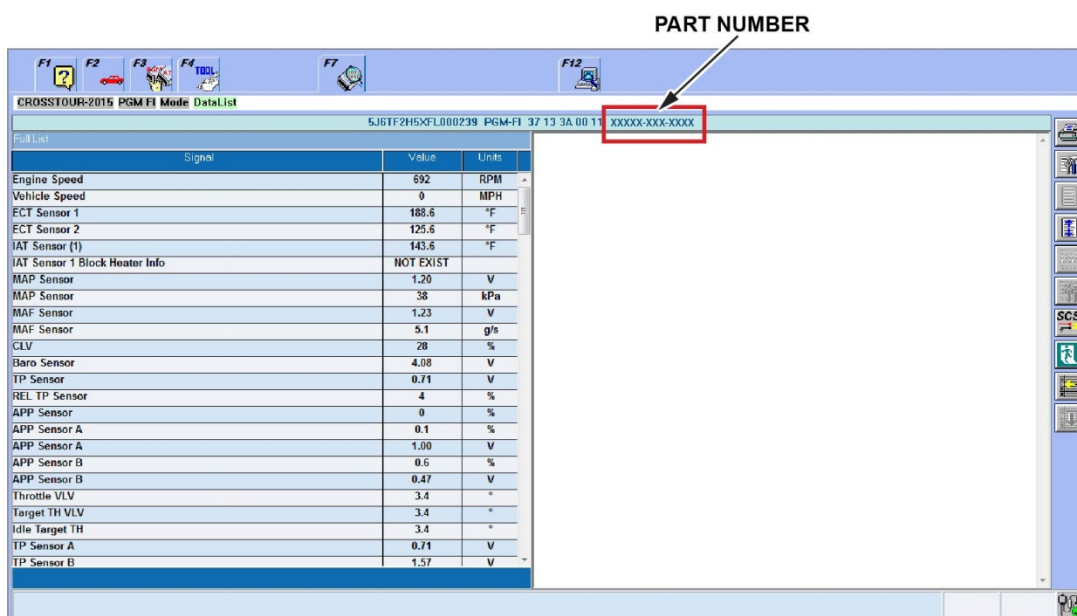
3. Check the PCM software version P/N located above the **PGM FI Data List**.

Year/Model	Program ID (or later)	Program P/N (or later)
2008 Odyssey (EX-L, Touring)	GWA950	37805-RGW-A95
2009–10 Odyssey (EX-L, Touring)	GWA050	37805-RGW-A05

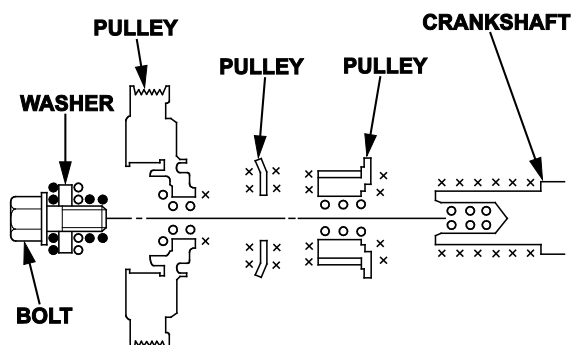
13. Depending on the diagnosis, remove the appropriate WU-TWC support bracket bolts.
14. Remove the EGR lower pipe nuts.
15. Remove the crankshaft pulley bolt but not the pulley.

NOTE: Make sure to apply new oil to the bolt flange and threads before reinstallation.

X : Remove any oil

O : Clean

● : Lubricate with new engine oil

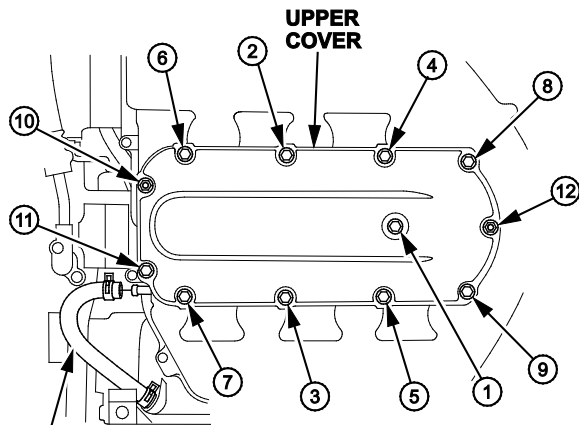
28. Remove the engine intake upper cover bolts and nuts. Then remove the cover and the PCV hose.

**SPECIFIED TORQUE**

6 x 1.0 mm

12 N·m (8.7 lb-ft)

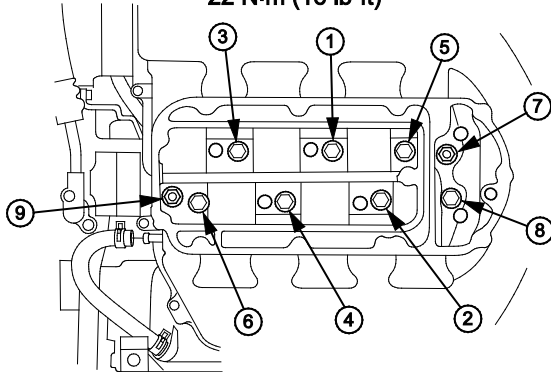
29. Remove the intake manifold bolts and nuts in three steps, then remove the intake manifold.

**SPECIFIED TORQUE**

22 N·m (16 lb-ft)

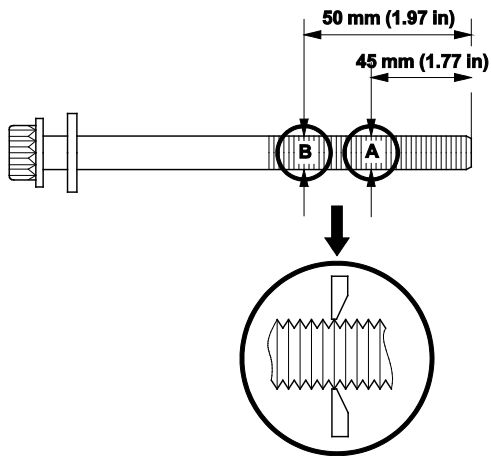
41. Measure the head bolts to determine if they need replacement. If either diameter is less than **11.3 mm (0.445 in)**, replace the cylinder head bolt.

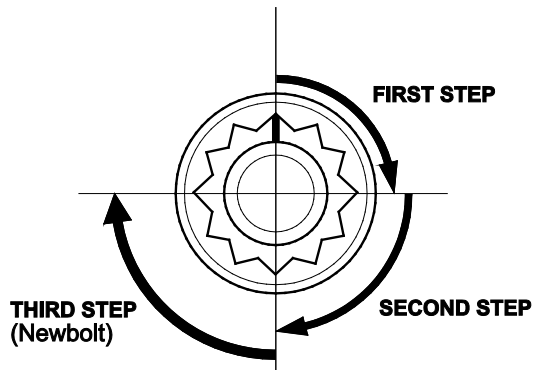
NOTE: Below are the head bolt torque specifications for reinstallation.

- First step: torque the cylinder bolts in sequence to **29 N•m (22 lb-ft)**.
- Second step: tighten in sequence an additional **90 degrees**.
- Third step: tighten in sequence an additional **90 degrees**.
- If the bolts are new, tighten an additional **90 degrees**.

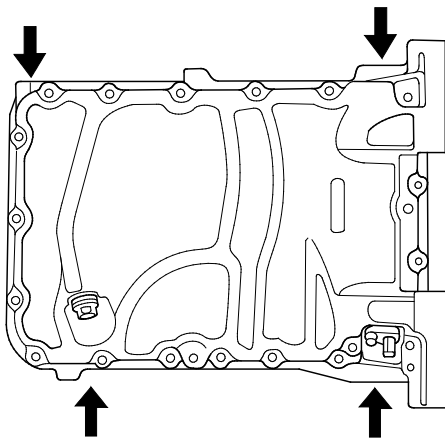
46. Using a flat blade screwdriver, separate the oil pan from the engine block in the areas shown.

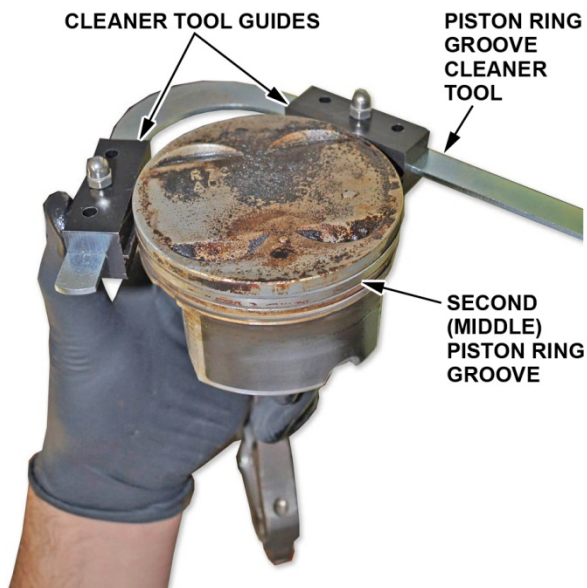
2. Spray the piston head and piston ring grooves thoroughly with Honda throttle plate cleaner.
3. While holding the piston upright in your left hand, take the piston ring groove cleaner tool in your right hand and line up the cleaner tool guides with the second (middle) piston ring groove.

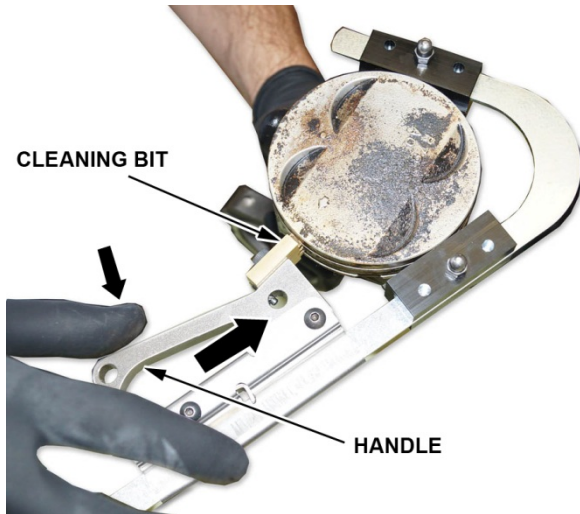
4. Press the handle on the piston ring groove cleaner tool and slide the cleaning bit onto the appropriate piston ring grooves.

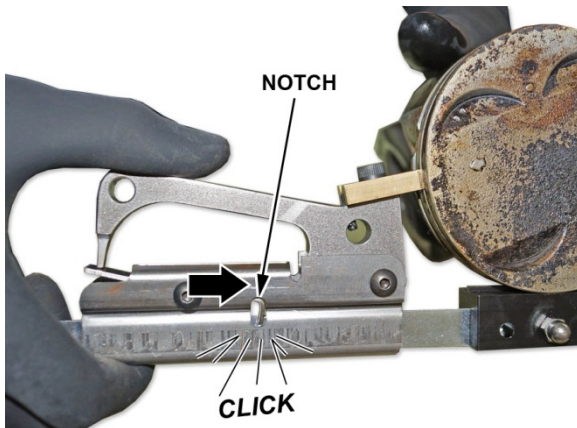
5. Once the cleaning bit is in the appropriate ring grooves of the piston, make sure the tool handle clicks into place.  
NOTE: There is only one notch on the tool for the handle to engage.

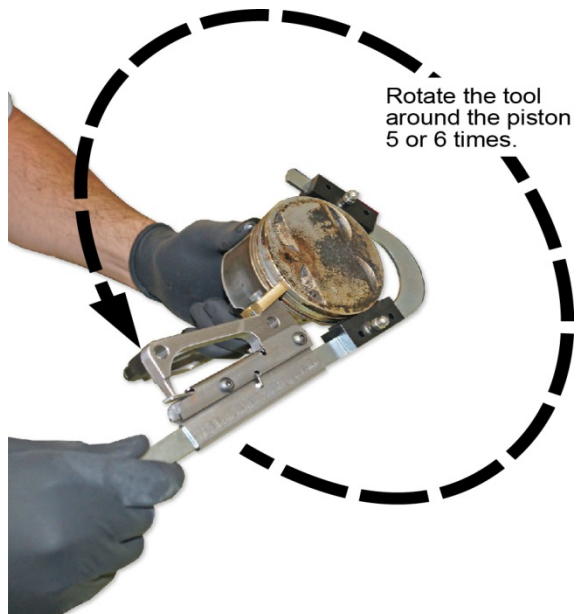
6. Hold the piston steady and rotate the tool counter-clockwise five to six times to remove any carbon deposits in the piston ring grooves. **Do not** rotate the tool clockwise.

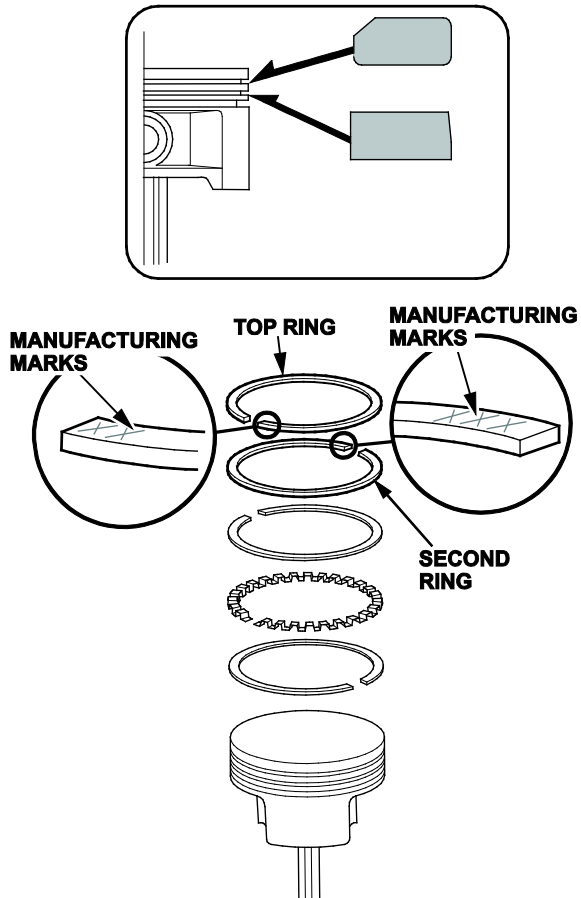
9. Install the piston rings as shown.

NOTE: The first (top) ring has a **1D** manufacturing mark and the second (middle) ring has an **SPR** manufacturing mark. The manufacturing marks must be facing upward.

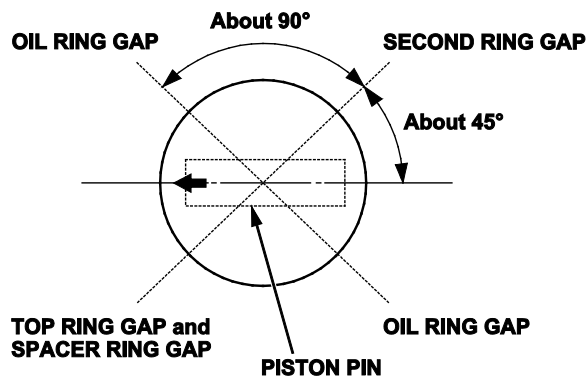
10. Position the ring end gaps as shown.

NOTE: If the ring gaps are not positioned correctly, excessive blowby may occur.

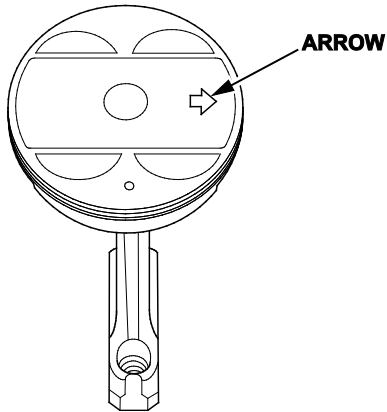
12. Install the piston/connecting rod assembly into the cylinder bore with the arrow on top of the piston facing the timing belt side of the engine.

NOTE: Be careful not to damage the cylinder wall when installing the piston.

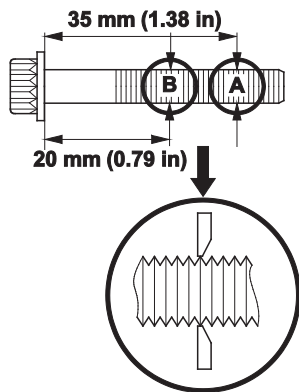
13. Measure the diameter of the connecting rod bolts to determine if they need replacement. Calculate the difference in diameter between point A and point B. It should not be more than **0–0.1 mm (0–0.004 in)**.

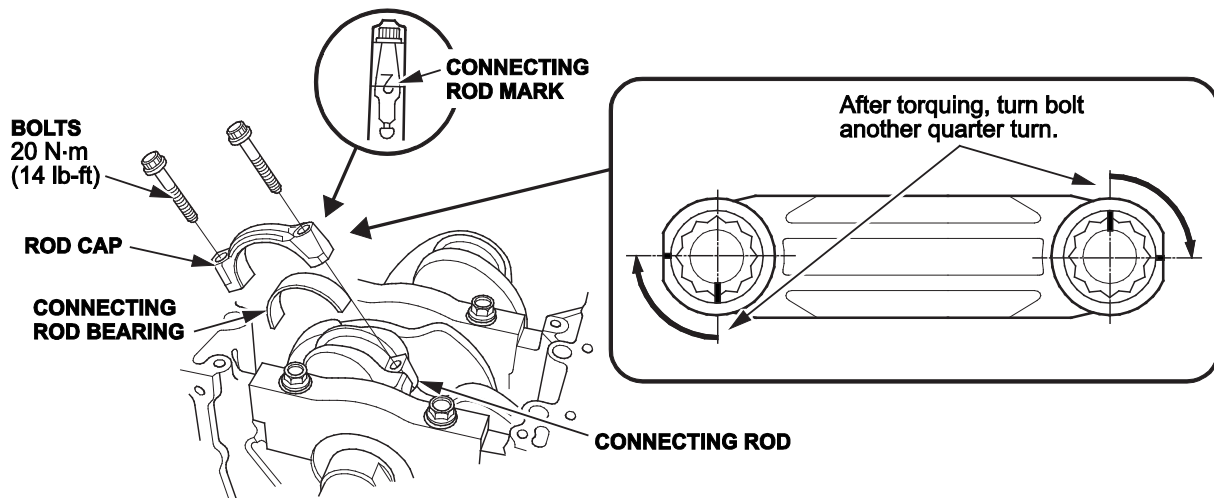
14. Apply new oil to the connecting rod bolt threads and flanges. Torque the bolts to **20 N·m (14 lb-ft)** then tighten the connecting rod bolts an additional **90 degrees**.
