October 1, 2015

02518 Version 1

Safety Recall: Front Passenger's Airbag Inflator Can Be Over-Pressurized

Year	Model	Trim	VIN Range
2003	MDX	ALL	Check the iN VIN status for eligibility

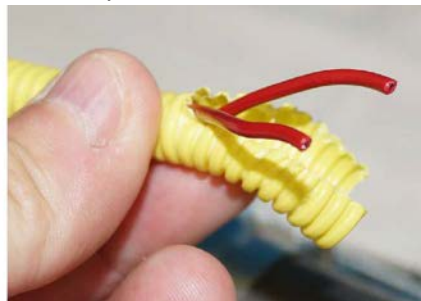
- Cut about 2 inches of the corrugated tube, then pull out the two red wires.

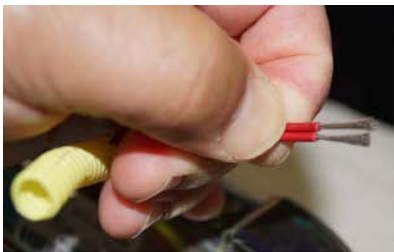
- Strip away about 1 inch of the wire insulation, then twist the wires together.

- Tape the twisted ends with electrical tape.

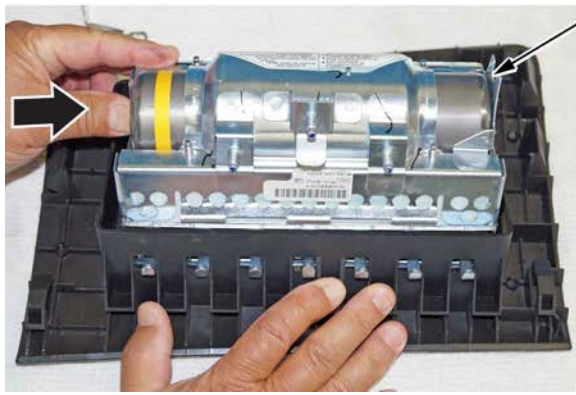
- Slide the inflator in until the “D” aligns with the tab on the inflator bracket. There should be no space or gap between the inflator and bracket.

No gap.

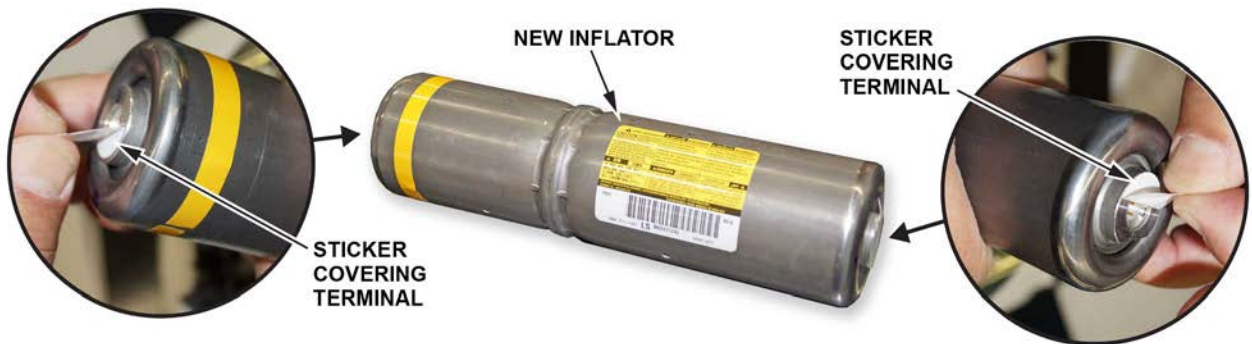
10. Remove the stickers covering the terminals on both sides of the new inflator.

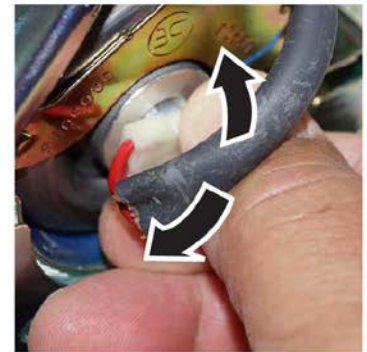
③ Wiggle the connector to make sure it's secure.

- After you hear each connector click, wiggle it to make sure it is secure.
NOTE: If the connector is not properly aligned, it will come out.
