51868-02139 Version 4

Warranty Extension: MIL Comes On with DTCs P0301 Thru P0304

AFFECTED VEHICLES

Year	Model	Trim	VIN Range
2010–12	Crosstour	All V6	Check the iN VIN Status for Eligibility.

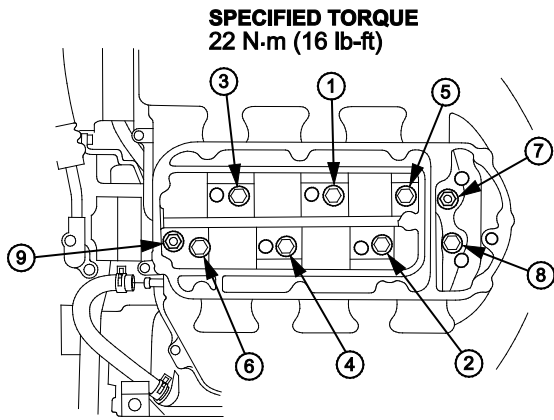
31. Remove the intake manifold bolts and nuts in three steps, then remove the intake manifold.

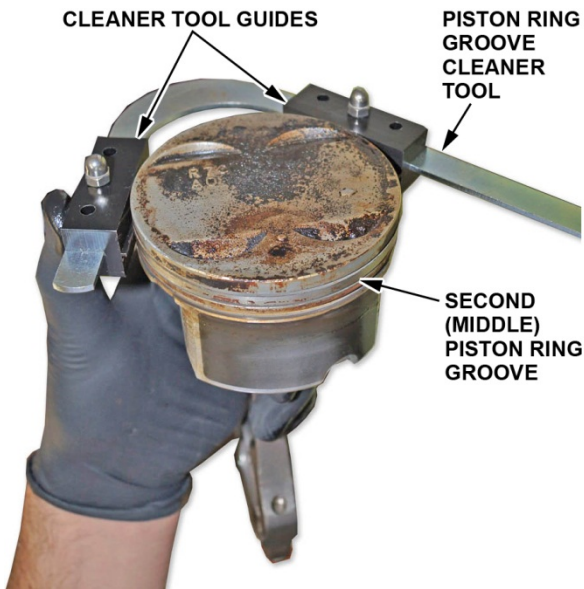
3. While holding the piston upright in your left hand, take the piston ring groove cleaner tool in your right hand and line up the cleaner tool guides with the second (middle) piston ring groove.

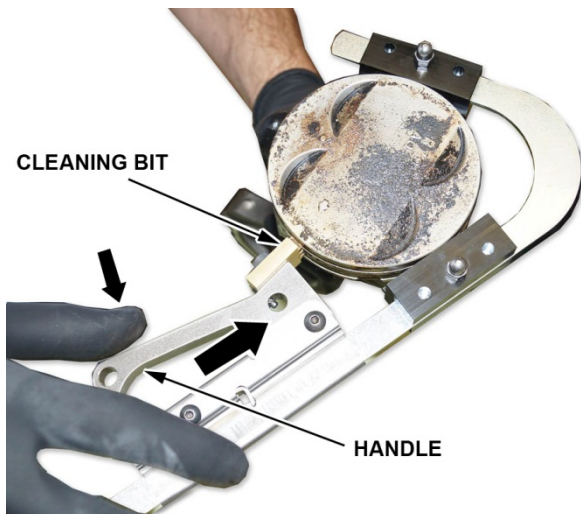
4. Press the handle on the piston ring groove cleaner tool and slide the cleaning bit onto the appropriate piston ring grooves.

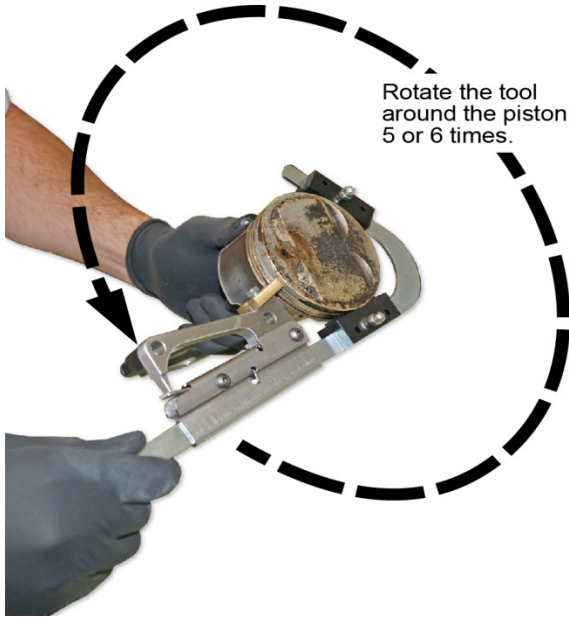
6. Hold the piston steady and rotate the tool counterclockwise five to six times to remove any carbon deposits in the piston ring grooves. **Do not** rotate the tool clockwise.

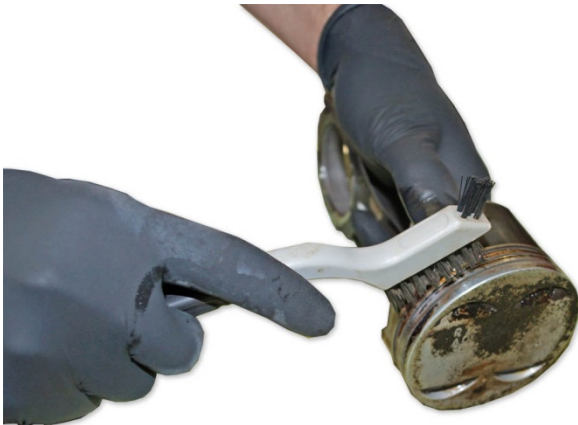
7. Remove the piston groove cleaning tool and clean off the carbon from the tool bit.
8. Finish cleaning the piston with throttle plate cleaner and the nylon brush. **Do not** use a steel wire brush.

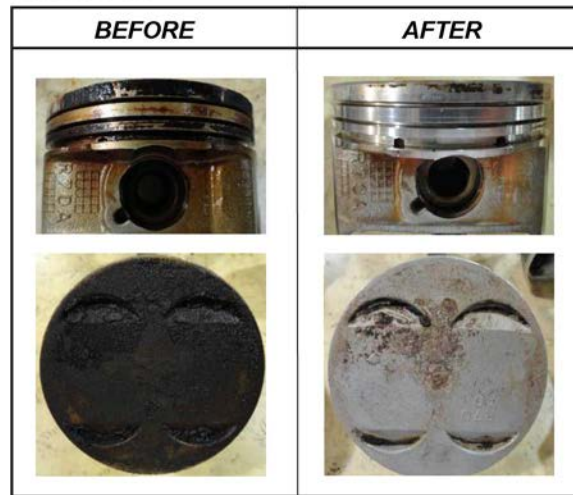
54K PISTON

NOTE: Below are some examples of before and after pictures. Depending on mileage and running conditions, the pistons will achieve different levels of cleanliness.
