51869-02164 Version 5

Warranty Extension: MIL Comes On With DTCs P0301 thru P0304

AFFECTED VEHICLES

Year	Model	Trim	VIN Range
2009–13	Pilot	ALL	Check the iN VIN Status for Eligibility

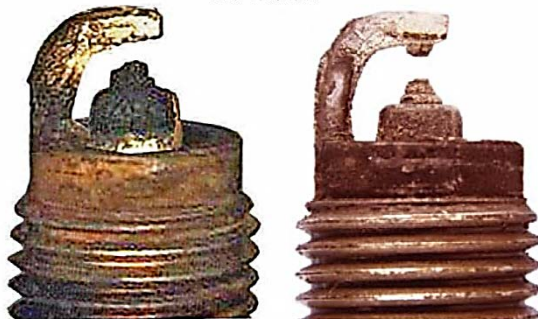
2. Remove and check the spark plug(s) on the affected cylinders (example: if P0301 is stored, check the spark plug on cylinder No. 1).

Are the spark plug(s) fouled?

GOOD

NO GOOD

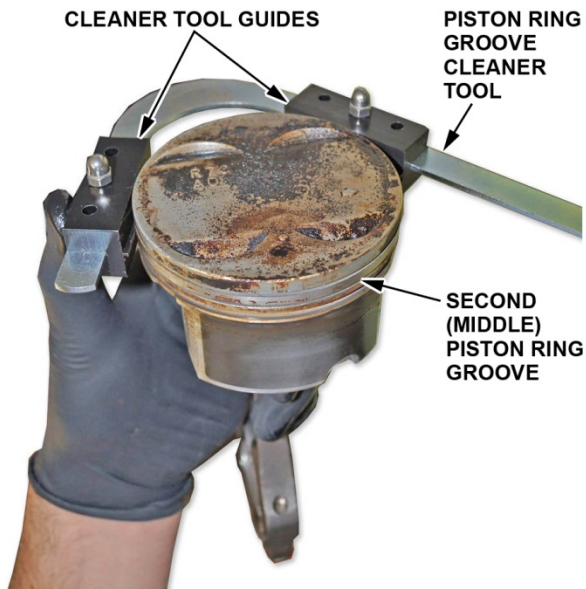
3. While holding the piston upright in your left hand, take the piston ring groove cleaner tool in your right hand and line up the cleaner tool guides with the second (middle) piston ring groove.

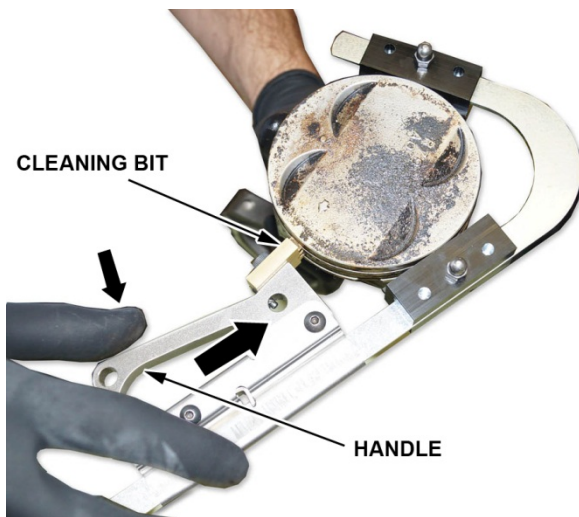
4. Press the handle on the piston ring groove cleaner tool and slide the cleaning bit onto the appropriate piston ring grooves.

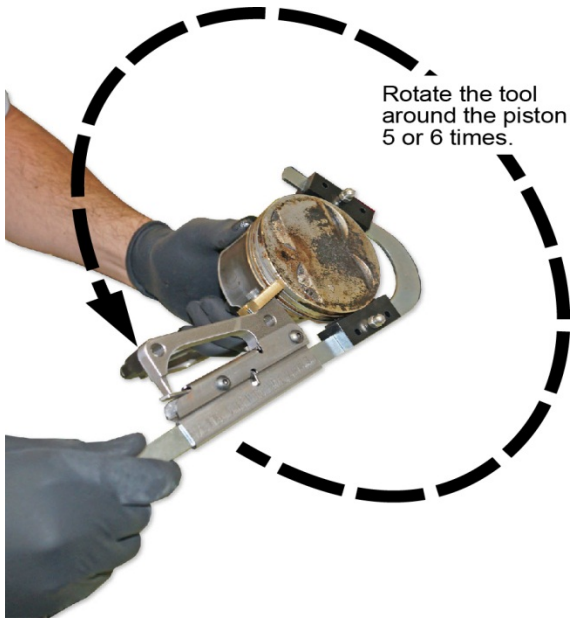
6. Hold the piston steady and rotate the tool counter-clockwise five to six times to remove any carbon deposits in the piston ring grooves. **Do not** rotate the tool clockwise.

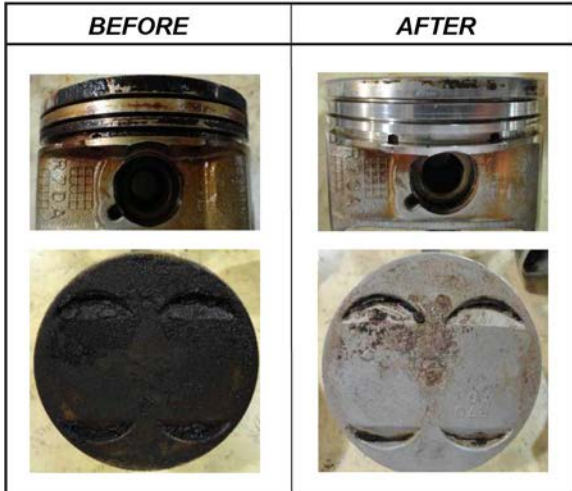
54K PISTON

NOTE: Below are some examples of before and after pictures. Depending on mileage and running conditions, the pistons will achieve different levels of cleanliness.
