02024 Version 4

Safety Recall: Driver's Airbag Inflator Can Be Over-Pressurized

Supersedes 15-033, dated September 16, 2015, to revise the information highlighted in **yellow**

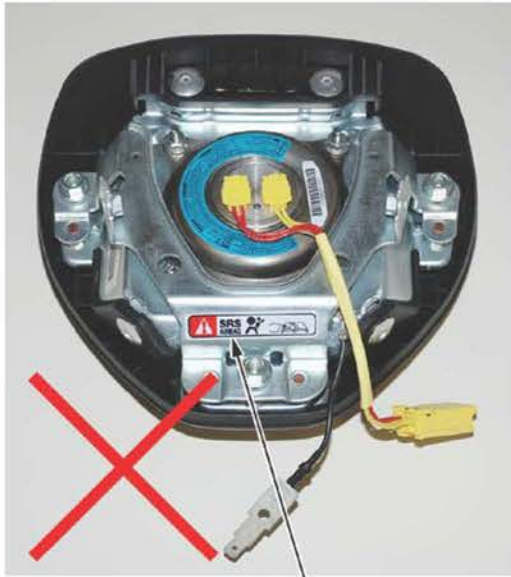
**NON-STANDARD
SAFETY LABEL**

- If there is nothing unusual about the airbag or the inflator, go to step 6.
- If there are any unusual markings, like an incorrect label or a model year written in marker, the airbag and inflator may not be the correct airbag and/or inflator for the vehicle or it may be a counterfeit part. For more information about counterfeit airbags, you can refer to safercar.gov, enter keywords **MANAGING COUNTERFEIT**, and select **Recommended Dealer Guidance for Managing Counterfeit Air Bags** from the list. **If you suspect that the airbag or inflator is counterfeit, do not continue this procedure.** Contact your DPSM for assistance.

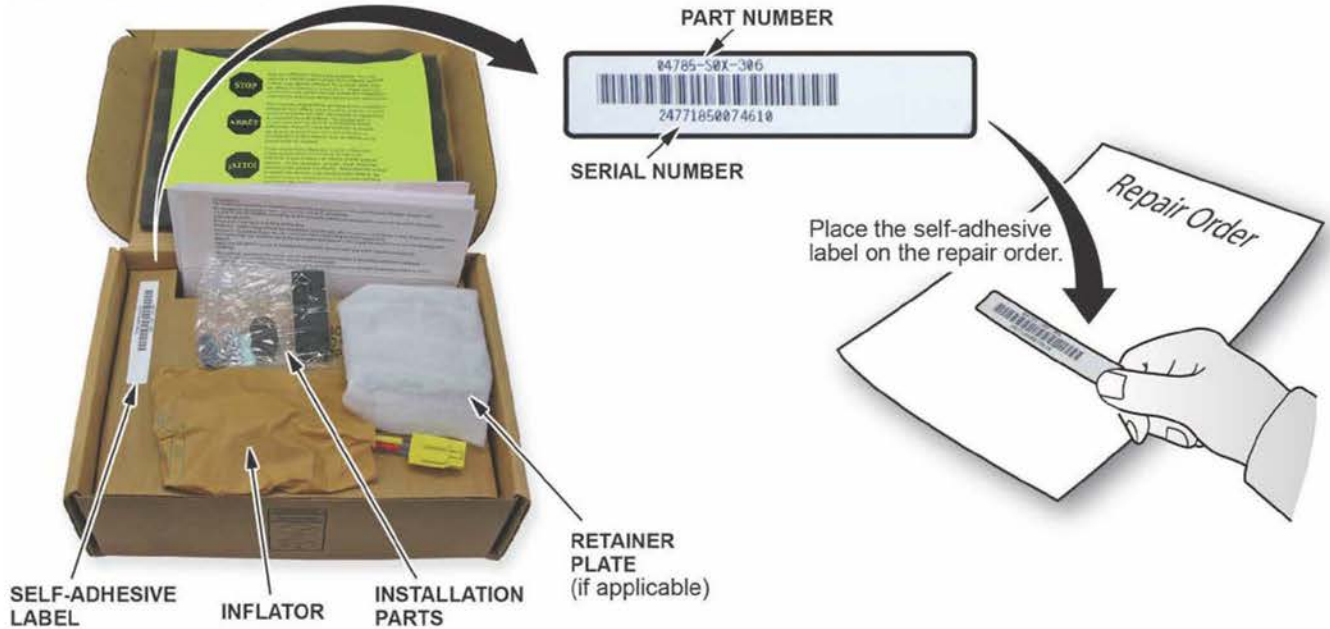
INFLATOR PARTS BOX

6. Peel the label located inside the inflator box from its backing and attach it to the RO. For the warranty claim to be paid, the **replacement inflator part number that you received** must be included in the warranty claim.

- The replacement part number is printed on the top part of the label and the serial number is printed on the bottom. **Make sure you attach the label to the R.O. and give it to the warranty clerk.**
- There may also be a colored sticker located in the kit, ignore it because it is not used.
- Not all inflator kits have a label included. In those cases, write the serial number and part number from the side of the inflator box on the R.O. The part number always starts with 047.

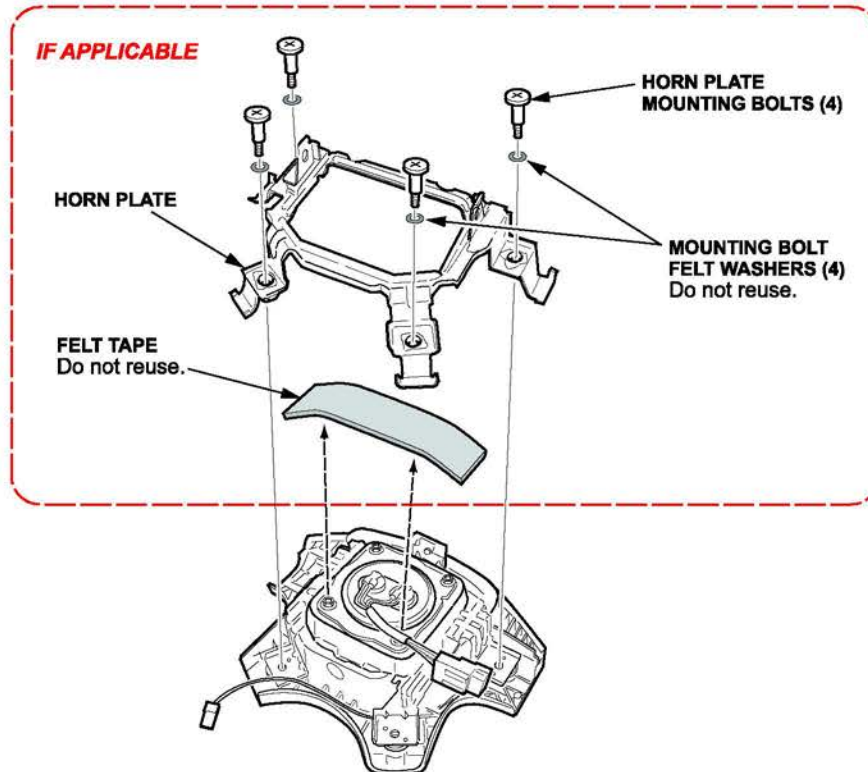
7. If there is no horn plate installed, go to step 8. If there is a horn plate installed, remove the four horn plate mounting bolts, the mounting bolt felt washers, the horn plate, and remove the felt tape covering the lower two inflator locknuts. The felt washers and felt tape will not be reused.

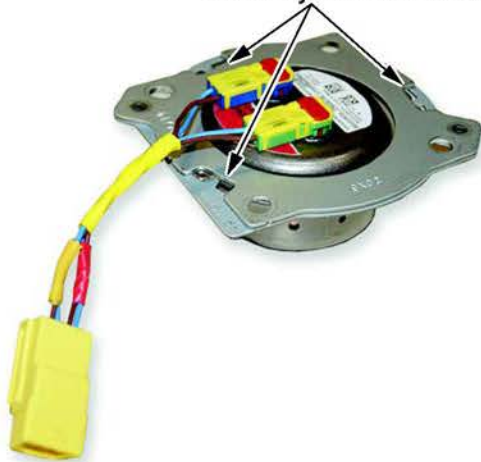
The inflator is held down by a directional retainer that is keyed to the inflator.

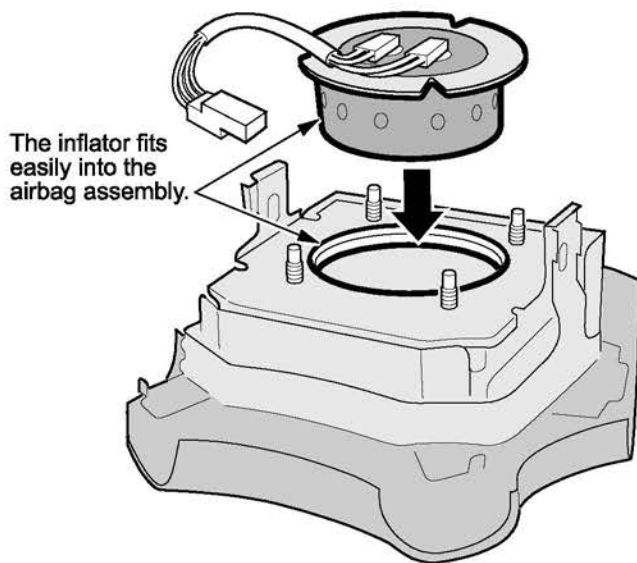
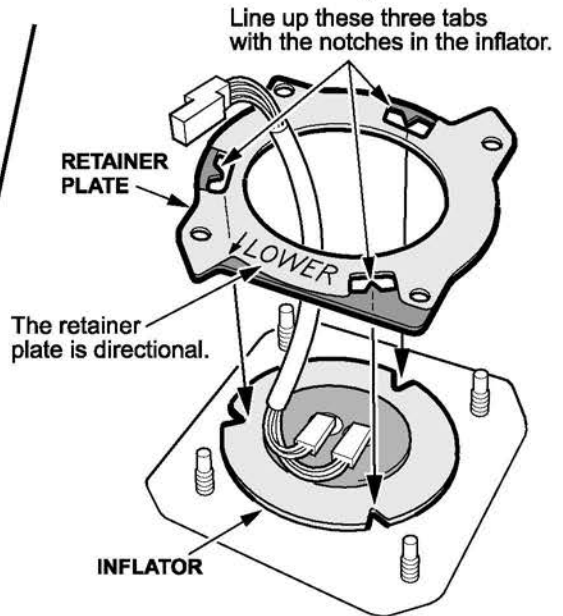
- Place the inflator into the opening with the inflator harness toward the bottom of the airbag.

- Install the bracket onto the studs with the stamp **LOWER** at the bottom of the airbag.
- Make sure the three tabs and notches are properly aligned.

- The tabs and notches are designed to align in one direction only. If the tabs and notches are not aligned, the inflator and bracket are not installed correctly.
- Make sure the harness comes out through the center opening. Do not install the bracket over the harness wires.
