September 16, 2015

02040 Version 4

Safety Recall: Front Passenger's Airbag Inflator Can Be Over-Pressurized

Supersedes 15-041, dated July 15, 2015, to revise the information highlighted in yellow

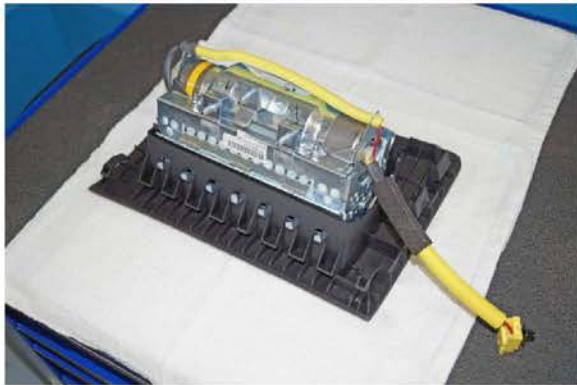
4. Place the airbag, face-down, on a clean shop towel.

- The orientation of the airbag is critical because if the inflator is installed incorrectly, the harness will be too short when you reinstall the airbag.
- The brackets between the various models are similar but may differ from the example shown.

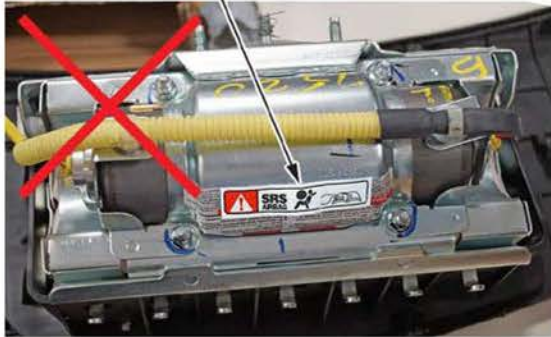
NON-STANDARD SAFETY LABEL

- If there is nothing unusual about the airbag or the inflator, go to step 6.
- If there are any unusual markings, like an incorrect label or a model year written in marker, the airbag and inflator may not be the correct airbag and/or inflator for the vehicle or it may be a counterfeit part. For more information about counterfeit airbags, you can refer to safercar.gov, enter keywords **MANAGING COUNTERFEIT**, and select **Recommended Dealer Guidance for Managing Counterfeit Air Bags** from the list. **If you suspect that the airbag or inflator is counterfeit, do not continue this procedure.** Contact your DPSM for assistance.

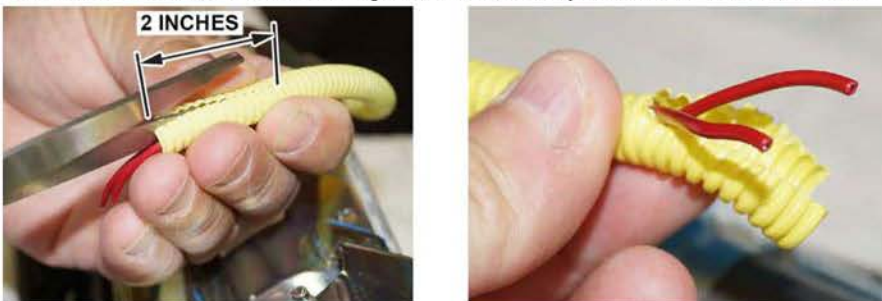
- Cut about 2 inches of the corrugated tube, then pull out the two red wires.

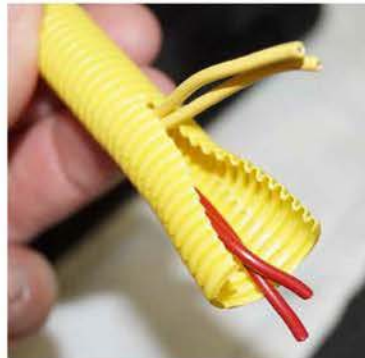
- Cut about 2 inches of the corrugated tube, then pull out the yellow wires.

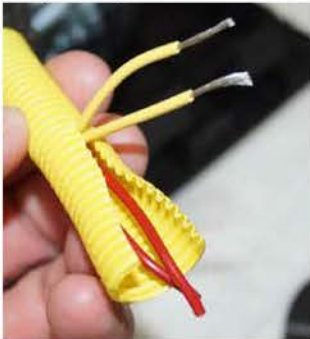
- Strip away about an inch of the wire insulation, then twist the wire ends together.

- Tape the twisted ends with electrical tape.

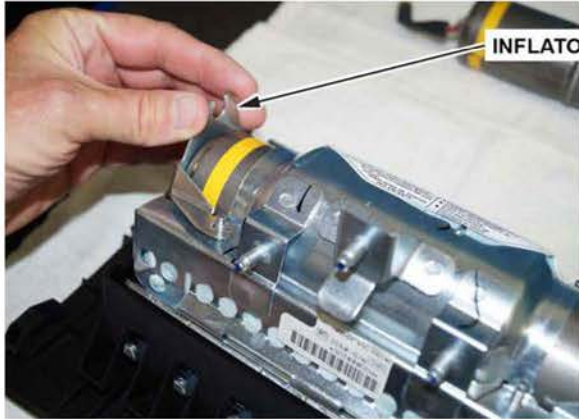
- Reinstall the inflator bracket. There should be no space or gap between the bracket and inflator.

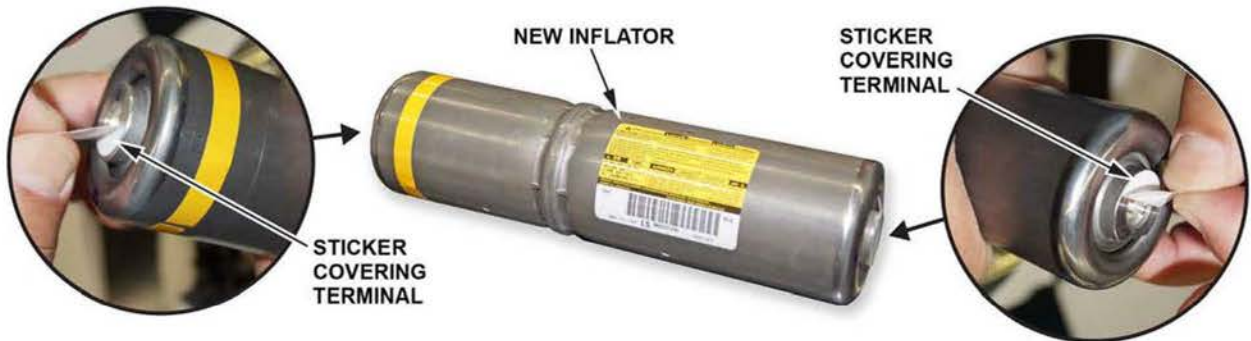
15. Remove the stickers covering the terminals on both sides of the new inflator.
