September 16, 2015

02024 Version 3

Safety Recall: Driver's Airbag Inflator Can Be Over-Pressurized

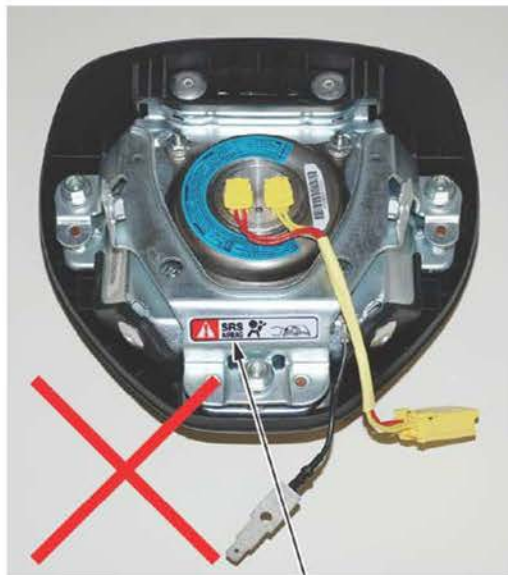
NON-STANDARD
SAFETY LABEL

- If there are any unusual markings, like an incorrect label or a model year written in marker, the airbag and inflator may not be the correct airbag and/or inflator for the vehicle or it may be a counterfeit part. For more information about counterfeit airbags, you can refer to safercar.gov, enter keywords **MANAGING COUNTERFEIT**, and select **Recommended Dealer Guidance for Managing Counterfeit Air Bags** from the list. **If you suspect that the airbag or inflator is counterfeit, do not continue this procedure.** Contact your DPSM for assistance.

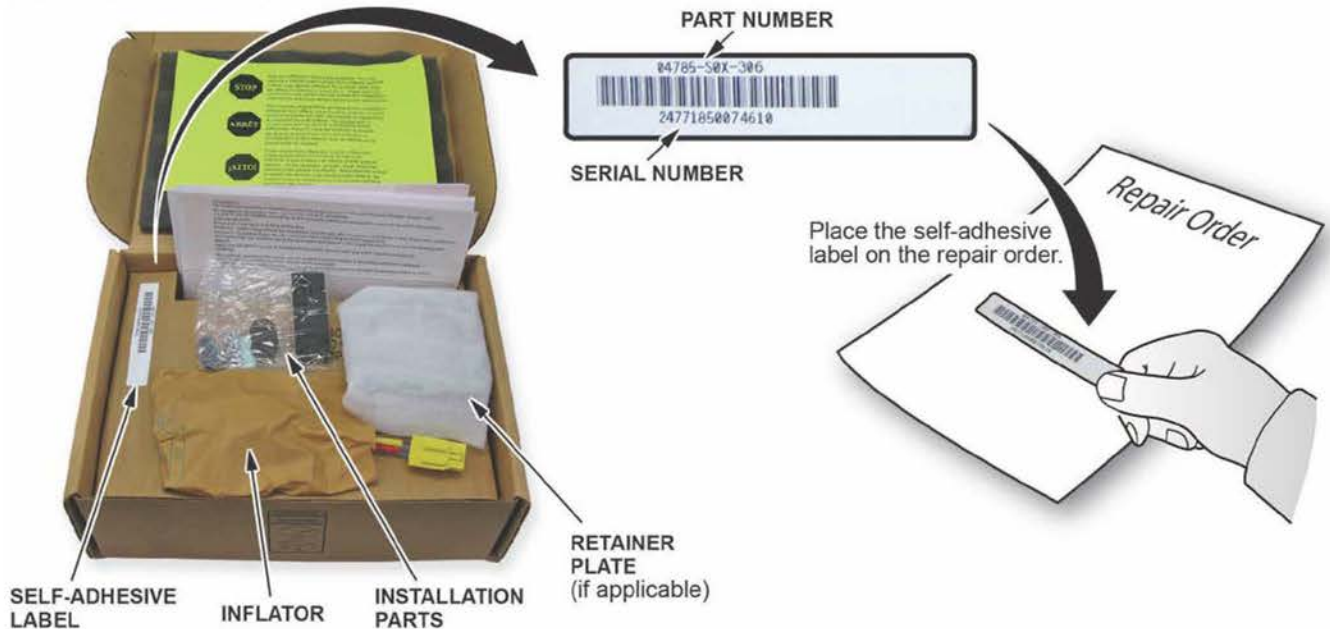
INFLATOR PARTS BOX

6. Peel the label located inside the inflator box from its backing and attach it to the RO. For the warranty claim to be paid, the **replacement inflator part number that you received** must be included in the warranty claim.

- The replacement part number is printed on the top part of the label and the serial number is printed on the bottom. **Make sure you attach the label to the R.O. and give it to the warranty clerk.**
- There may also be a colored sticker located in the kit, ignore it because it is not used.
- Not all inflator kits have a label included. In those cases, write the serial number and part number from the side of the inflator box on the R.O. The part number always starts with 047.

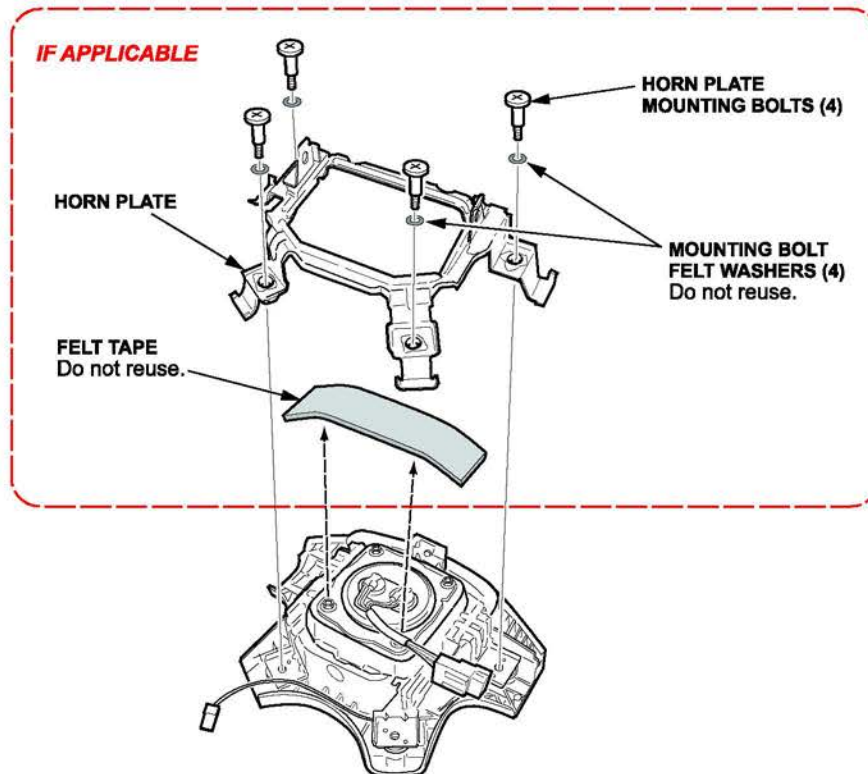
7. If there is no horn plate installed, go to step 8. If there is a horn plate installed, remove the four horn plate mounting bolts, the mounting bolt felt washers, the horn plate, and remove the felt tape covering the lower two inflator locknuts. The felt washers and felt tape will not be reused.

- Using needle-nose vise grips or a 3/8 in. 6-point socket, remove the four locknuts from the inflator. The locknuts will not be reused.

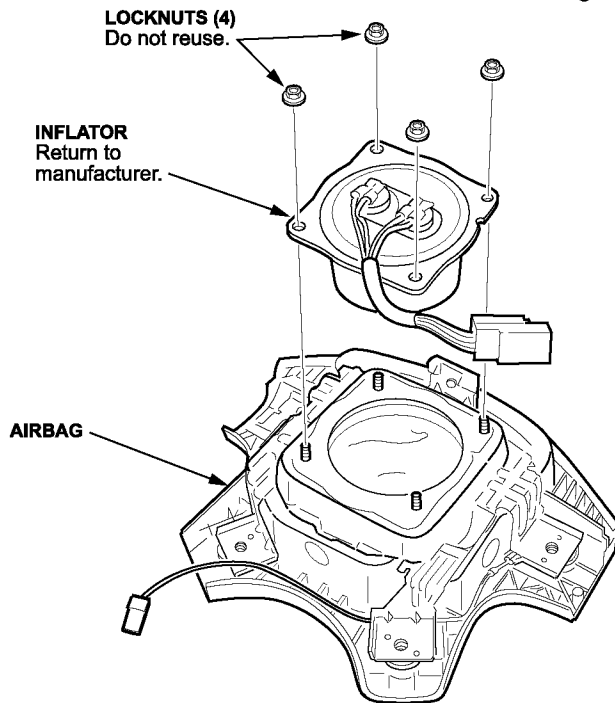
- Use shop air to clean any debris that may be on the inflator, then remove the inflator from the airbag.

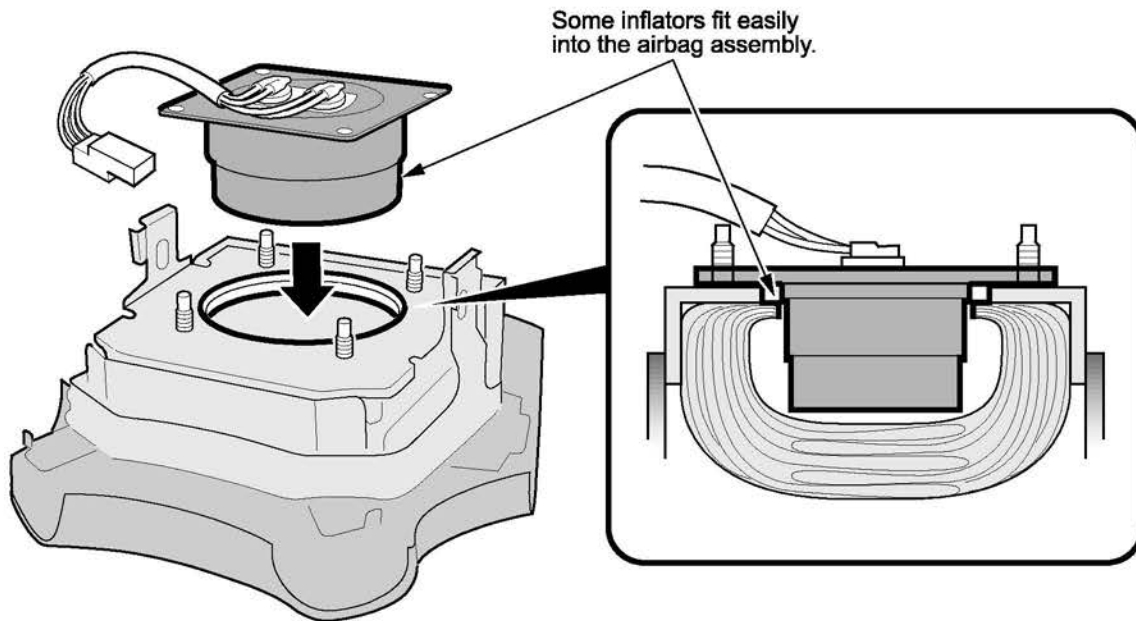
- Insert the inflator into the opening.

NOTE: Make sure the inflator wires are positioned toward the bottom of the airbag. If you install the inflator incorrectly, you may not be able to reconnect the SRS airbag harness.

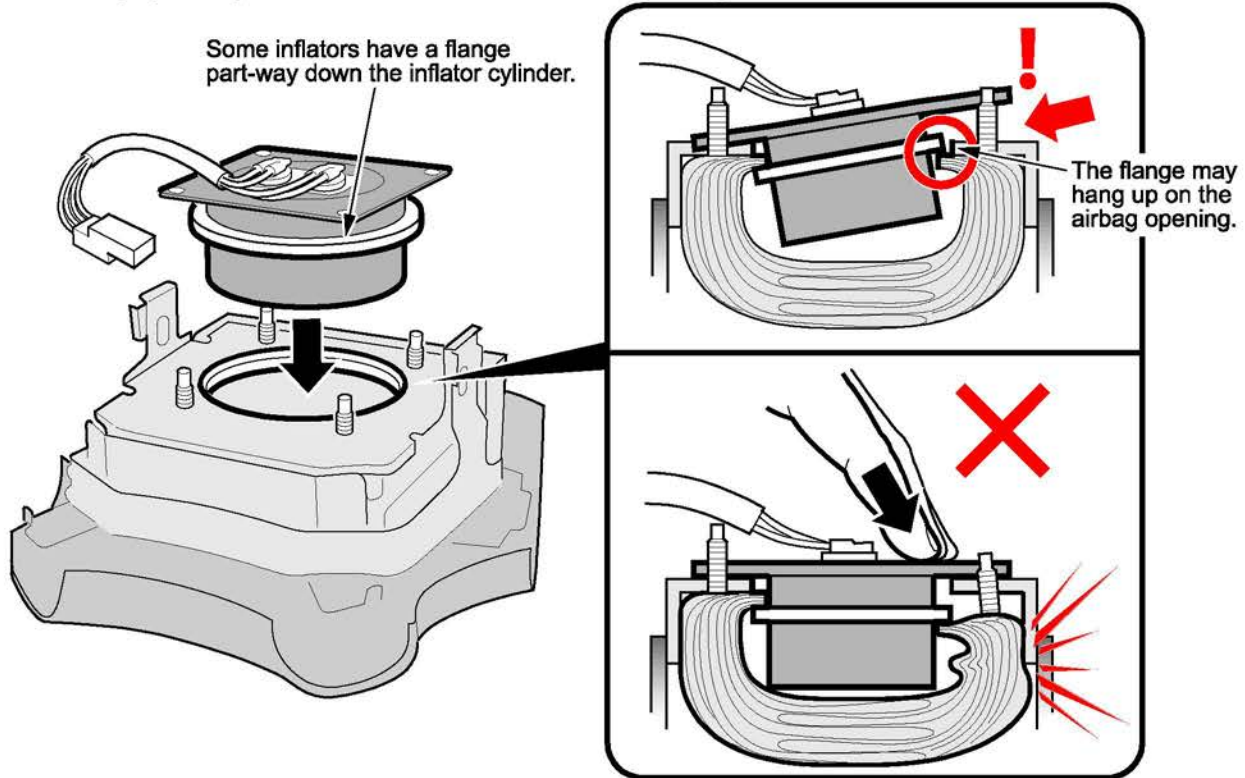
- Insert the inflator into the opening. Do not force it into the airbag module.

NOTE: Make sure the inflator wires are positioned toward the bottom of the airbag. If you install the inflator incorrectly, you may not be able to reconnect the SRS airbag harness.

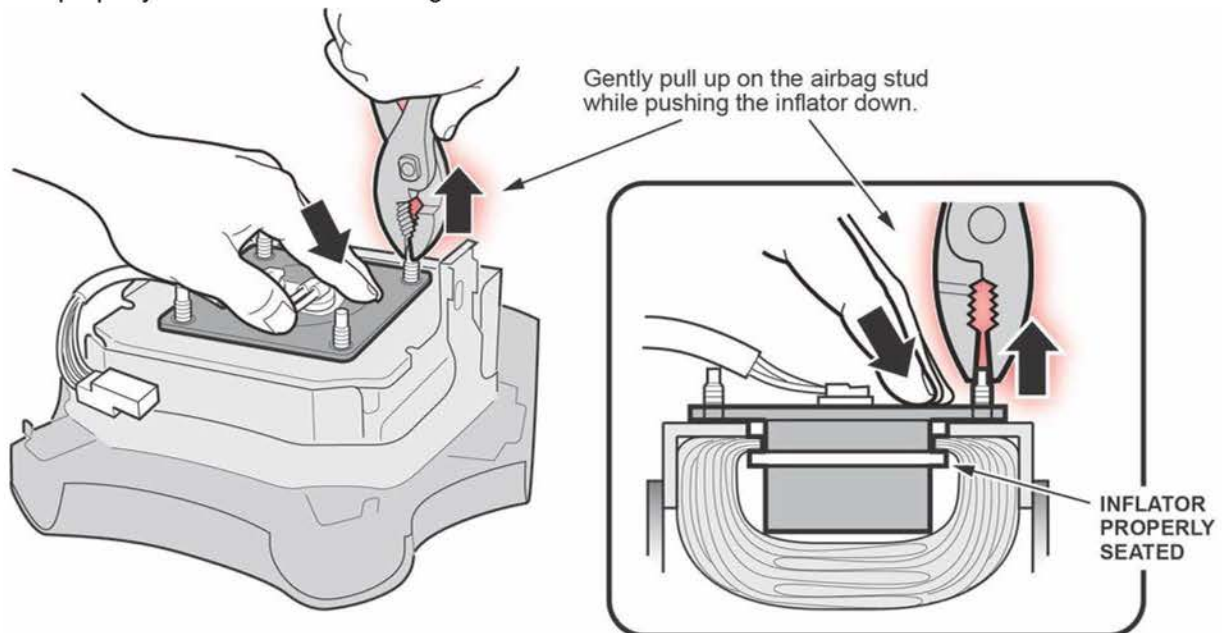
- Using a pair of pliers, gently pull up on each stud up while pushing the inflator module down until the airbag is properly seated within the airbag module.

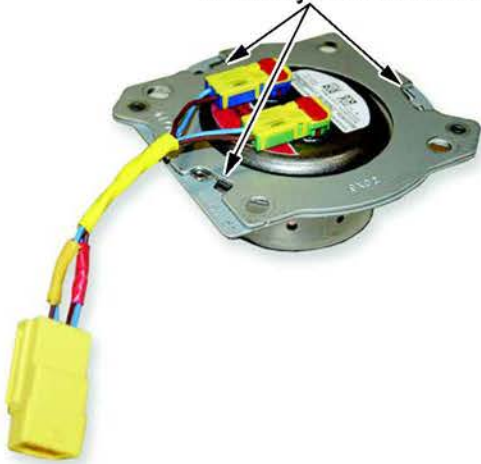
The inflator is held down by a directional retainer that is keyed to the inflator.

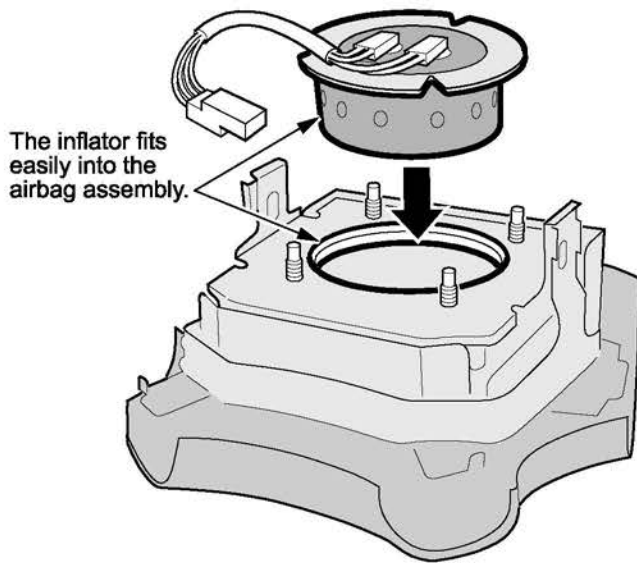
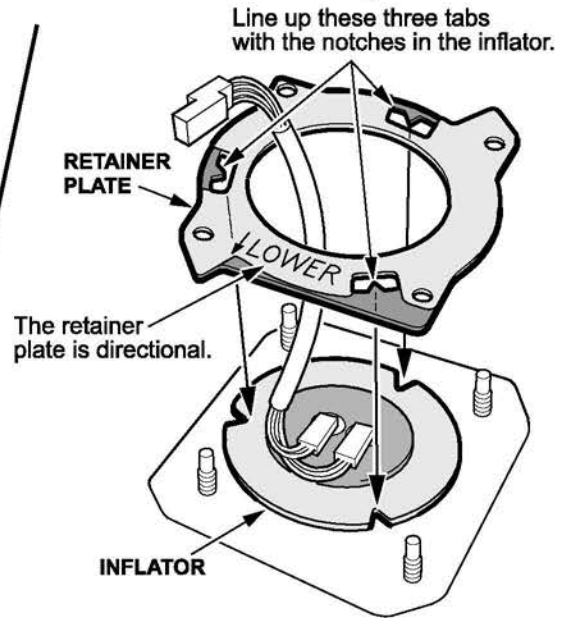
- Place the inflator into the opening with the inflator harness toward the bottom of the airbag.

- Install the bracket onto the studs with the stamp **LOWER** at the bottom of the airbag.
- Make sure the three tabs and notches are properly aligned.

- The tabs and notches are designed to align in one direction only. If the tabs and notches are not aligned, the inflator and bracket are not installed correctly.
- Make sure the harness comes out through the center opening. Do not install the bracket over the harness wires.

12. Install and torque the new locknuts to **3.9 N·m (2.8 lb-ft, 34 lb-in)**.
13. Cover the lower two inflator locknuts with new felt tape.
14. Reinstall the horn plate with new felt washers on its mounting bolts. Torque the mounting bolts to **3.4 N·m (2.5 lb-ft, 30 lb-in)**, then make sure the horn plate moves freely.
15. Reinstall the driver's airbag using new Torx bolts and torque the bolts to **9.8 N·m (7.2 lb-ft)**. Refer to the applicable electronic service manual.
16. Reconnect the negative battery cable.
17. Start the vehicle and check that the SRS indicator comes on for about 6 seconds, then turns off.
18. Give your warranty clerk the RO that includes the replacement inflator serial number and replacement part number. For the warranty claim to be paid, the **replacement inflator part number** must be included in the warranty claim.
