Reference	SSM41438
Models	Range Rover Sport / L320
Title	Stabilizer bar fluid weep - Dynamic Response vehicles.
Category	Chassis
Last modified	05-Jan-2015 00:00:00
Symptom	304000 Suspension System
Attachments	Stabilizer bar pipe o-rings.pdf

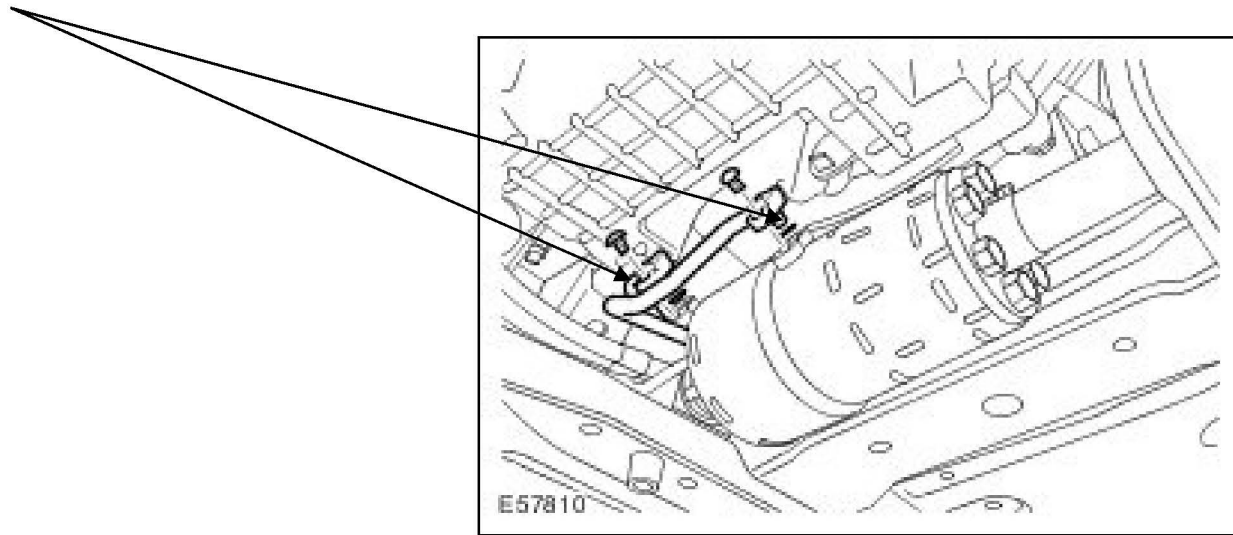
In order to correctly diagnose the leak path on a stabilizer bar, clean the suspected area thoroughly and confirm if the leak is from the pipe o-rings, the stabilizer bar hydraulic seal or somewhere else. If found to be from the pipe o-rings (see attached document), these are serviceable parts and should be replaced.

ARC pipe to Actuator joint

If the leak is found to be from the hydraulic seal, this is not a serviceable part and a new stabilizer bar will be required.
