Reference	SSM44211
Models	LR3 / L319 Range Rover Sport / L320
Title	Front Suspension Lower Arm Bush Knock.
Category	Chassis
Last modified	05-Jan-2015 00:00:00
Symptom	304000 Suspension System
Attachments	Lower arm front bush.pdf
Content	<p><u>Issue:</u> A review of Front Lower Control Arm warranty returns from various markets has shown that arm assemblies have been incorrectly changed for knock issues when the front bush is cracked and should have been replaced as per Technical Service Bulletins LTB00204v4 and LTB00123v4.</p> <p><u>Cause:</u> Incorrect diagnosis of front and rear bush issues. See attached photo showing an example of a cracked front bush.</p> <p><u>Action:</u> If source of a knock is suspected to be the front lower arm, then thorough inspection of both front and rear bushes is required. Refer to the above mentioned Technical Service Bulletins.</p>

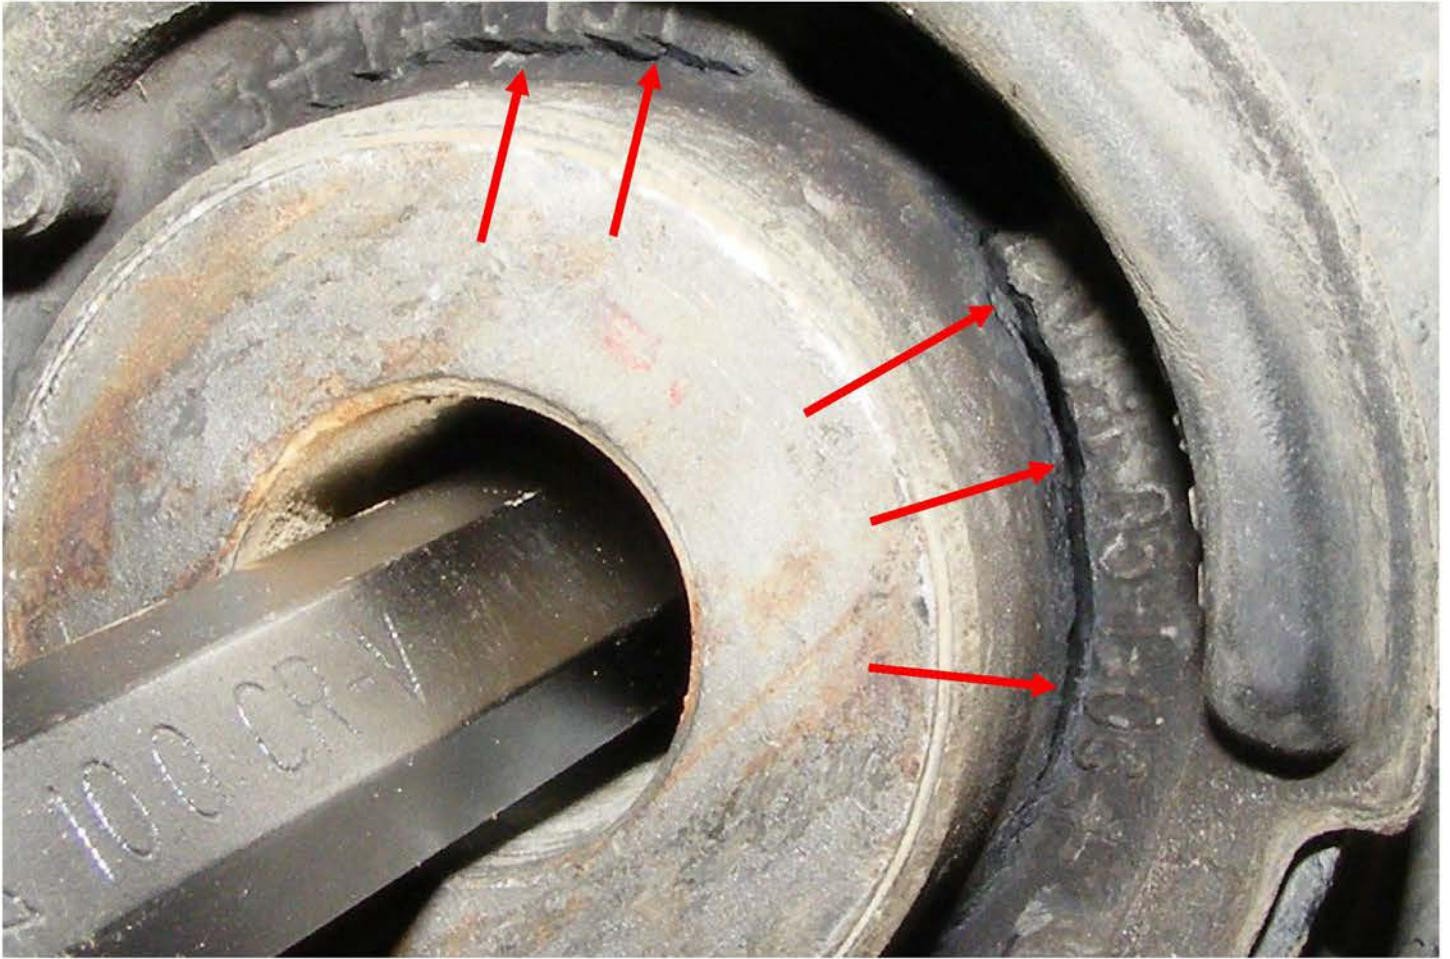
Cracked Front Bush
