Reference	SSM62857
Models	LR4 / L319 Range Rover / L322 Range Rover Sport / L320
Title	5.0L replacement engine will not start (Denso engine management)
Category	Engine
Last modified	05-Jan-2015 00:00:00
Symptom	499000 Basic Engine
Attachments	11AJ133.pdf

Issue: A replacement AJ133 engine has been fitted into a vehicle. The engine cranks normally but will not start.

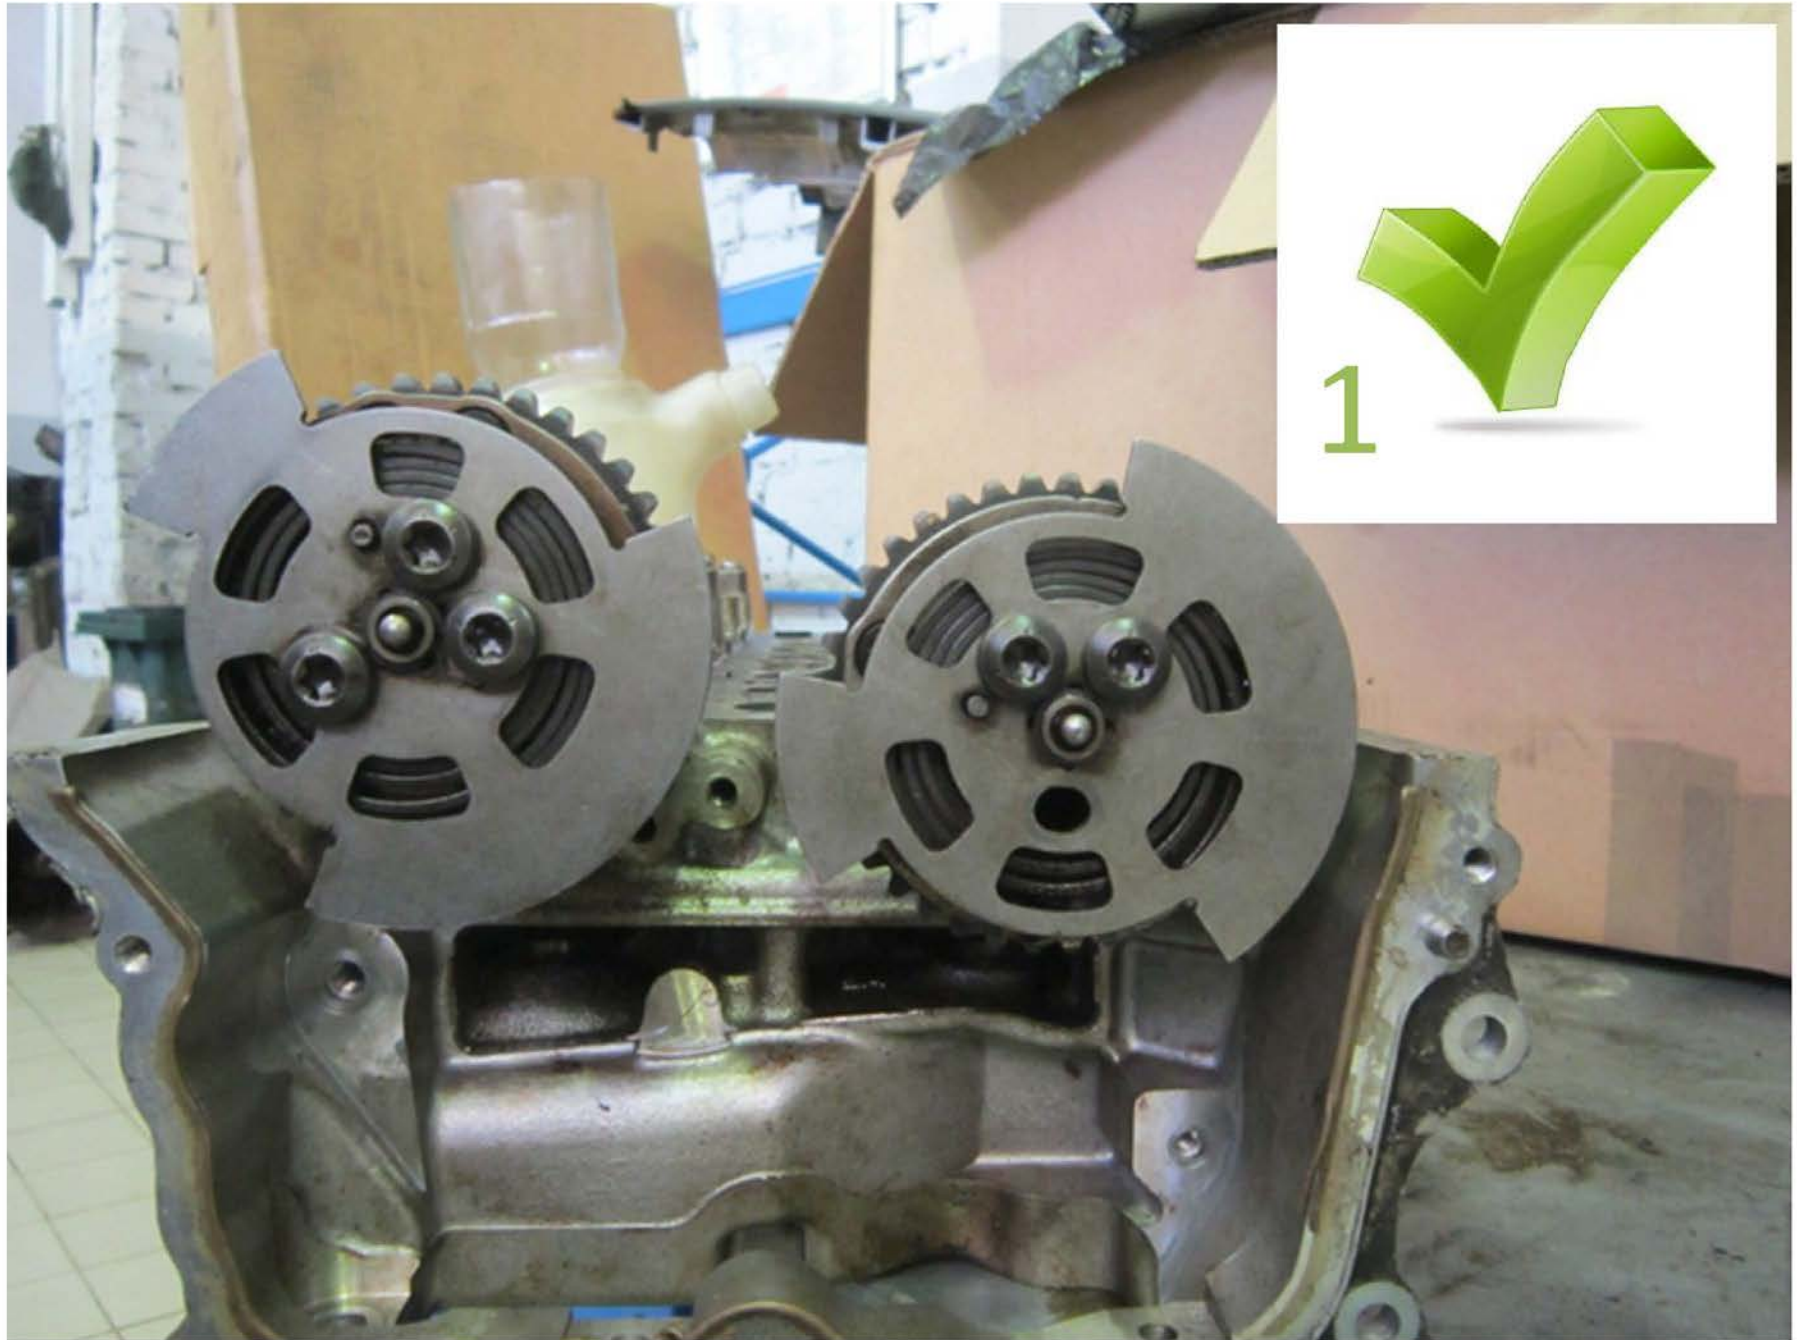
Picture 1 – this is the correct part for the engine - do not follow this procedure.

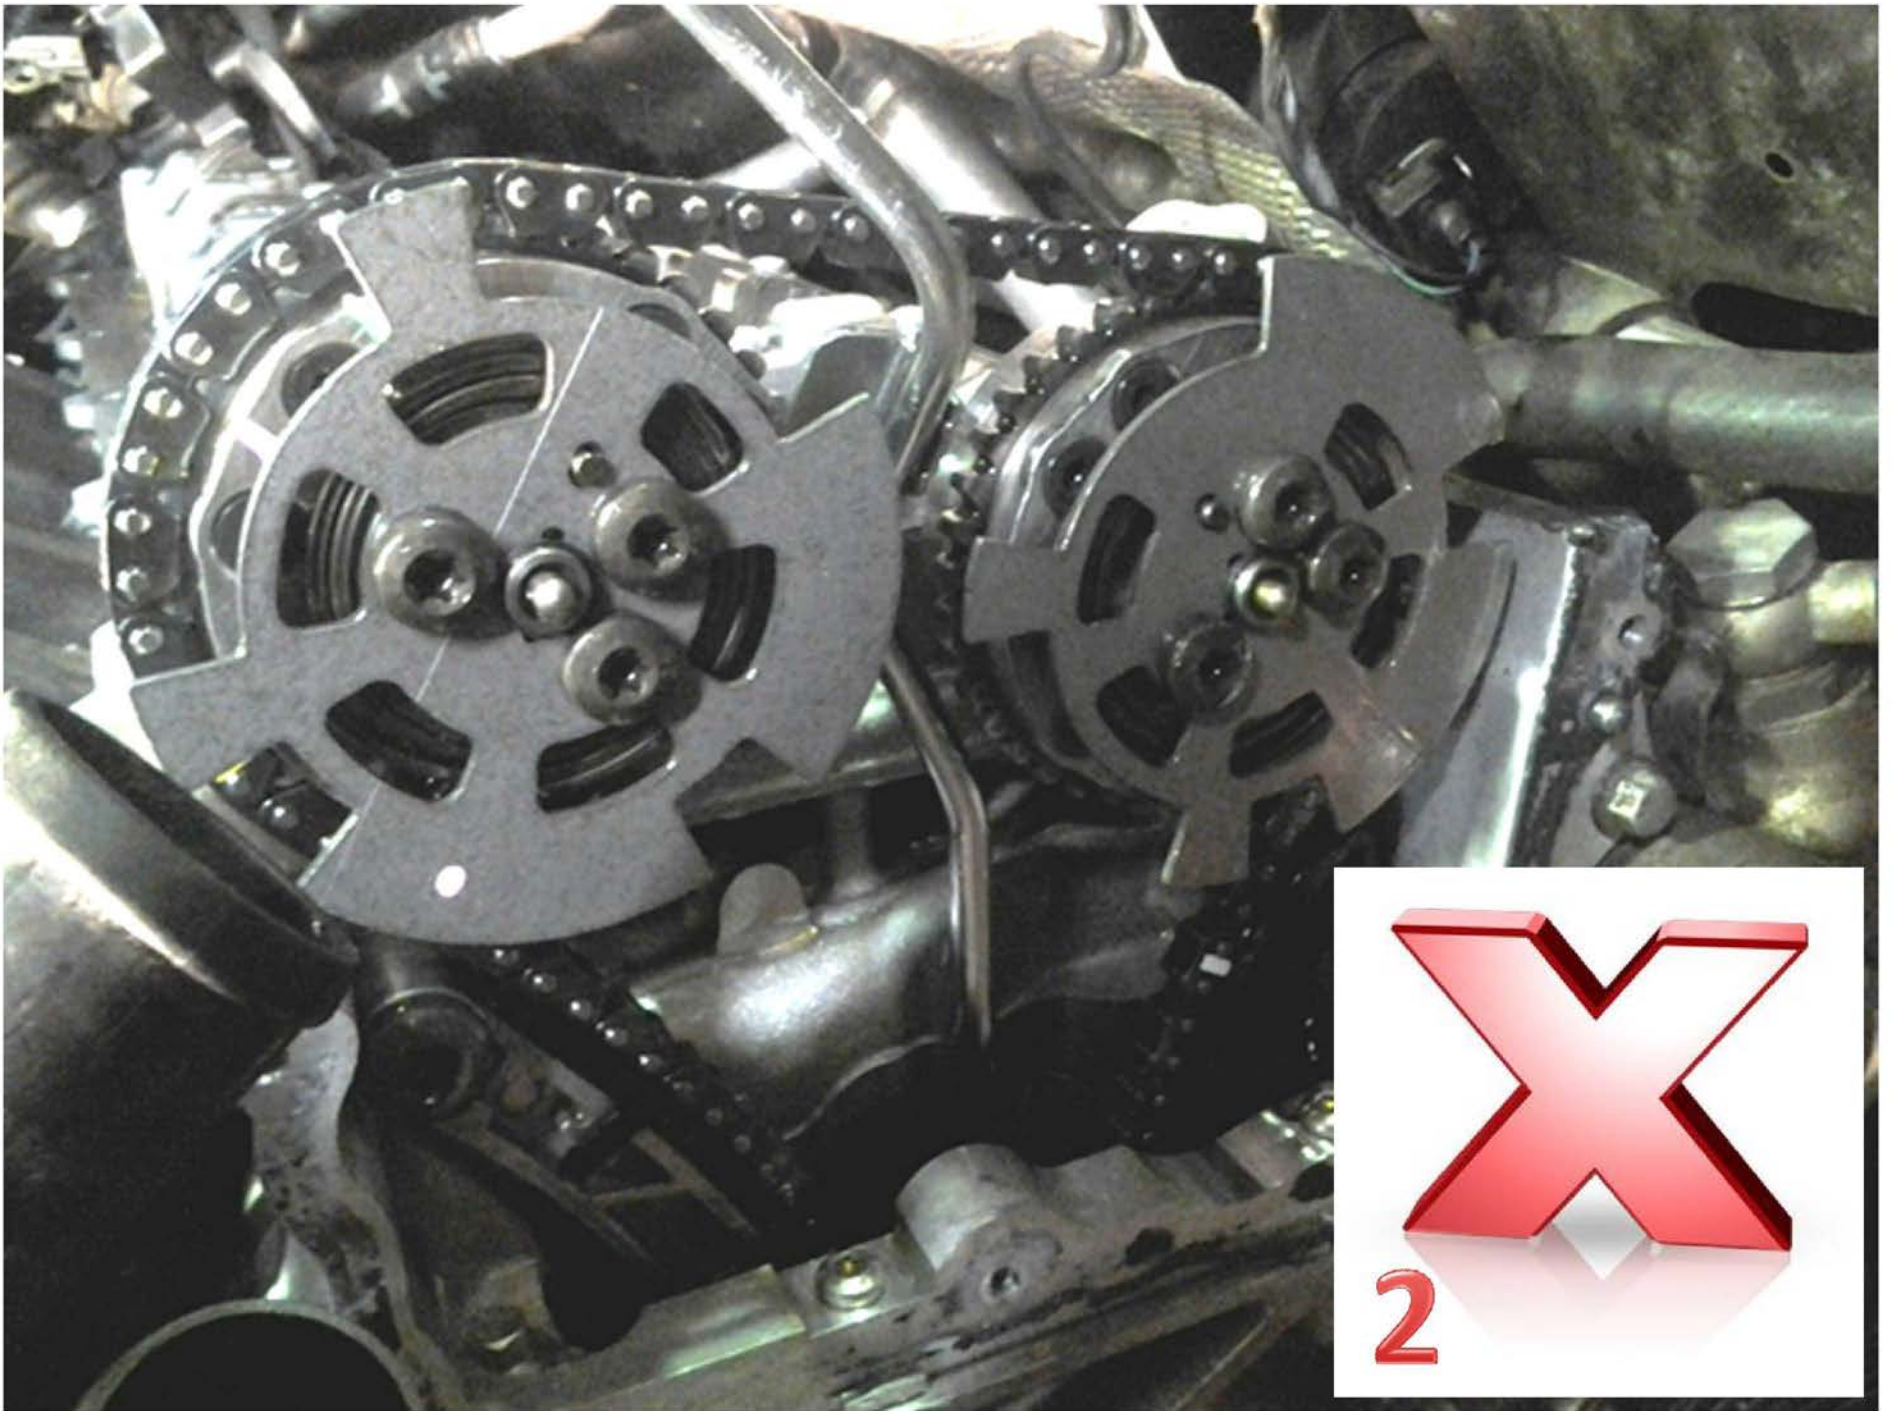
Picture 2 – this is the wrong part for the engine - follow the instruction below.

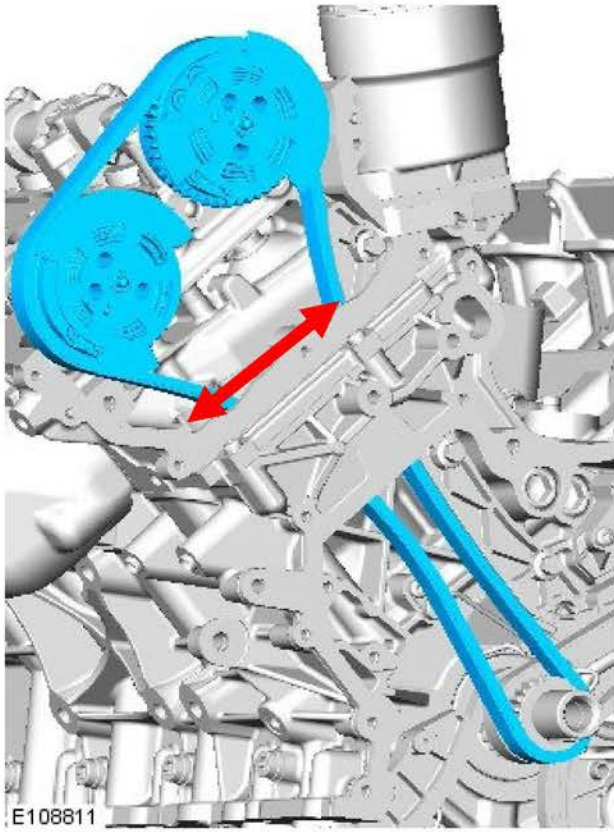
Picture 3 - Secure the timing chains using strong cable tie or vice grips. This must be done securely around the chain on each bank underneath the VVT units, so the chains do not become slack.

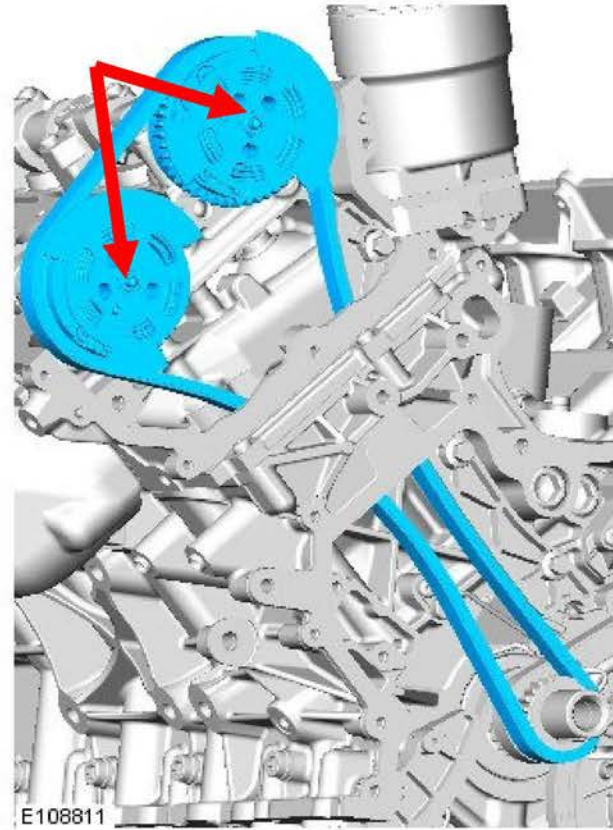
Picture 4 - While keeping the chain in position, carefully remove the circlip on the front of the VVT unit. The circlip is not needed and should be thrown away.

Carefully remove the torx bolts for one of the VVT sprockets and exchange the sensor ring from the original engine.
