Reference	SSM72189
Models	Range Rover / L405
Title	Rear Spoiler Contact With `D` Post - Range Rover (L405)
Category	Body
Last modified	24-Aug-2015 00:00:00
Symptom	111000 Body Panel(s)/Unibody
Attachments	1Rear Spoiler Contact.jpg

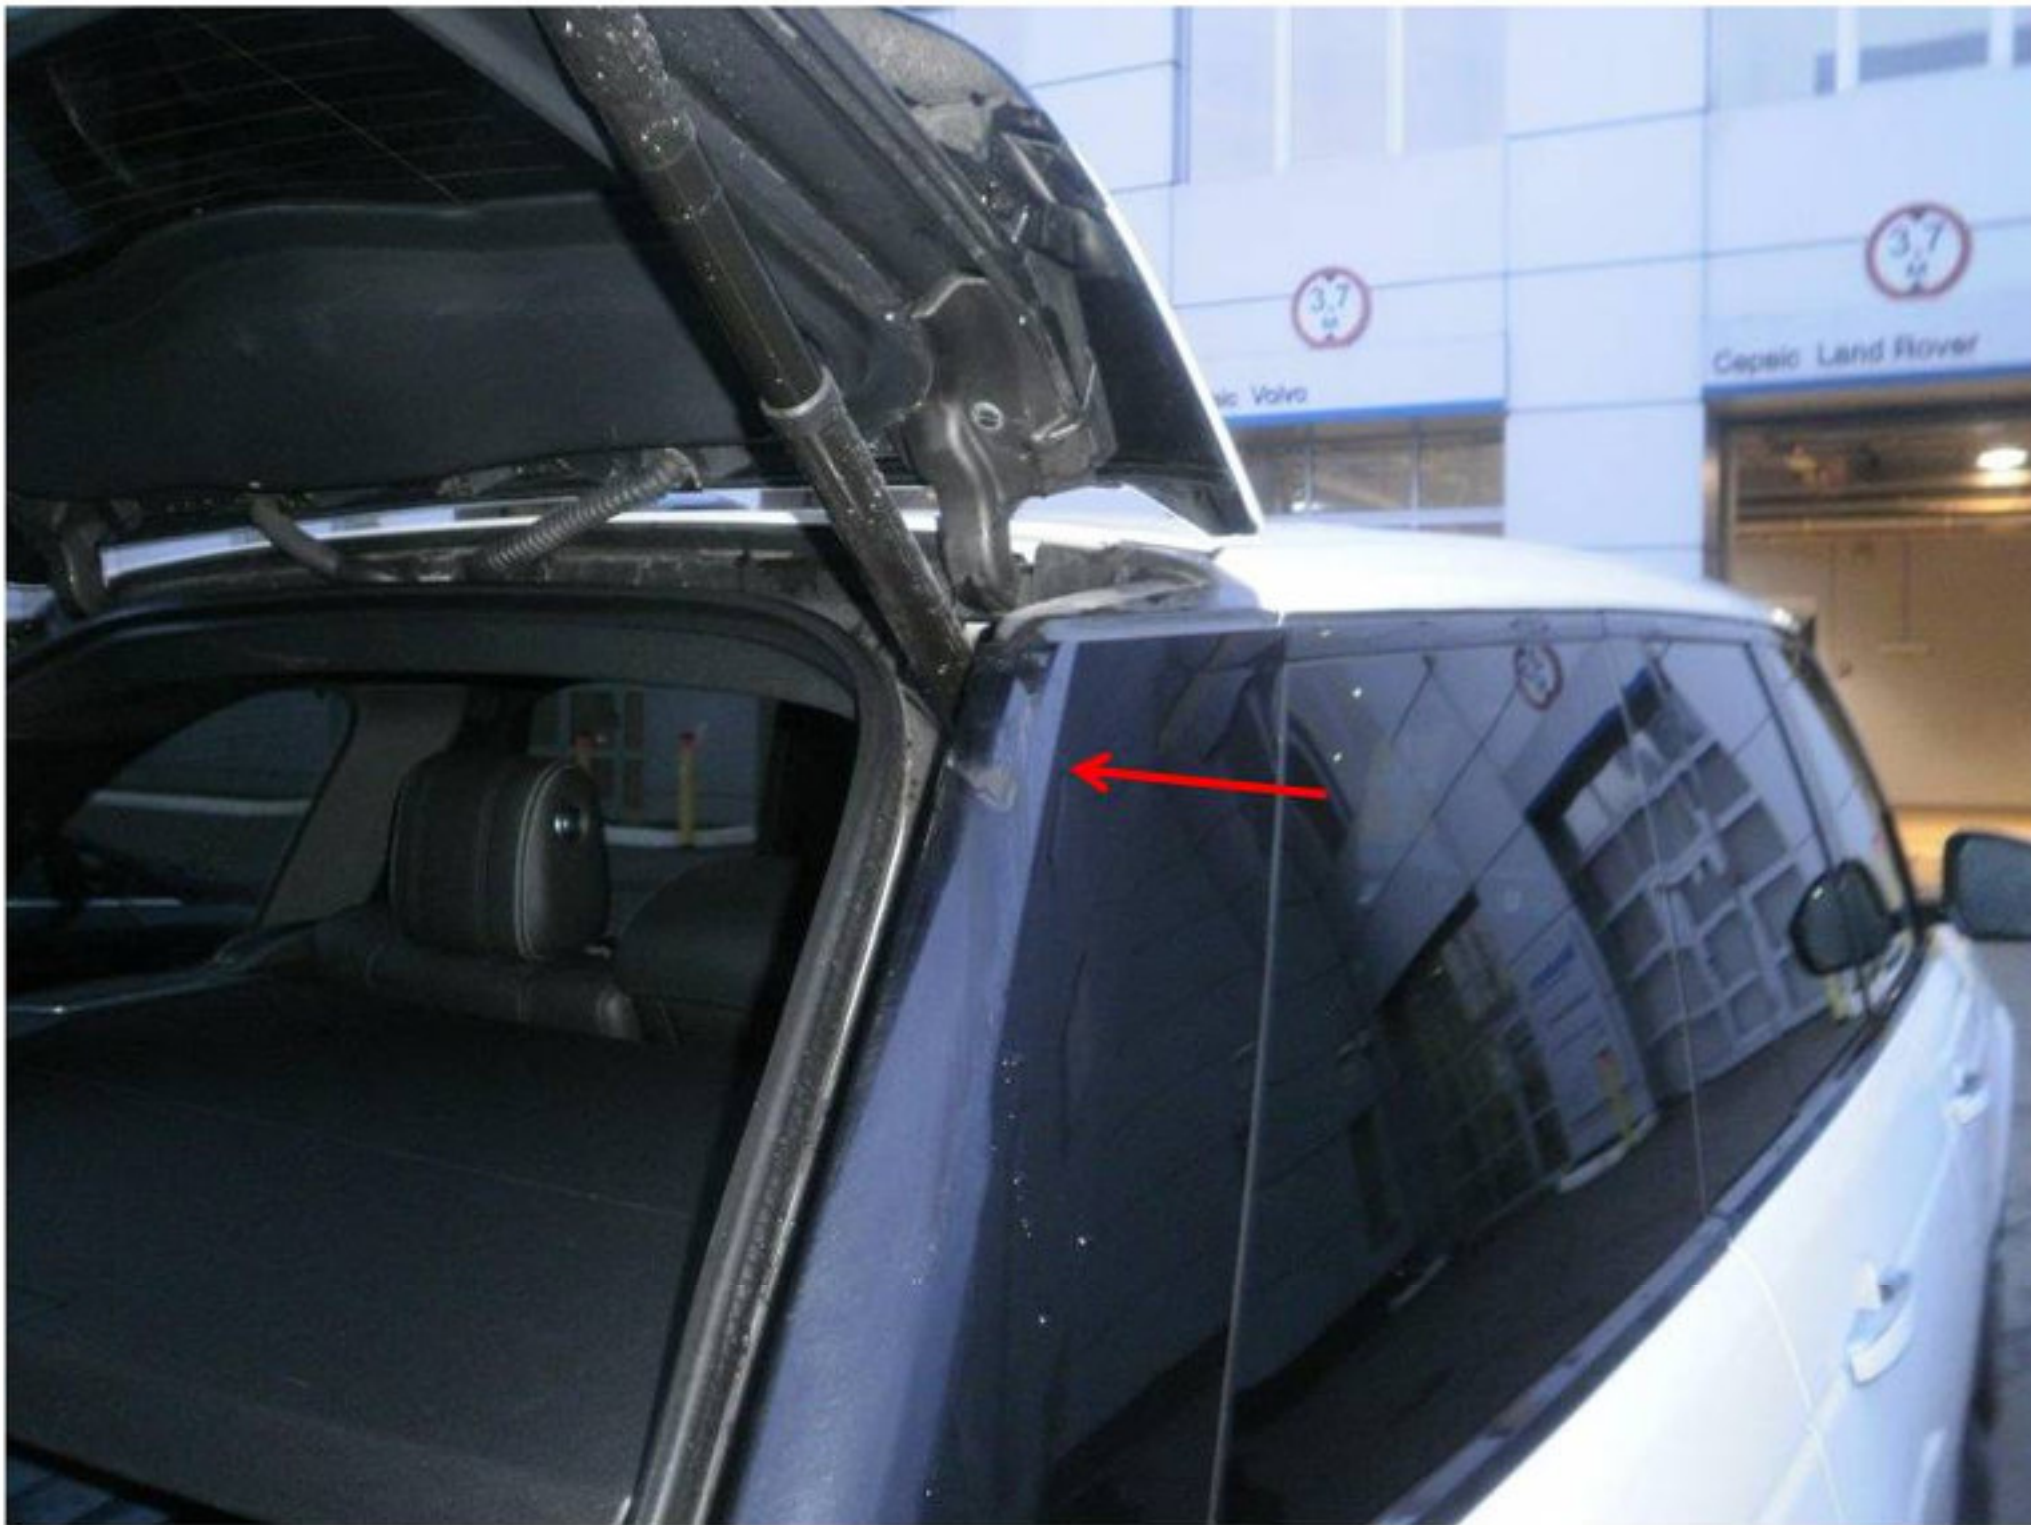
Rear spoiler contact with "D" post marking both trim panel and / or spoiler (see attached picture) on Range Rover (L405).

Incorrect setting during manufacturing process.

Tailgate setting process in manufacturing revised at VIN A225953.
