<b>Reference</b>	SSM72576
<b>Models</b>	Discovery Sport / L550
<b>Title</b>	L550 Discovery Sport Tow Hitch Assist accuracy
<b>Category</b>	Accessories
<b>Last modified</b>	23-Dec-2015 00:00:00
<b>Symptom</b>	General Accessories
<b>Attachments</b>	IMG_5523.JPG (IMG_5523.JPG)

**Content**      Issue: Customers are expressing concerns with the tow hitch assist accuracy.

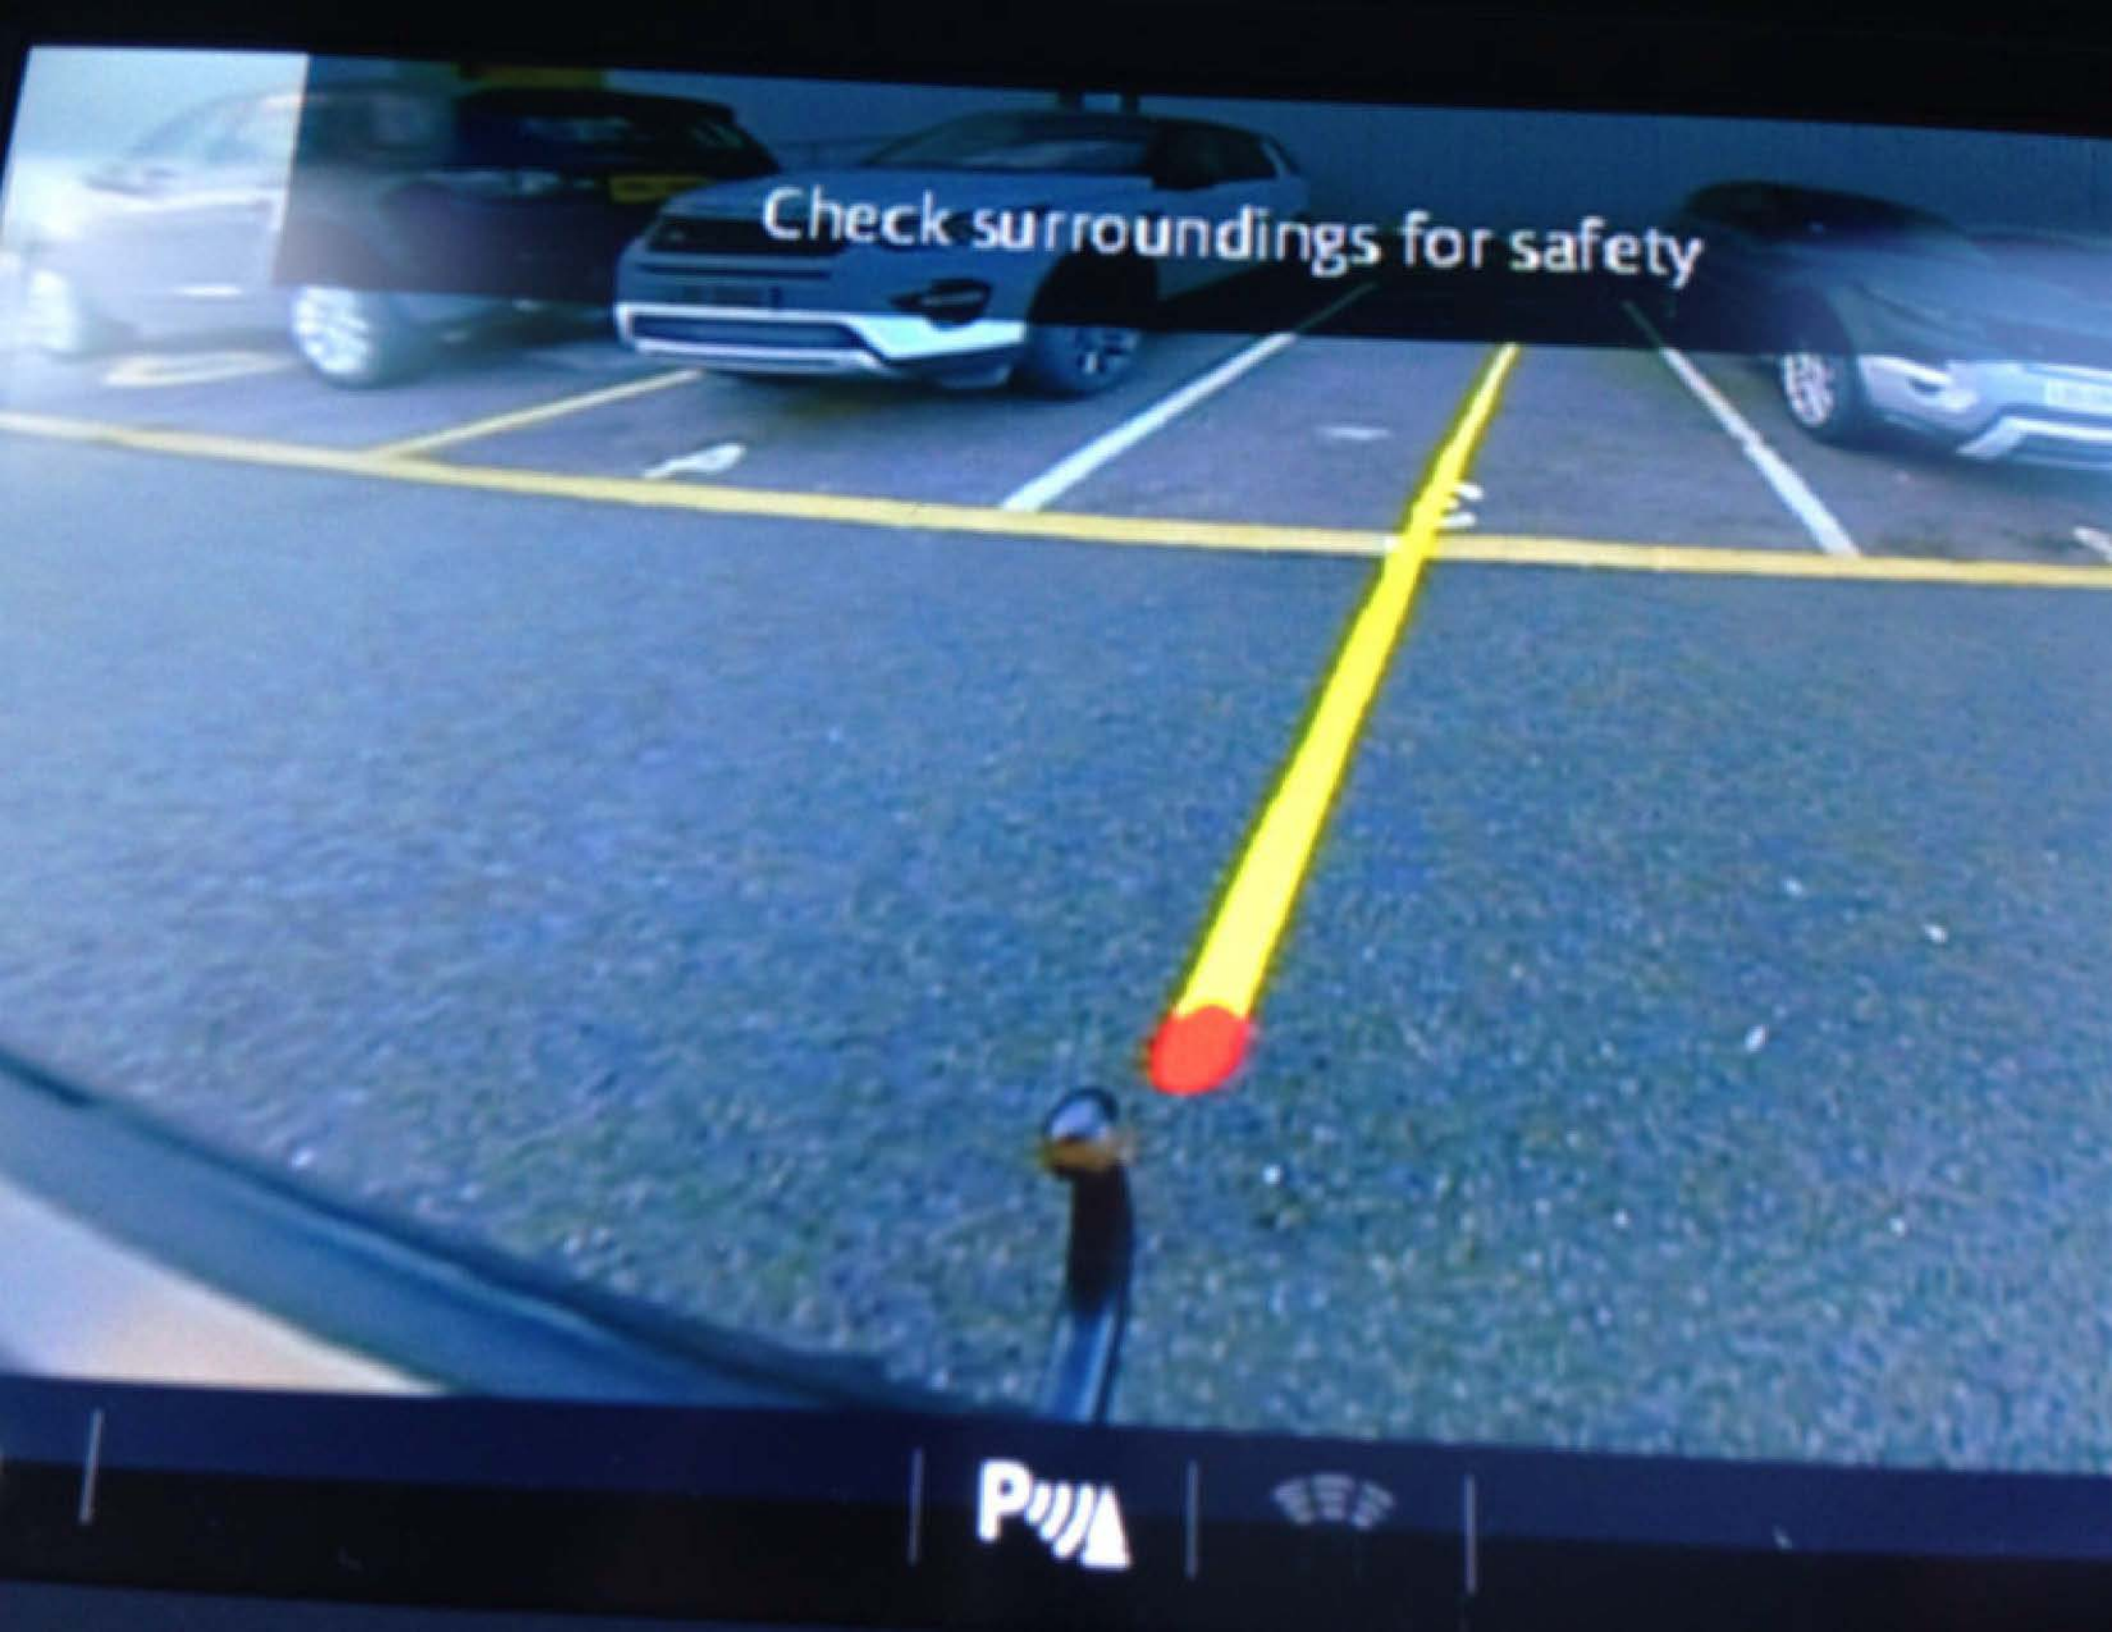
Cause: The image overlay on the HLDF is not accurately aligned to the tow hitch (see attachment).

Check surroundings for safety

Action: Could you please continue to raise EPQR's to help with the investigation.

Please assist JLR engineering to identify the following:

1. Spare wheel is fitted or No spare wheel.
2. Dealer fit or Factory fit.
3. Tow Bar type fitted: -
  - 7 Seat Detachable UK & Europe
  - 7 Seat Flange UK & Europe
  - 7 Seat NAS/AUS
  - 5 Seat Flange UK & Europe
  - 5 Seat NAS
  - 5 Seat detachable UK, Europe and ROW
  - 5 Seat Electric deployable UK & Europe
