# Service Bulletin

15-053

# Noncompliance Recall: HR-V Emission Label

# **Emission Label Inspection and Replacement**

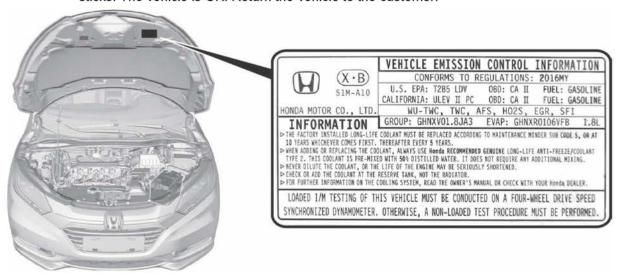
- 1. Open the hood and make sure the emission label is present at the location shown.
  - · If the label is present, go to step 2.
  - · If the label is missing, apply a new one:
    - NOTE: There are 2 emission labels available. Make sure you order the correct one for the vehicle.
    - Using alcohol and a clean shop towel, clean the hood area where the emission label is placed. Allow the
      area to dry.
    - Peel off the backing from the emission label, and apply it to the hood. Press the label firmly to make sure it sticks. The vehicle is OK. Return the vehicle to the customer.

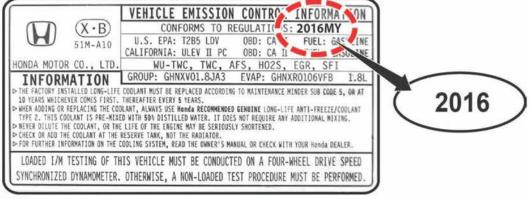
2. Inspect the emission label to make sure 2016 is the model year listed as shown.

- If the correct model year is listed, the vehicle is OK. Return the vehicle to the customer.
- If the wrong model year is listed, replace it with the correct one.
  - Remove the original label and use 3M adhesive remover to clean any remaining adhesive residue.
  - Using alcohol and a clean shop towel, clean the hood area where the emission label is placed. Allow the
    area to dry.
  - Peel off the backing from the emission label, and apply it to the hood. Press the label firmly to make sure it sticks. The vehicle is OK. Return the vehicle to the customer.
