July 15, 2015

02040 Version 3

Safety Recall: Front Passenger's Airbag Inflator Can Be Over-Pressurized

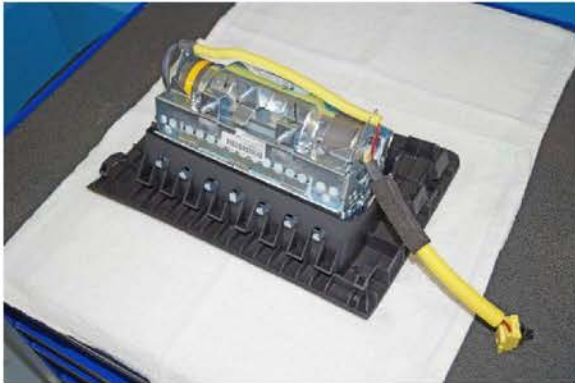
4. Place the airbag, face-down, on a clean shop towel.

- The orientation of the airbag is critical because if the inflator is installed incorrectly, the harness will be too short when you reinstall the airbag.
- The brackets between the various models are similar but may differ from the example shown.

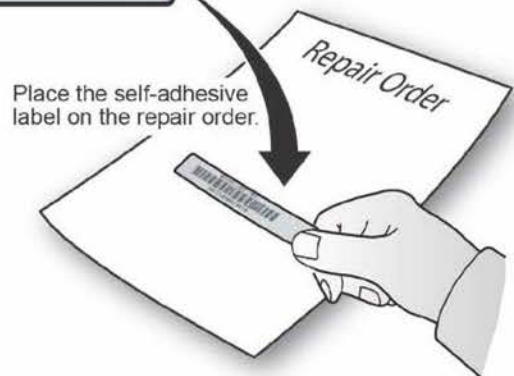
PASSENGER INFLATOR PARTS BOX

6. Peel the label located inside the inflator box from its backing and attach it to the RO. For the warranty claim to be paid, the **replacement inflator part number that you received** must be on the warranty claim and your warranty clerk must enter the serial number in the Diagnostic Trouble Codes field.

- The replacement part number is printed on the top part of the label and the serial number is printed on the bottom. **Make sure you attach the label to the RO and give it to the warranty clerk.**
- There may also be a colored sticker located in the kit; ignore it because it is not used.
- Not all inflator kits have a label included. In those cases, write the serial number and part number from the side of the inflator box on the RO. The part number always starts with 047.

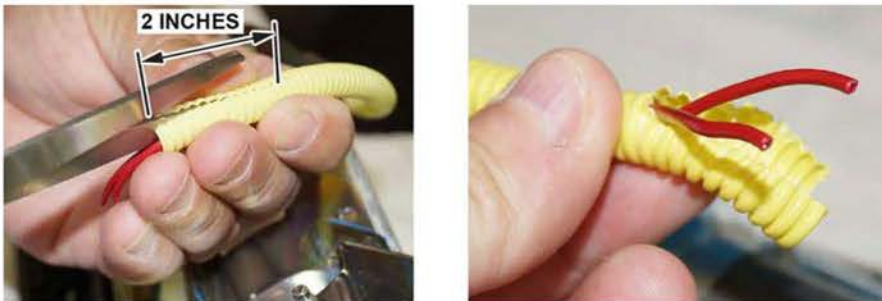
- Cut about 2 inches of the corrugated tube, then pull out the two red wires.

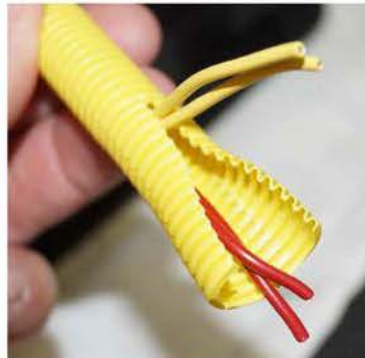
- Cut about 2 inches of the corrugated tube, then pull out the yellow wires.

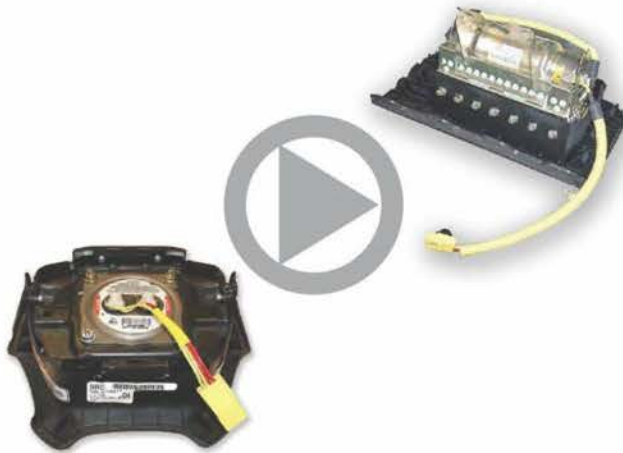
Click on the image below for a short video about the different variations of the driver's and front passenger's replacement inflators involved with the recalls related to inflators. While both the driver's and front passenger's inflators are shown in the video, this is informational only. Replace inflators only as directed by the iN VIN status inquiry.

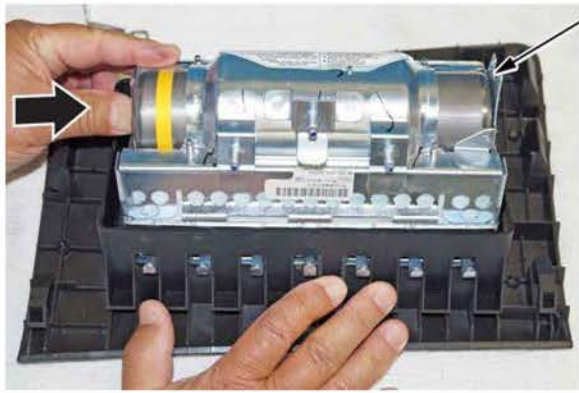
No gap.

- Slide the inflator in until the “D” aligns with the tab on the inflator bracket. There should be no space or gap between the inflator and bracket.

TAB ON BRACKET

“D” SHAPED END

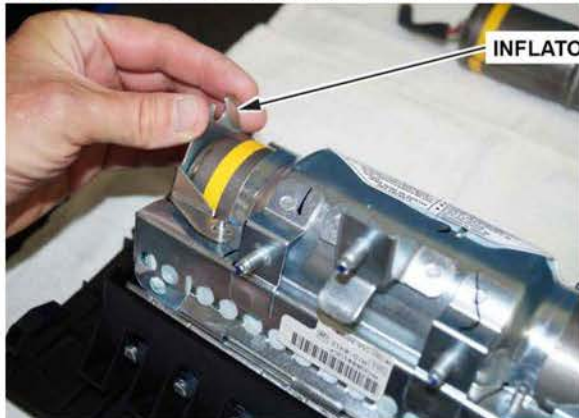
INFLATOR BRACKET

- Reinstall the inflator bracket. There should be no space or gap between the bracket and inflator.

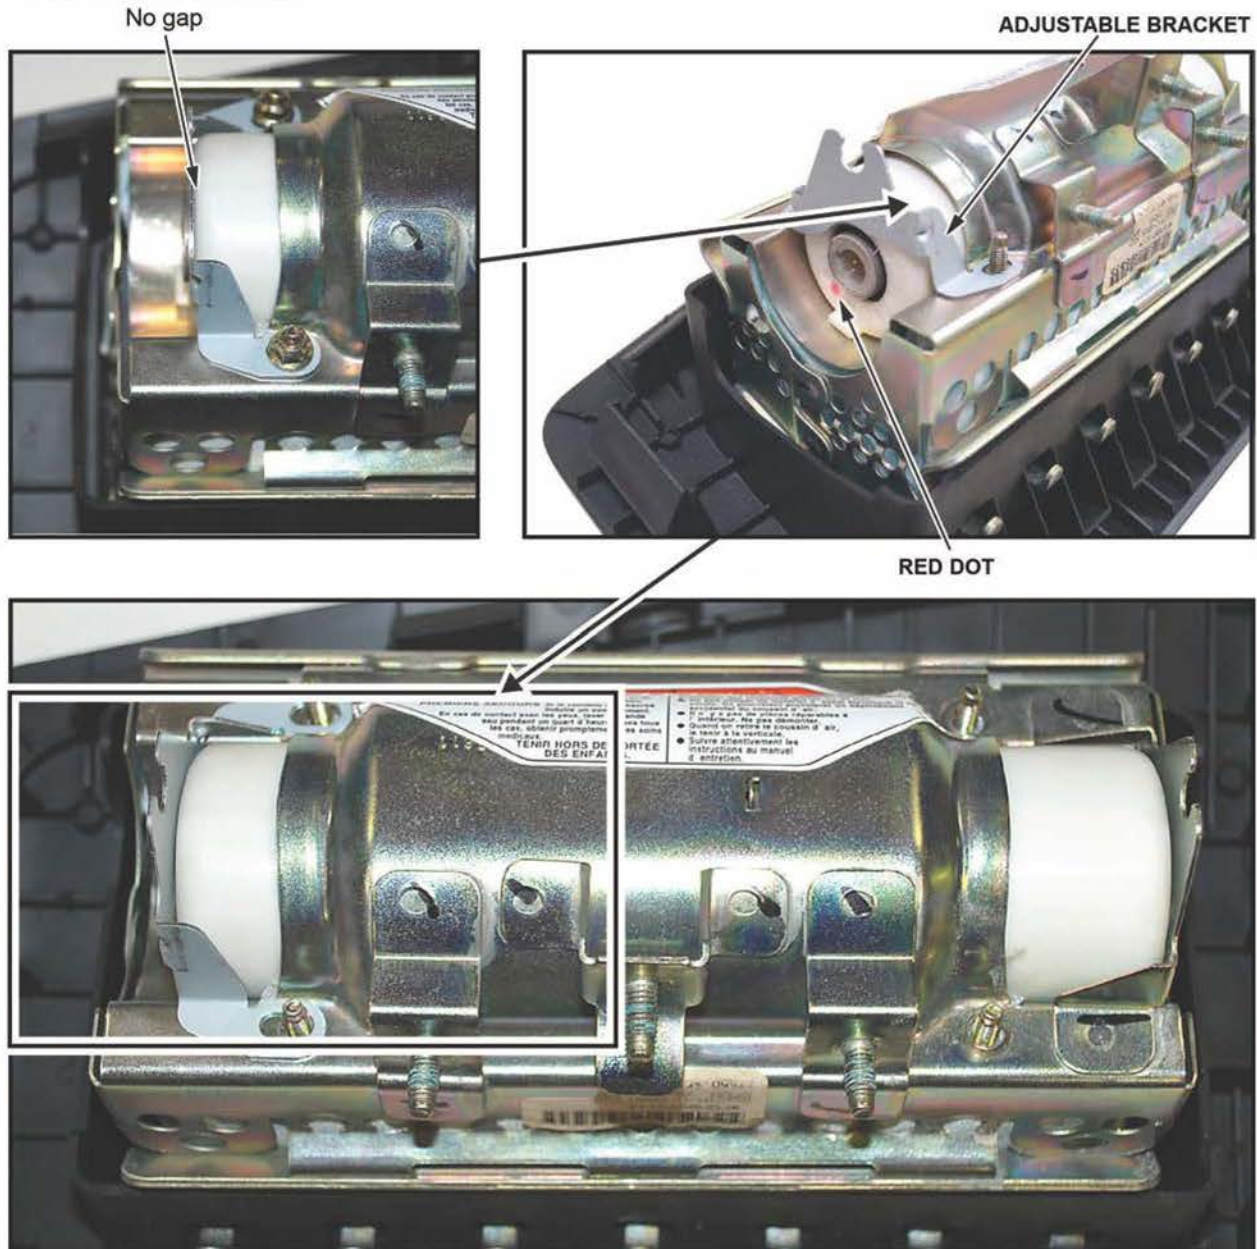
ADJUSTABLE BRACKET END

- Install the bracket included in the kit onto the airbag module. There should be a red dot visible on the end of the plastic connector. There should be no space or gap between the inflator and bracket.

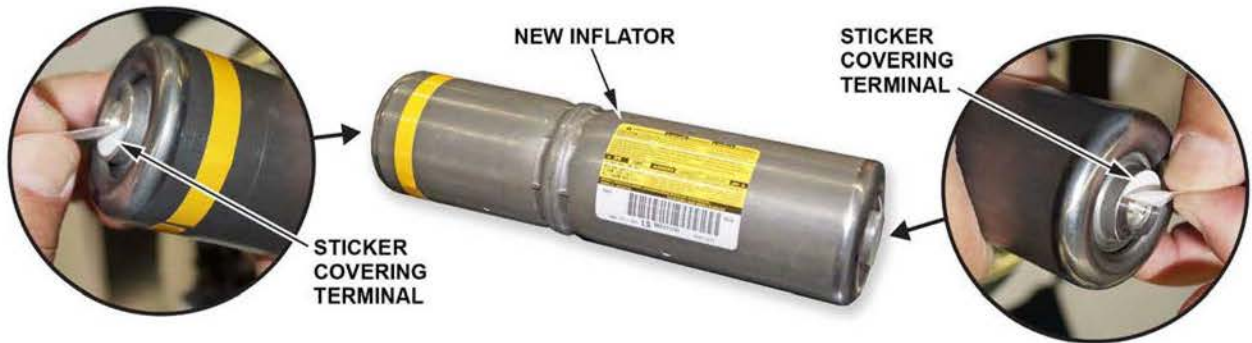
15. Remove the stickers covering the terminals on both sides of the new inflator.
