Service Bulletin

SAFETY RECALL

MULTIPLE MODELS - STARTER RELAY SWITCH INSPECTION/REPLACEMENT

MULTI-MODEL: STARTER RELAY SWITCH #1
REVISED: AUGUST 2015

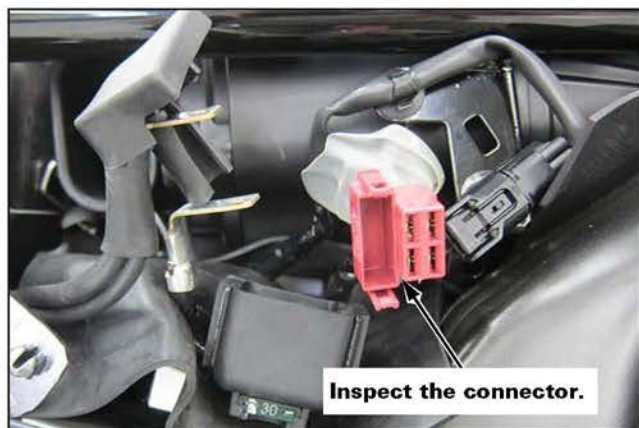
1. Refer to the [CLAIM and PARTS INFORMATION](#) section of this bulletin to find the correct replacement part number for the model being repaired.
2. Refer to the ELECTRIC STARTER section of the Service Manual and remove the starter relay switch.
3. Carefully inspect the starter relay switch 4P (Red) connector (wire harness side) for any damage (melted, burned).

- If the connector is damaged, call Tech-Line for further instructions.
 - If the connector is OK, proceed to Step 4.
4. Replace the starter relay switch with the new part.
Make sure the 30 A (Green) fuse is installed in the top of the relay switch assembly. *Do not use the 20 A or 15 A fuses supplied in the repair parts kit.*
 5. Reconnect the battery negative (-) cable.
 6. Confirm the repair by turning the ignition switch to ON and starting the engine.
 - If there is a problem, check that the correct starter relay switch repair kit was used.
 7. Proceed to the [IDENTIFICATION](#) section of this bulletin.

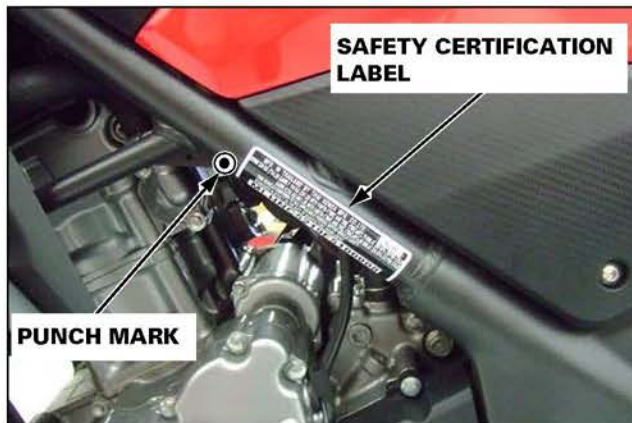
CB300F

Place a punch mark on the frame, next to the Safety Certification Label, nearby the VIN as shown.
