June 9, 2015

02024 Version 1

Safety Recall: Driver's Airbag Inflator Can Be Over-Pressurized

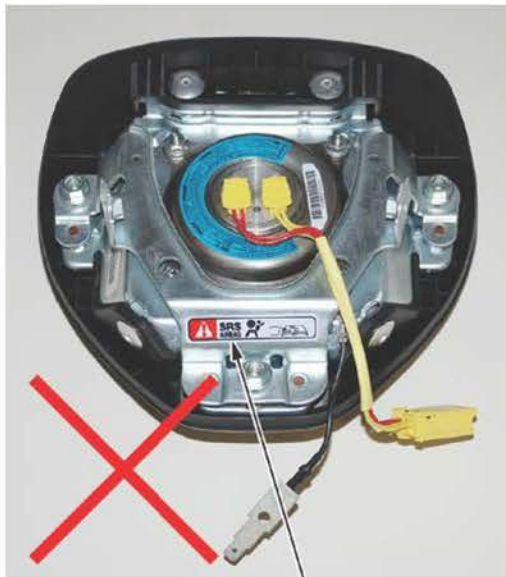
- If there are any unusual markings, like an incorrect label or a model year written in marker, the airbag and inflator may not be the correct airbag and/or inflator for the vehicle or it may be a counterfeit part. For more information about counterfeit airbags, you can refer to safercar.gov, enter keywords **MANAGING COUNTERFEIT**, and select **Recommended Dealer Guidance for Managing Counterfeit Air Bags** from the list. **If you suspect that the airbag or inflator is counterfeit, do not continue this procedure.** Contact your DPSM for assistance.

NON-STANDARD
SAFETY LABEL

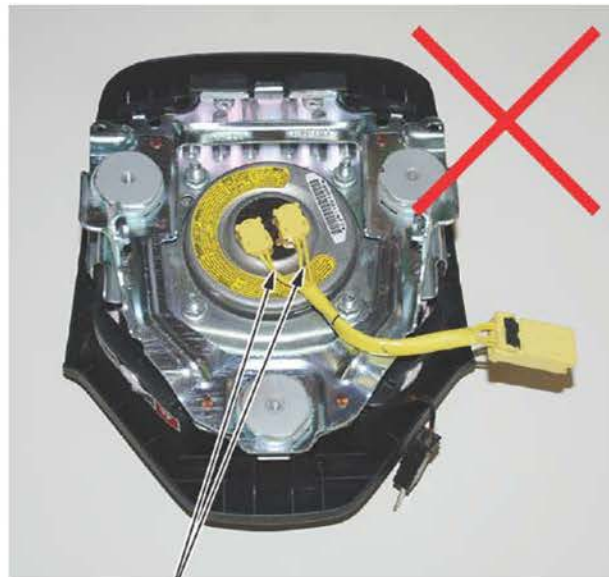
NON-STANDARD
WIRES

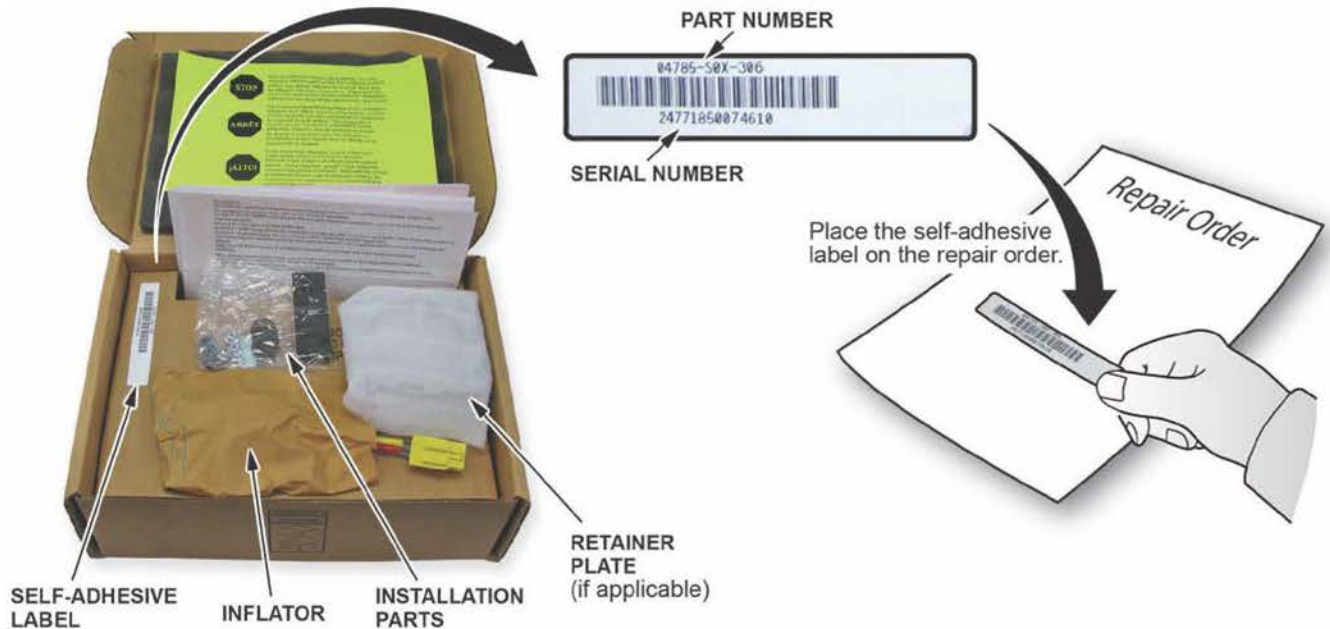
INFLATOR PARTS BOX

- Peel the label located inside the inflator box from its backing and attach it to the R.O. For the warranty claim to be paid, the **replacement inflator part number that you received** must be on the warranty claim and your warranty clerk must enter the serial number in the Diagnostic Trouble Codes field.

- The replacement part number is printed on the top part of the label and the serial number is printed on the bottom. **Make sure you attach the label to the R.O. and give it to the warranty clerk.**
- There may also be a colored sticker located in the kit, ignore it because it is not used.
- Not all inflator kits have a label included. In those cases, write the serial number and part number from the side of the inflator box on the R.O. The part number always starts with 047.

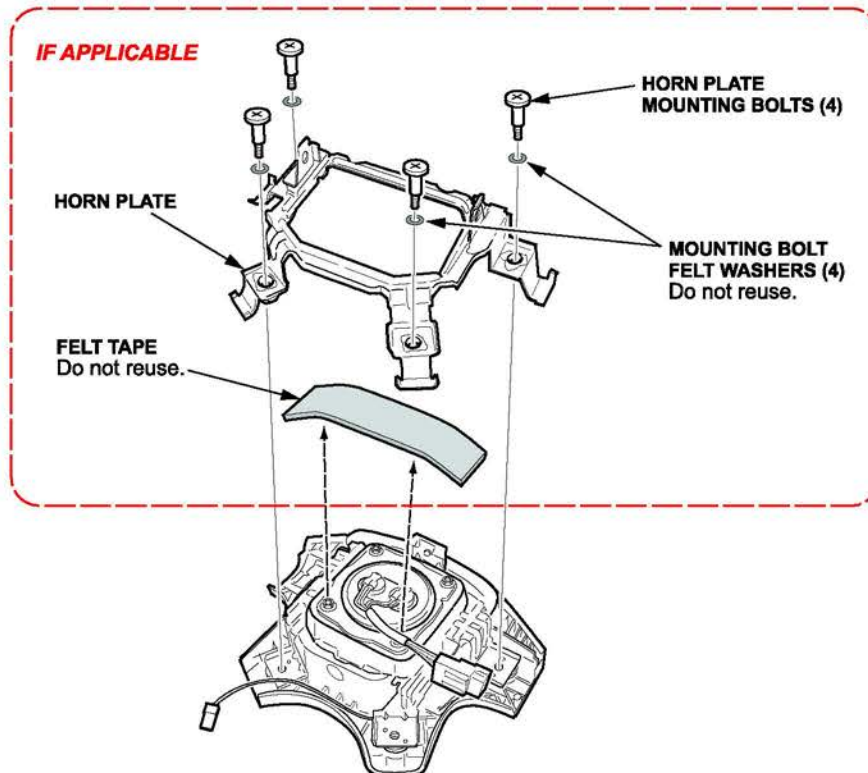
- If there is no horn plate installed, go to step 8. If there is a horn plate installed, remove the four horn plate mounting bolts, the mounting bolt felt washers, the horn plate, and remove the felt tape covering the lower two inflator locknuts. The felt washers and felt tape will not be reused.

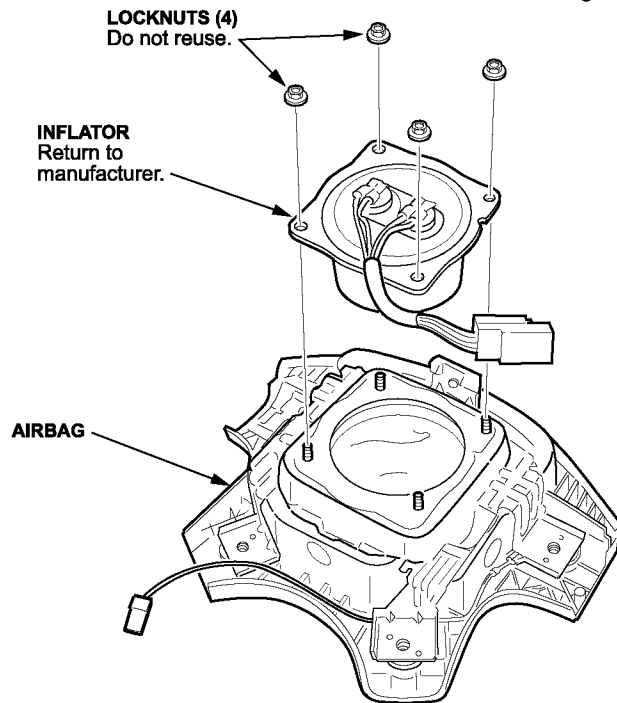
- Using needle-nose vise grips or a 3/8 in. 6-point socket, remove the four locknuts from the inflator. The locknuts will not be reused.

NOTE: Do not remove the inflator from the airbag until you complete step 9.

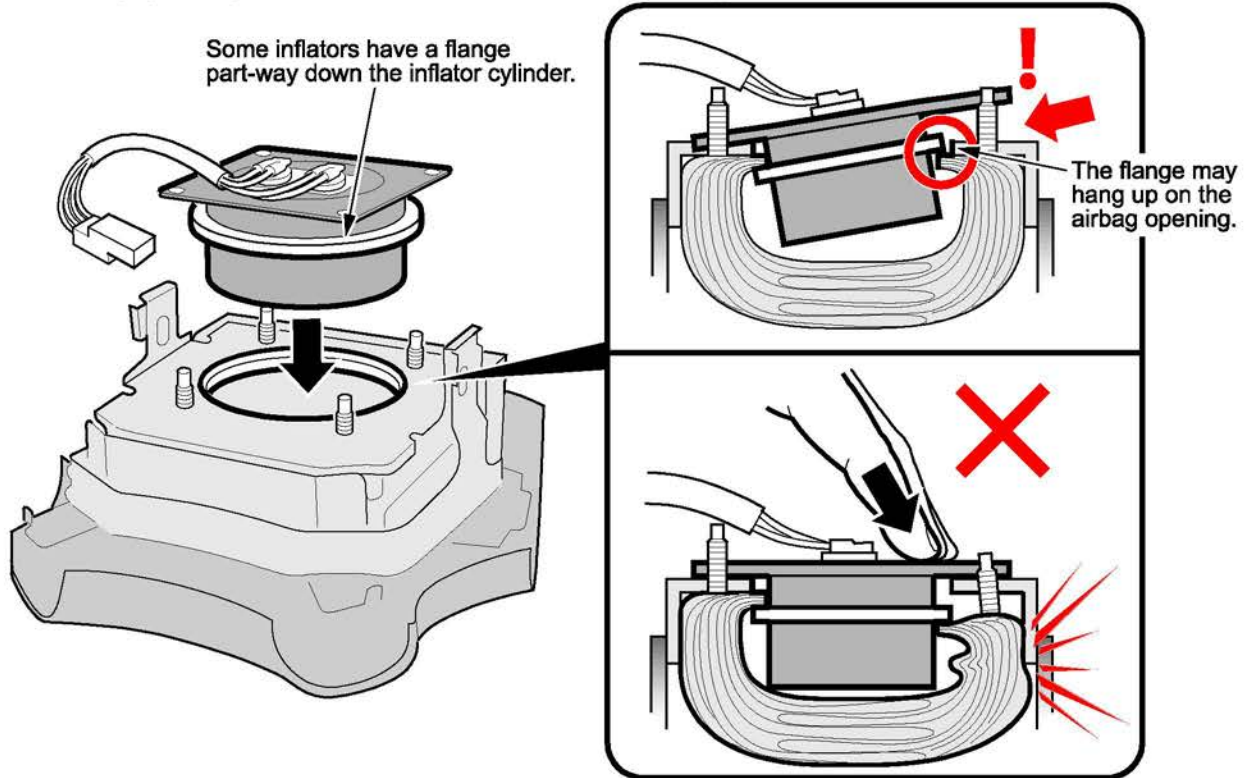
- Insert the airbag inflator into the opening. Do not force it into the airbag module.

NOTE: Make sure the inflator wires are positioned toward the bottom of the airbag. If you install the inflator incorrectly, you may not be able to reconnect the SRS airbag harness.

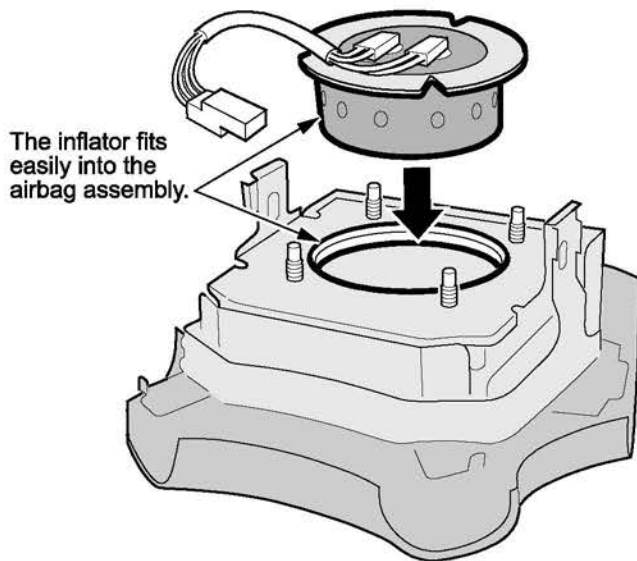
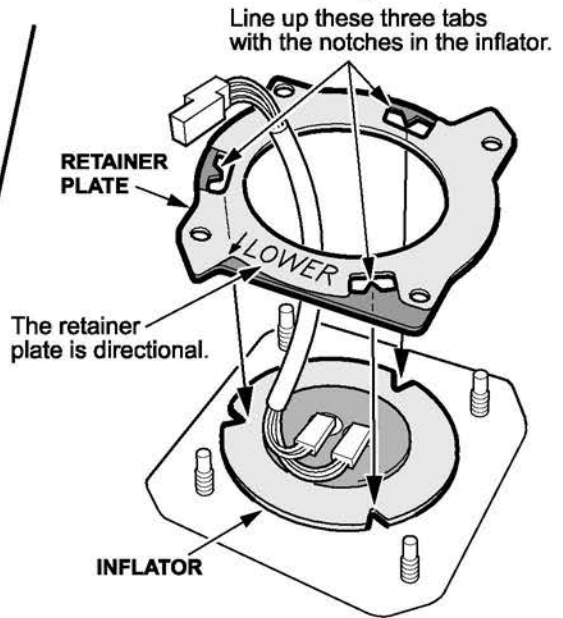
- Install the bracket onto the studs with the stamp **LOWER** at the bottom of the airbag.
- Make sure the three tabs and notches are properly aligned.

- The tabs and notches are designed to align in one direction only. If the tabs and notches are not aligned, the inflator and bracket are not installed correctly.
- Make sure the harness comes out through the center opening. Do not install the bracket over the harness wires.

12. Install and torque the new locknuts to **3.9 N·m (2.8 lb-ft, 34 lb-in)**.
13. Cover the lower two inflator locknuts with new felt tape.
14. Reinstall the horn plate with new felt washers on its mounting bolts. Torque the mounting bolts to **3.4 N·m (2.5 lb-ft, 30 lb-in)**, then make sure the horn plate moves freely.
