# Service Bulletin

Bulletin No.: 13-08-66-001A

**Subject:** Information on Tailgate (Endgate) Hinge Lubrication

**Models:** 2014 Chevrolet Silverado 1500  
2015-2016 Chevrolet Silverado  
2014 GMC Sierra 1500  
2015-2016 GMC Sierra  
All Equipped With EZ Lift-and-Lower Tailgate (RPO PPA)

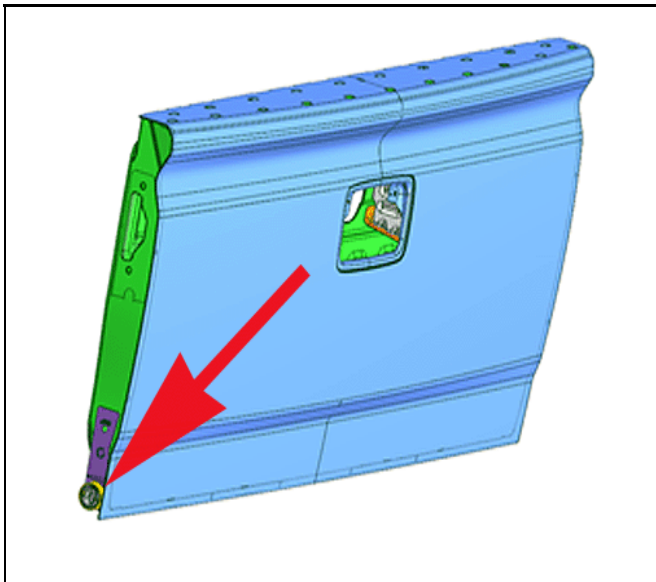
1. Attach the extension tube onto a can of Super Lube® Synthetic Multipurpose Lubricant 11 oz. Aerosol.

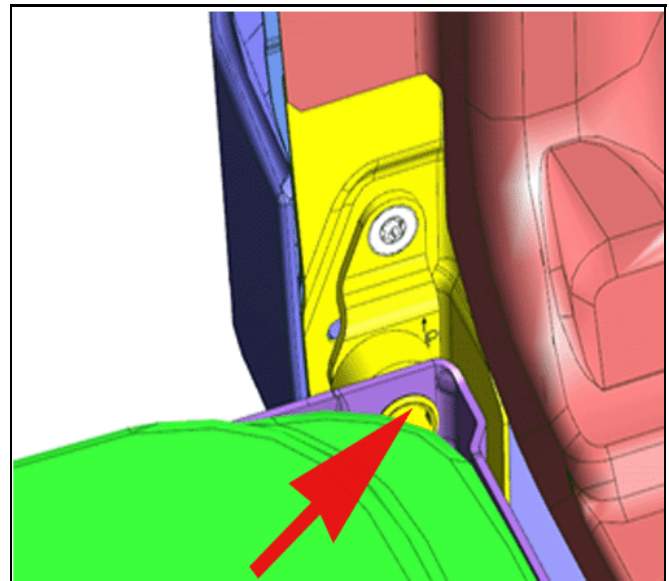
2. Spray lubricant into the inboard side of the left tailgate hinge assembly.
