Bulletin No.: PIC5907A

Service Bulletin

Subject: Water Leak Into Rear Floor

Models: 2010 - 2015 Chevrolet Camaro

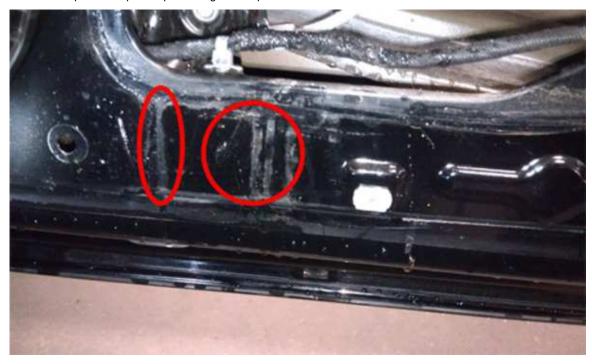
Water may pool into the rear floor pan on either the driver or passenger side. This condition could occur on either the coupe or convertible body style and should be inspected for prior to performing other repairs.

Water test the vehicle to duplicate the condition. Remove the door trim panel of the affected side of the vehicle to inspect for water pooling in or leaking from the door water deflector. If water is pooling between the door and water deflector or is leaking past the water deflector then carefully remove the water deflector. Reseal it to the door using a butyl rope such as 3M Strip-Calk*, or equivalent, to eliminate the possibility for pooling or leaking.
