# PREVOST

## Instruction Sheet

## IS-08080A

### Sound Selector replacement, VSS04 vs. VSS05

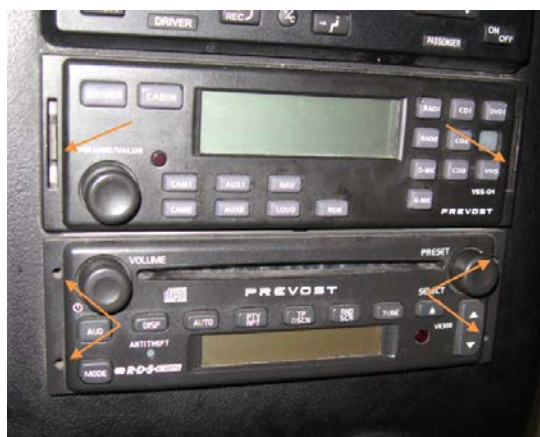
**Fig.5** vertical openings and holes position on the VSS and radio unit

3. Remove the hex nut that holds the sound selector to the dashboard support (Fig.3).
4. Repeat operations 2 and 3 for the radio; remove the hex nut, harness and antenna.
5. Insert two (2) flat radio removing tools in the vertical openings located on both sides of the sound selector front panel and pull out the sound selector (Fig.4 and Fig.5).

6. Insert two (2) U-shaped radio removing tools in the four (4) holes located on both sides of the radio front panel and pull it out (Fig.5 and Fig.6).

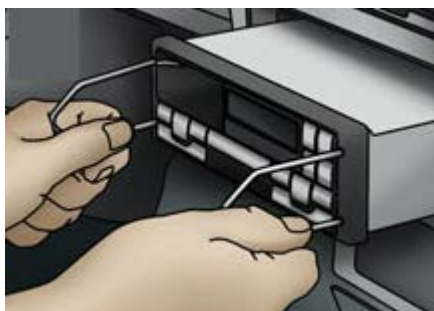
**Fig.6** Typical radio removal using U-shaped tools.

**NOTE:** Some radio models may require flat radio removing tools.
