TECHNICAL SERVICE BULLETIN

Technical Service Bulletin: 10-08052016-0236

The bedroom A/C Control Module boxes should have a sticker on the face plate of the box that has a part number of 9430A755.

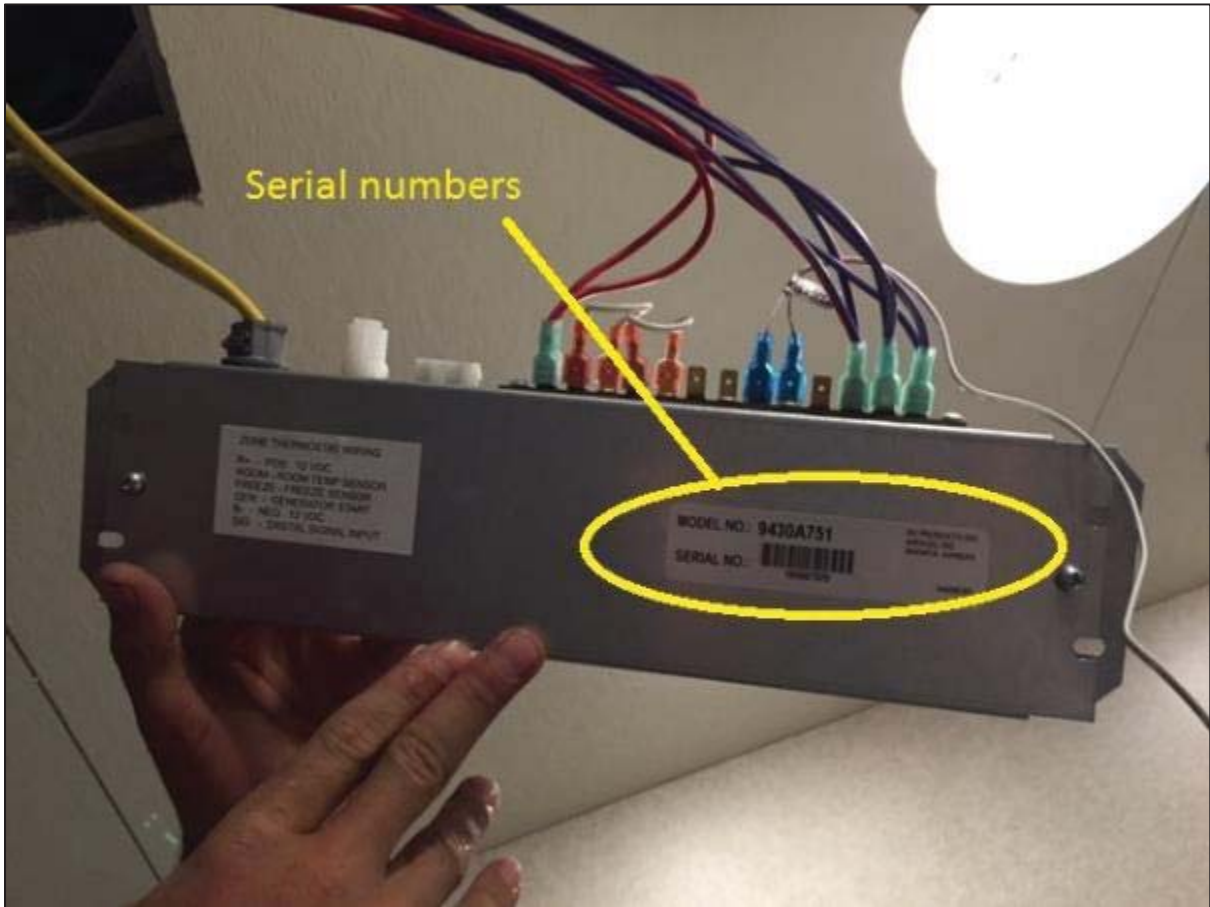
Lower the Control Module Box down from Air Conditioner compartment, inspect the serial number ([Figure A](#));

Figure A. – Location of Control Module Box serial number.

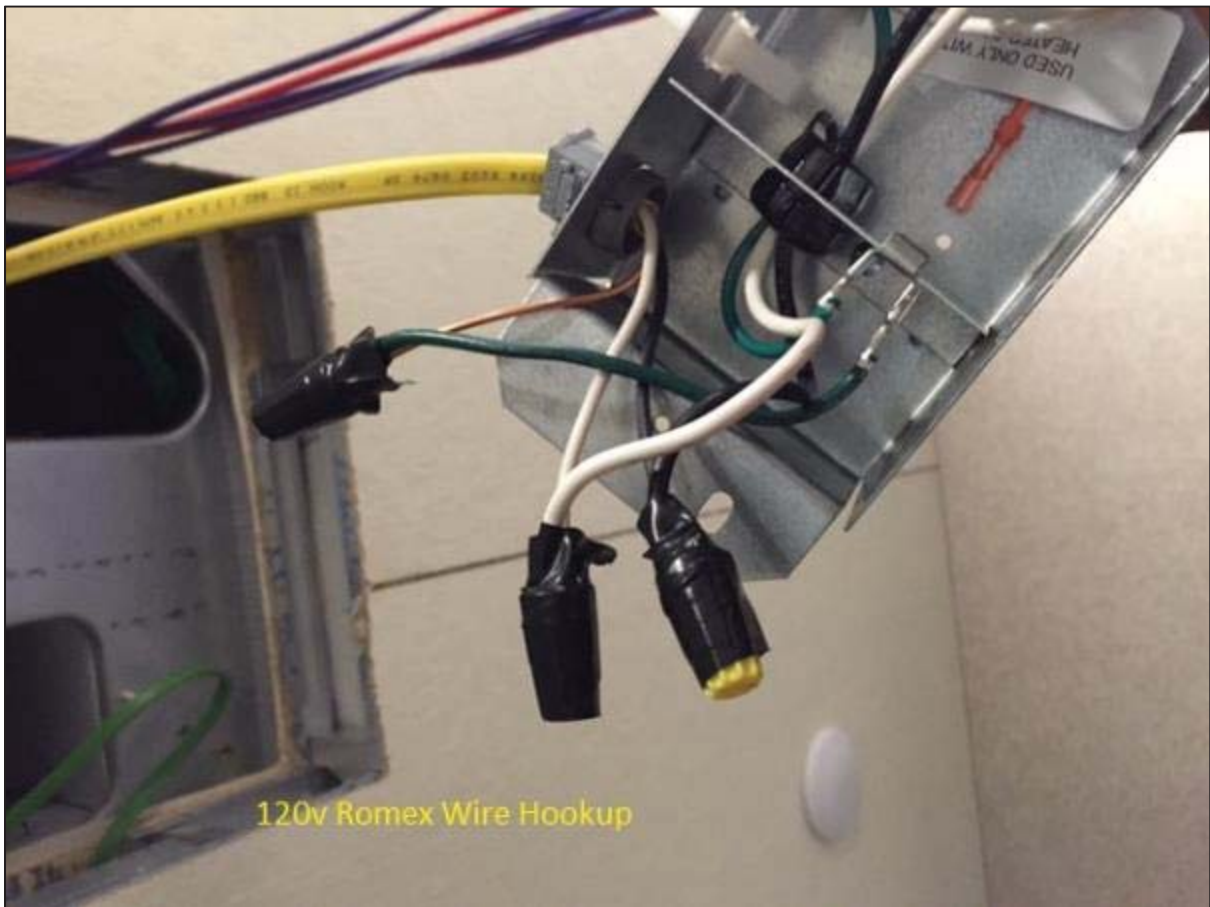
Figure B. – 12/2 Romex 110V Yellow Wire Nuts (3)

6. Unscrew 2 square head screws that secure that face plate of the Control Module Box;
7. Unplug the 2 wire harnesses
 - a. Note one from the Air Conditioner
 - b. Note one from the Heat Strip Box
8. Locate 3 Yellow Wire Nuts (these may be taped with electrical tape) that the 12/2 Romex 110V Wire is connected to and remove the wire from the Control Module Box ([Figure B](#));
9. Simply, but gently disconnect each of the 12V Power and Sensor wires that are connected to the Control Module Box; ([Figure C](#))
10. Reverse all steps to install the 9430A755 control module box. ([Figure D](#))

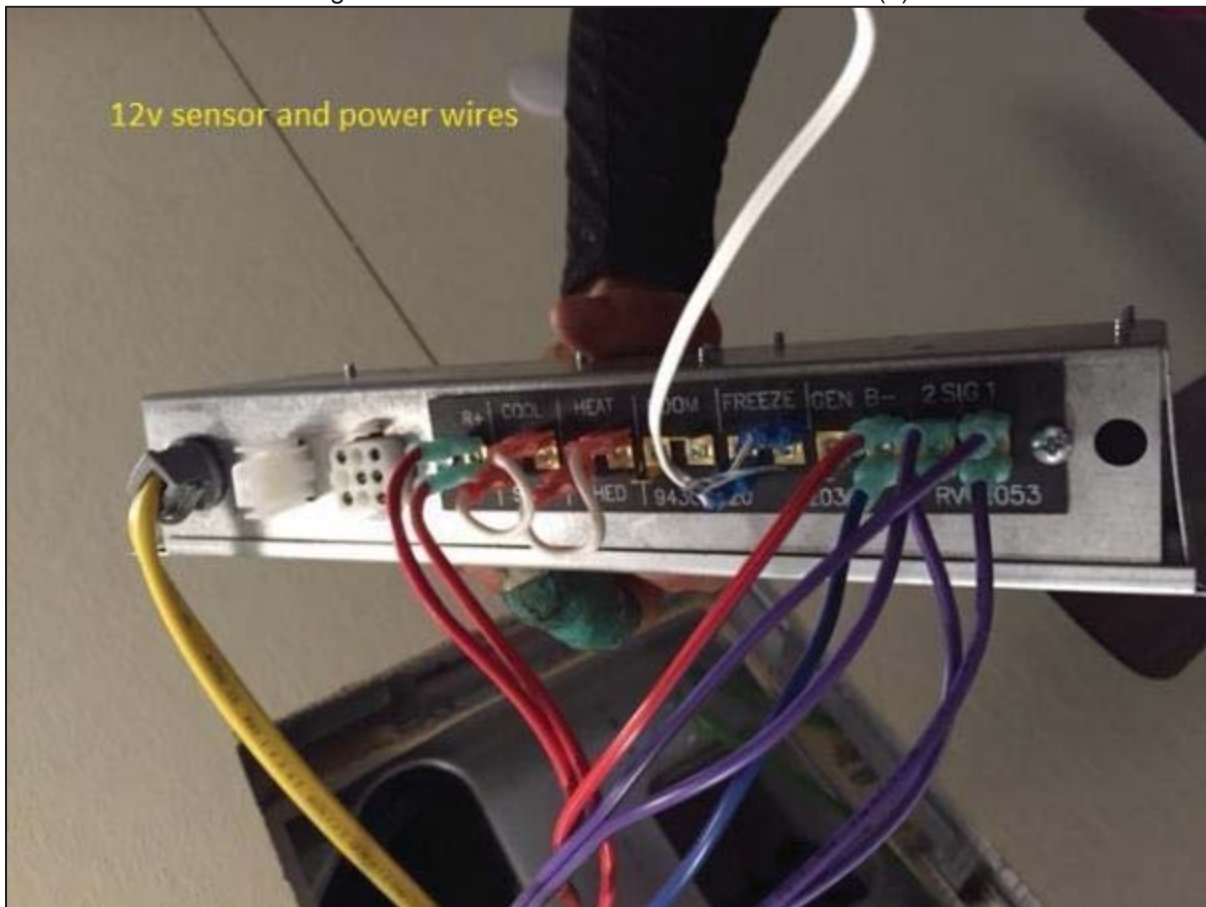
Figure C. – 12V Sensor and Power Wire Schematic

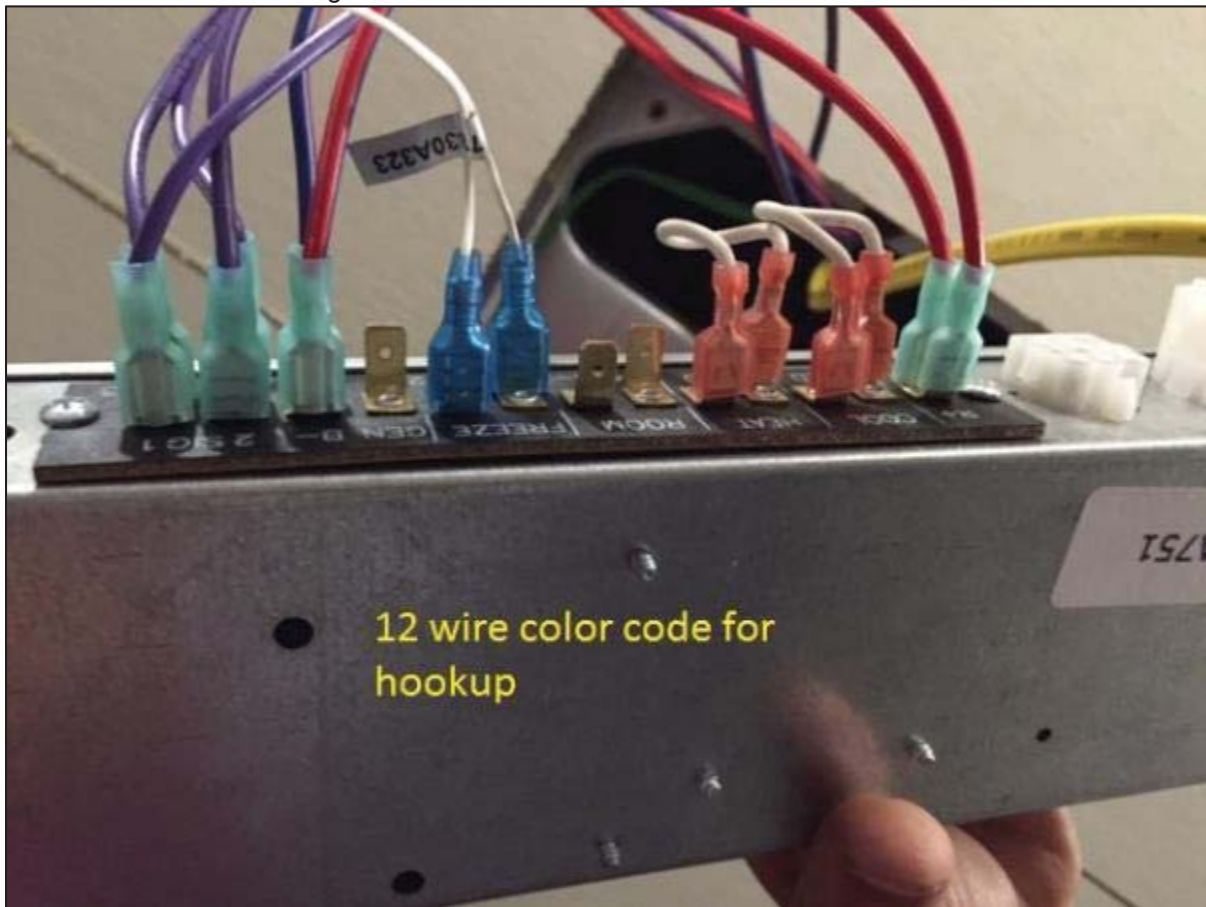
Figure D. – 12V Wire Schematic for Re-Installation
