Bulletin No.: PIT5498A

**Subject:** Tailgate Contacts Bed Floor When Closed

**Models:** 2014 Chevrolet Silverado 1500  
2015-2016 Chevrolet Silverado  
2014 GMC Sierra 1500  
2015-2016 GMC Sierra  
Built Prior to October 1st, 2015

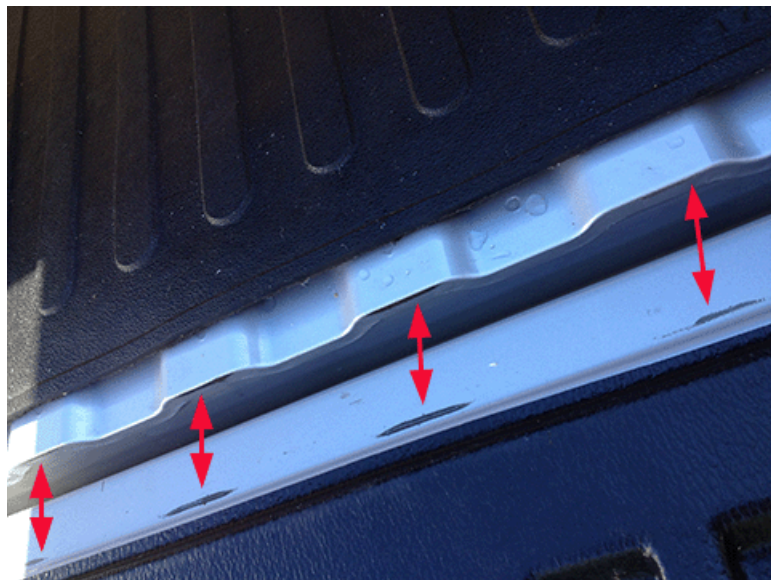
Some owners may comment that the tailgate contacts the bed floor when the tailgate is closed. This can occur on vehicles with or without the factory spray in bedliner (RPO CGN).

Engineering has released an updated tailgate to correct this concern. Replace the tailgate using the applicable updated part number reflected below.

If the pickup is equipped with a spray-in bed liner, please follow latest version of Service Bulletin 12-08-51-002D: Spray-in Bed Liner General Information and Repair Procedures and submit the cost in Net.
