ALL SKYACTIV MODELS - CHECK ENGINE LIGHT ON WITH DTC P0137

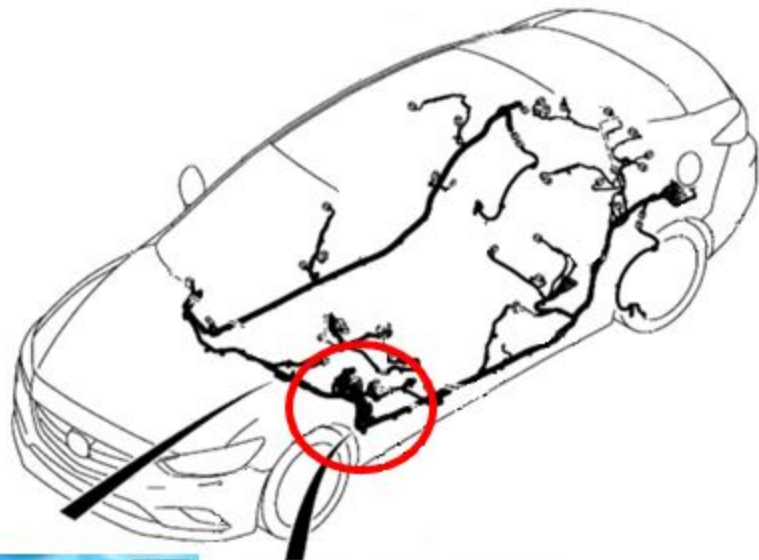
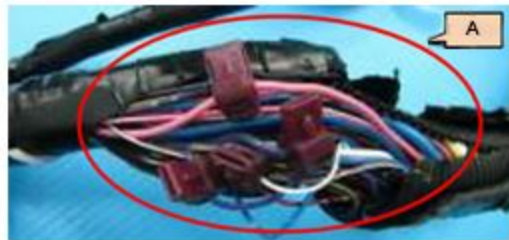
If you encounter a vehicle with DTC P0137 (Circuit Low Input), check the rear harness at the red circled area in the following diagram. If an aftermarket alarm system is installed, the rear harness might have received damage from electro-tap connectors (A) or to the protector tube (B). This damage is not covered under Warranty.
