Technical Service Bulletin

SUBJECT:			No: TSB-16-54-003
SOFTWARE UPDATE FOR NEW OR REPLACEMENT ROCKFORD FOSGATE AMPLIFIER (DAS)			DATE: September, 2016
			MODEL: 2017 Mirage
CIRCULATE TO:	<input type="checkbox"/> GENERAL MANAGER	<input checked="" type="checkbox"/> PARTS MANAGER	<input checked="" type="checkbox"/> TECHNICIAN
<input checked="" type="checkbox"/> SERVICE ADVISOR	<input checked="" type="checkbox"/> SERVICE MANAGER	<input checked="" type="checkbox"/> WARRANTY PROCESSOR	<input type="checkbox"/> SALES MANAGER

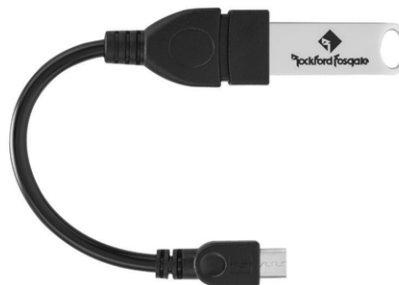
USB flash drive and adapter cable.

It is recommended to only use the USB thumb drive supplied by Mitsubishi. Other drives may cover up the status lights on the amplifier.

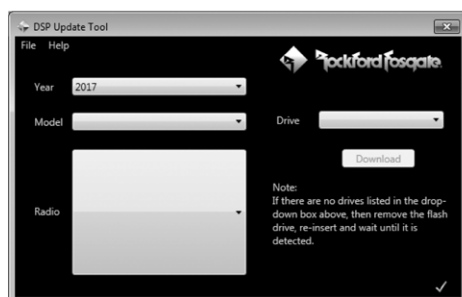
2. Find and select the year of the vehicle from the dropdown list.

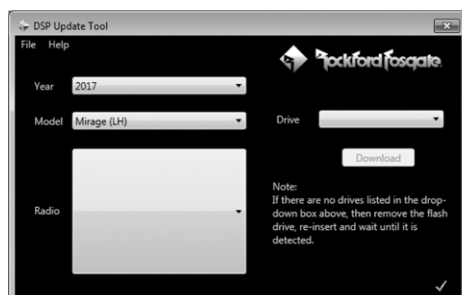
3. Find and select the vehicle model from dropdown list.

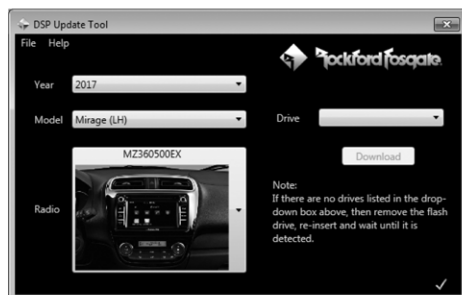
4. Find and select vehicle radio type from dropdown list.

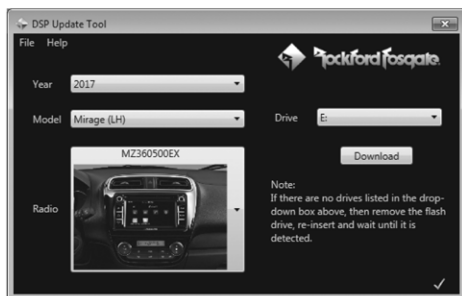
5. Insert a flash drive into the USB port of the computer and wait for the associated drive letter to be displayed in the "Drive" dropdown.

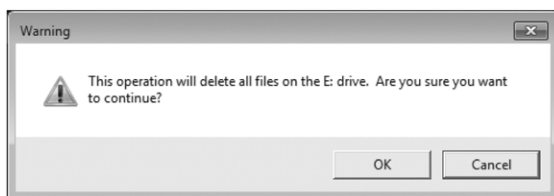
6. Press the "Download" button and then press "OK" to confirm that all files will be erased on the flash drive.

Any existing files present on the flash drive will be deleted. DO NOT use a flash drive with files on it that you wish to keep.

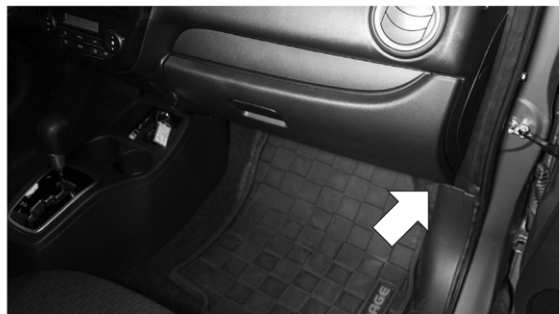
The amplifier is located on the passenger side of the vehicle about the kick panel.

The AMP STATUS light should be illuminated solid BLUE.

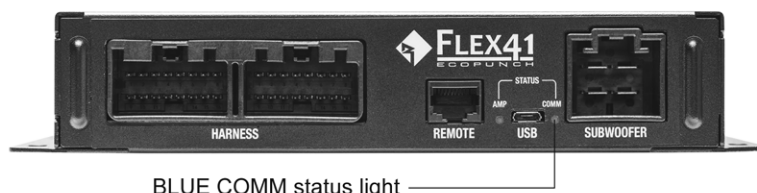
- When the update is complete. Unplug the USB thumb drive assembly and the amplifier will reset and turn back on (AMP STATUS light is SOLID BLUE). The amplifier has been successfully re-programmed.

- Once the amplifier has been successfully updated, make sure to turn the radio ON and check the audio system for normal operation.
- Turn vehicle off.

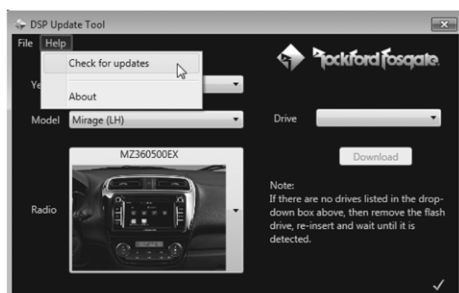
The tool has an automatic update feature that will check for new updates when launched. The computer with tool installed needs to be connected to the internet for this feature to work. In the event you feel the software is not automatically updating, there is a manual update feature available. The user can check for updates at any time by selecting **Help->Check for Updates** from the menu.

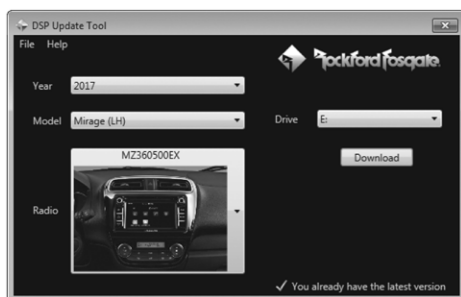
The status of the update check can be found in the lower right hand corner of the screen.
