How to Properly Use 4WD System on 16MY Tacoma Vehicles

16MY Tacoma 4WD

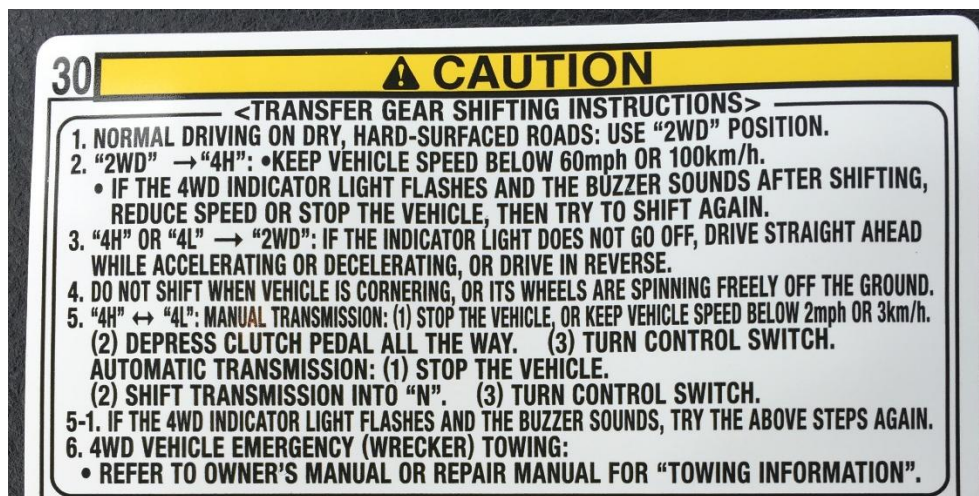
Please instruct the customer to use correct shifting procedure for entering/exiting 4LO by making sure transmission remains in N until the 4LO entering/exiting operation is complete and no 4WD lights are flashing. Please refer customer to driver's sun visor label for correct operating procedure to prevent malfunction.
