Date: August 2, 2016  
To: Audi Dealer Principal, Service Manager, Warranty Administrator, Sales Manager & Parts Manager  
From: Audi Customer Protection  
Subject: Upcoming Service Action 82B8 – Climate Control Module Software Update  
Certain 2013-2016 MY Audi allroad, A5 Cabriolet, A4 Sedan, A5 Coupe and Audi Q5 Vehicles

# Service Action

## Code: 82B8

<b>Subject</b>	<b>Climate Control Module Software Update</b>
<b>Release Date</b>	August 3, 2016
<b>Affected Vehicles</b>	<b>U.S.A. &amp; CANADA: Certain 2013 - 2016 MY Audi allroad, A5 Cabriolet, A4 Sedan, A5 Coupe, and Audi Q5</b>  <i>Check Campaigns/Actions screen in Elsa on the day of repair to verify that a VIN qualifies for repair under this action. Elsa is the <u>only</u> valid campaign inquiry &amp; verification source.</i> <ul style="list-style-type: none"><li>✓ Campaign status must show "open."</li><li>✓ If Elsa shows other open action(s), inform your customer so that the work can also be completed at the same time the vehicle is in the workshop for this campaign.</li></ul>
<b>Problem Description</b>	On Audi vehicles with auxiliary air heater (PTC element) manufactured within a specific period, the heating performance m

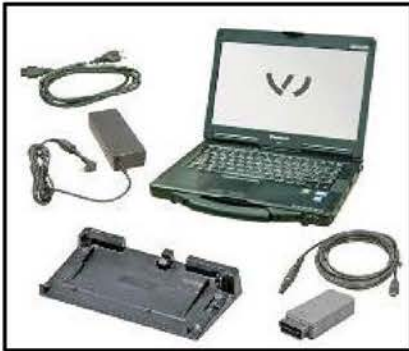
- VAS6150C – Diagnostic Tester (or equivalent)

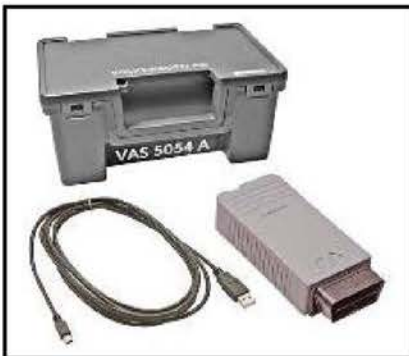
- VAS5054A – Remote Diagnosis Head (or equivalent)

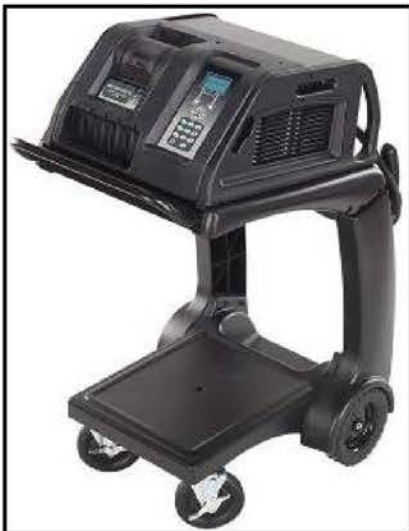
- GRX3000VAS – Battery Tester/Charger (or equivalent)

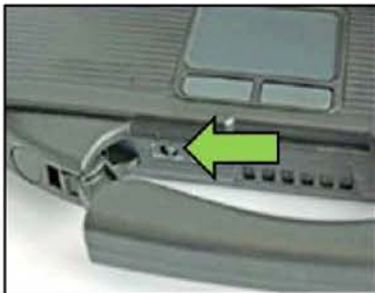
**VAS 6150 & VAS 6150A**  
(Front panel behind handle)

- ✓ **The Bluetooth function of the scan tool is physically switched off <see pictures below>.**

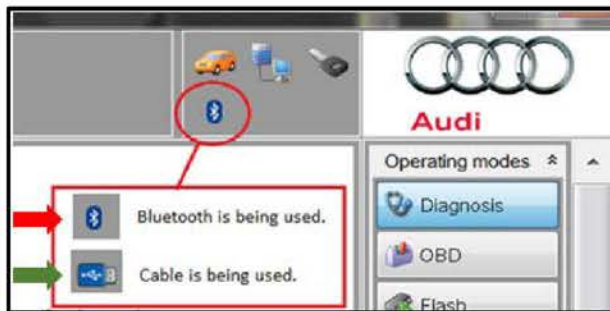
- Open the hood.
- Open the battery cover.
- Attach the GRX3000VAS Tester/Charger (or equivalent) to the vehicle battery.
- Connect the VAS6150C Diagnostic Tester (or equivalent) to the vehicle.
- Start the ODIS program.
- Confirm that scan tool is communicating with the diagnostic head by USB <Green Arrow>.
  - If the Bluetooth symbol is shown <Red Arrow> then disconnect the diagnostic head from the vehicle and reconnect the USB cable to the diagnostic head and then reattach to the vehicle.
- From the home screen of the scan tool select Flash.
- Follow the on-screen prompts.
- Select "SVM code input."
- Enter SVM code 82B8A256.
- Follow the on-screen prompts.
- Send Flash log online.
