Service Bulletin

PRELIMINARY INFORMATION

Subject: Buzz / Rattle Noise From Dash Or Front Of Vehicle

Models: 2015 - 2016 Cadillac Escalade Models
2015 - 2016 Chevrolet Suburban, Tahoe
2015 - 2016 GMC Yukon Models

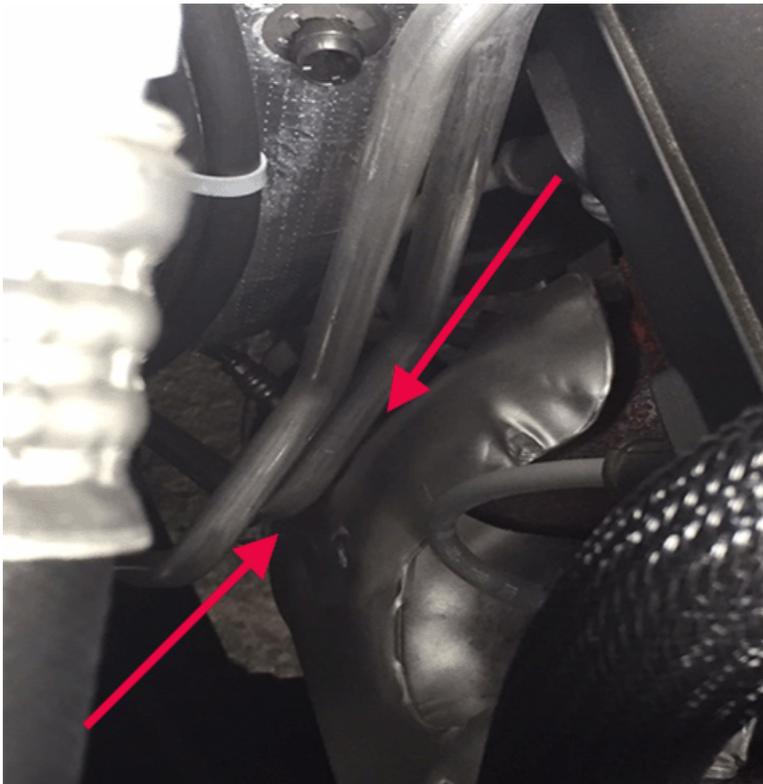
Some customers may comment that they hear a rattle or buzz noise from the dash or front of the vehicle. It may be most noticeable with engine RPM or when turning left or right.

Inspect for the rear heater pipes contacting the passenger side exhaust manifold. If the rear heater pipe is found to be contacting the exhaust manifold (as shown below), reposition the heater pipe so it no longer makes contact.

Labor Operation	Description	Labor Time
4480348 *	Reposition The Rear Heater Pipe	0.4 hr
* This is a unique labor operation for bulletin use only.
