Service Bulletin

PRELIMINARY INFORMATION

Subject: Rough Idle Crank No Start Extended Crank Or Misfire Due to Excessive Carbon On Top of the Valves or Sticking Valves

Models: 2000-2015 All Passenger Cars with Gasoline Engines
2000-2015 All Light Duty Trucks with Gasoline Engines

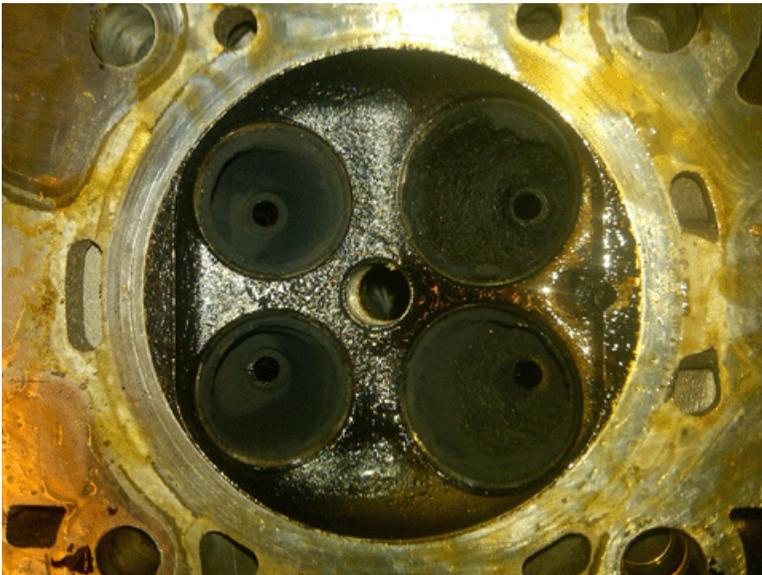
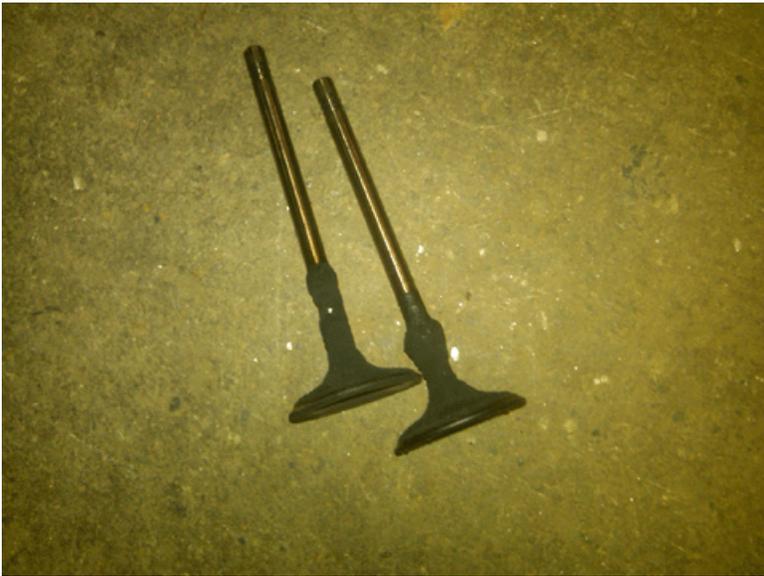
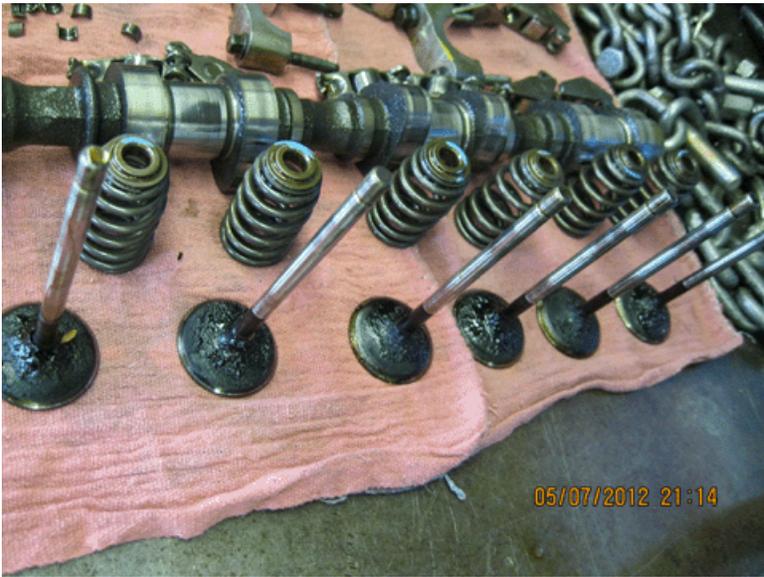
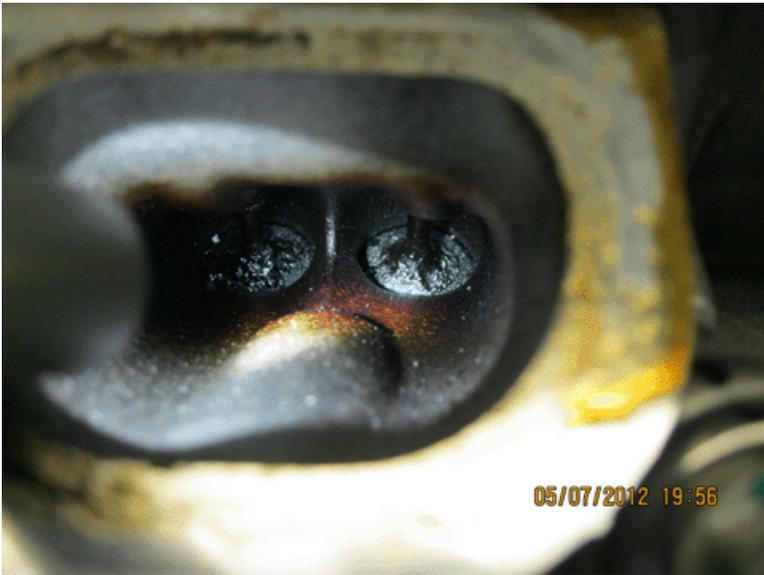
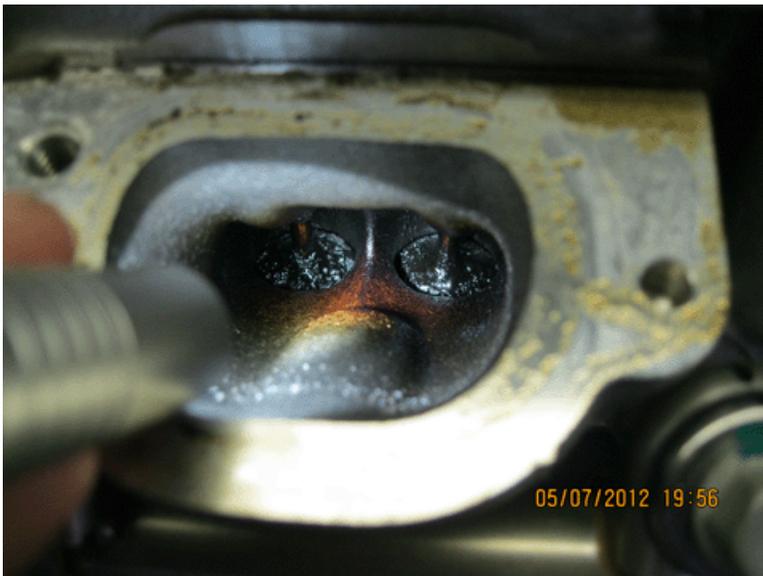
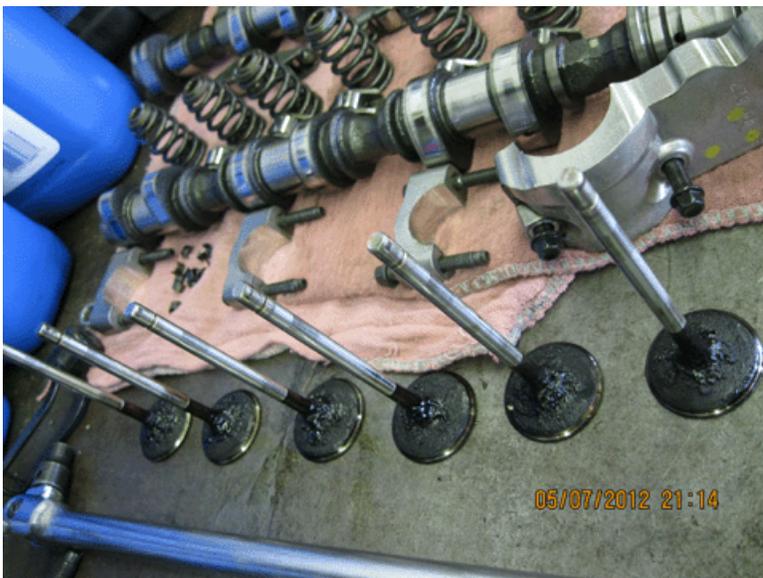
This may be the result of major carbon build up on the intake and/or exhaust valves due to fuel contamination or incomplete burning of the fuel as shown below so the misfires should not have appeared until accumulating at least 5,000 miles or more.

When the engine is cold, the compression on multiple cylinders may be at 0 PSI.

The engine also may pop through the intake or exhaust while cranking and the spark plugs may be fuel fouled when inspected.

Some engines may also experience valve damage or cam followers that are out of position as a result of this.

If there is no sign of valve damage or cam followers that are out of place, perform the following procedure to free up sticking valves and to remove carbon from the valves and pistons.

If valve damage is present or if there are cam followers that are out of place, perform engine mechanical repairs as necessary to correct the concern and then perform the procedure below to prevent the concern from returning.

Perform an upper engine and valve cleaning procedure as outlined below.
