LED Taillight Lens Fogged Up?

AFFECTED VEHICLES

2014–15 Accord with LED taillights

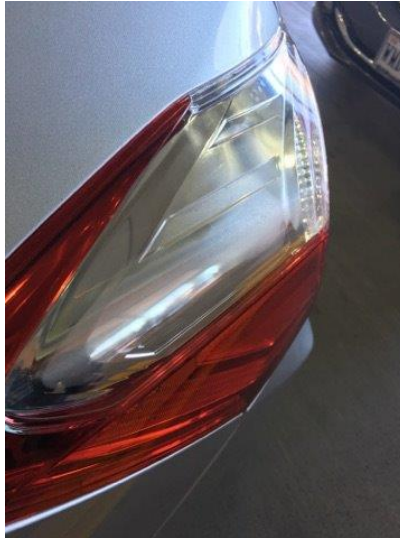
Is the LED taillight lens fogged up? It's really noticeable through the clear section of the lens if it is.

What you're seeing is probably just normal condensation resulting from the temperature difference between sun-heated air inside the taillight and cooler air outside.

To check if this is the case, start the engine and let it idle for **30 minutes** with the headlights turned on. If the condensation is gone after that time, it was just normal condensation, so **don't** replace the taillight!

Of course, if the condensation is still there, then do what's needed to fix the problem.
