Model(s)	Year	Eng. Code	Trans. Code	VIN Range From	VIN Range To
Golf, Tiguan, CC, Passat, Golf SportWagen, Jetta SportWagen	2013-2017	All	All	All	AII

87 16 12 July 19, 2016 **2043704** Supersedes Technical Bulletin V871606 dated May 25, 2016 to add additional models.

A/C Compressor Replacement, GFF Performance Test Required Regardless of Concern

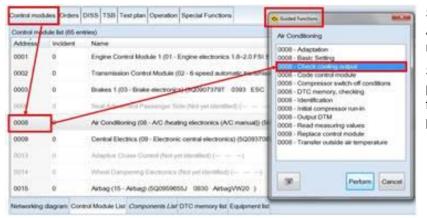
Figure 1: AC Performance test CC Tiguan, Golf, Golf SportWagen, Jetta SportWagen, Climatic/Climatronic

Select Guided Functions from 08 AC/heating electrical control module.

Select Check cooling performance from the Guided functions menu and select perform. (Figure 1)

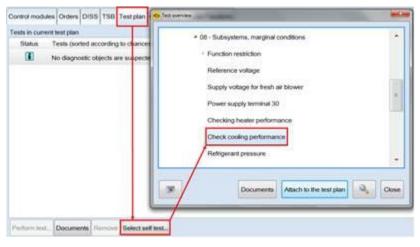
Figure 2: AC Perfomance test, Passat NMS.

Select the Test Plan tab from 08 AC/heating electrical control module.

Select self-test and locate the Check cooling performance test under the following sub menus.

Passat: Body/ Heating Ventilation-Air Conditioning/01 Systems Capable of selfdiagnosis/08 Air Conditioning-Heating Electronics/08 Subsystems marginal condition.
